SUBJ: RCRA Compliance Evaluation Inspection
Remington Outdoor Company
EPA ID Number: ALD981932882

RCRA Inspection Report

REMINGTON OUTDOOR COMPANY

COMPLIANCE EVALUATION INSPECTION PHOTOGRAPHS

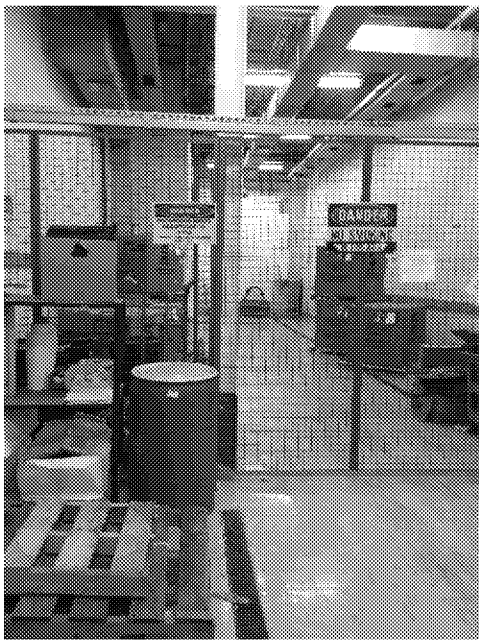
The less than 90-day hazardous waste storage area (HWSA) was enclosed with gate (Pictures 1). The inspectors observed the following enclosed in the area (Pictures 2-10):

Picture [SEQ Picture * ARABIC] – HWSA gate

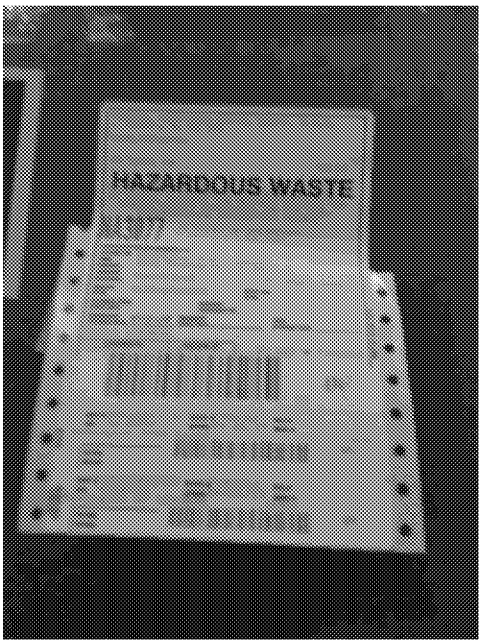
- A Gaylord box and two 55-gallon drums of hazardous waste Goff blast media pending analysis and profile;
- A 4-foot and 8-foot universal waste lamp boxes;
- Eight 30-gallon drums of hazardous waste black oxide;
- Three Gaylord boxes of hazardous waste lead contaminated filters;
- Three Gaylord boxes of non-regulated oil and absorbent pads; and
- A new 30-gallon drum of lead contaminated personal protective equipment (PPE) hazardous waste being labeled during the inspection.

Picture [SEQ Picture * ARABIC] – HWSA waste pending analysis

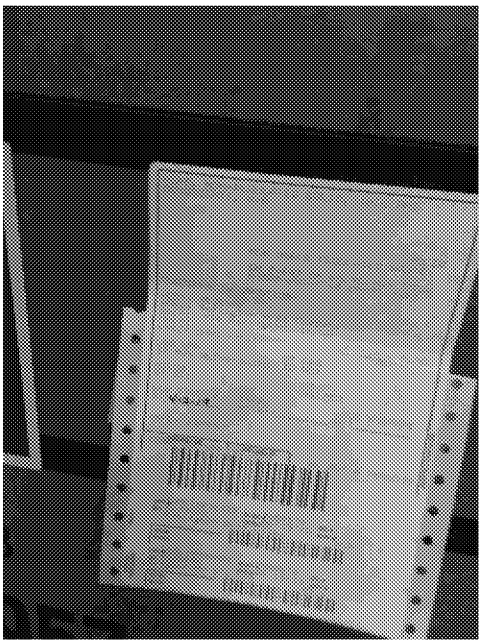
Picture [SEQ Picture * ARABIC] – HWSA label

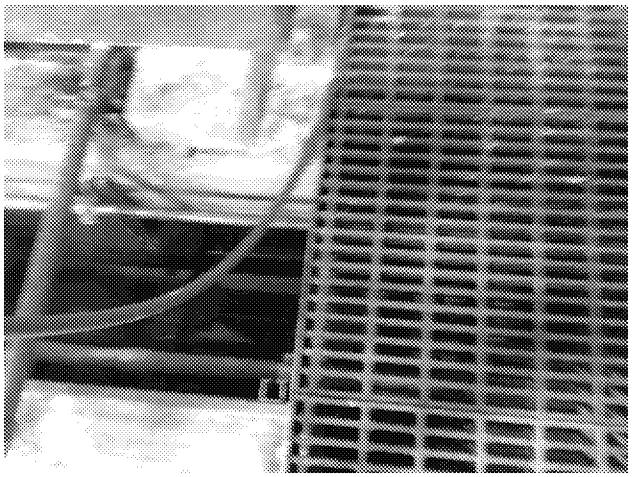
Picture [SEQ Picture * ARABIC] – Black Oxide Area floor grate

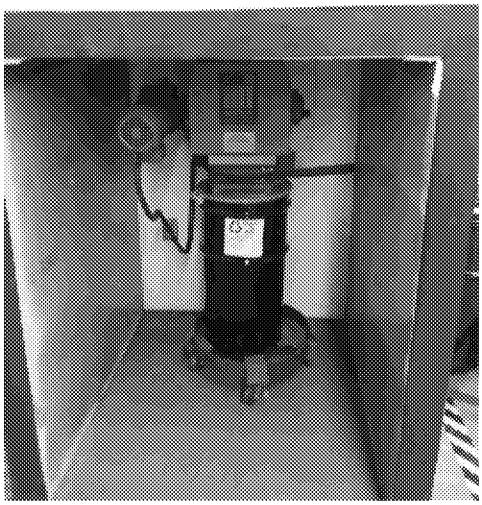
At the time of the inspection, the 100-meter was in not operation. Outside of the range was conveyor box with a 16-gallon drum to capture lead debris (Picture 23).

Picture [SEQ Picture * ARABIC] –100 Meter Range conveyor box debris drum
