SUBJ: RCRA Compliance Evaluation Inspection
Kohler Company
EPA ID Number: ALD05702558

RCRA Inspection Report

Kohler Company
176 Cochran Road
Huntsville, Alabama 35824
Sumter County
EPA ID: ALD05702558

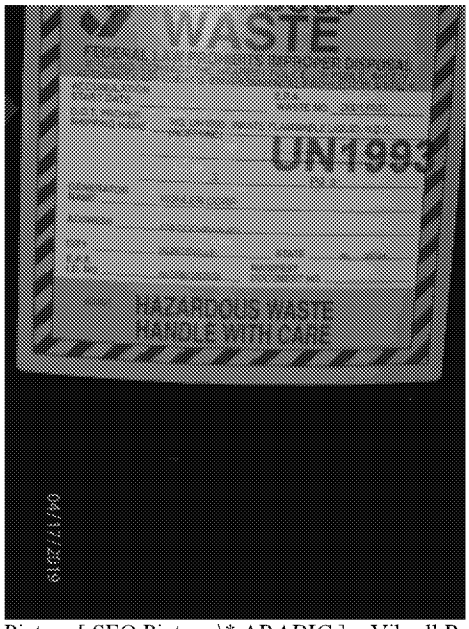
Picture [SEQ Picture * ARABIC] – Vikrell Room hazardous waste drum label

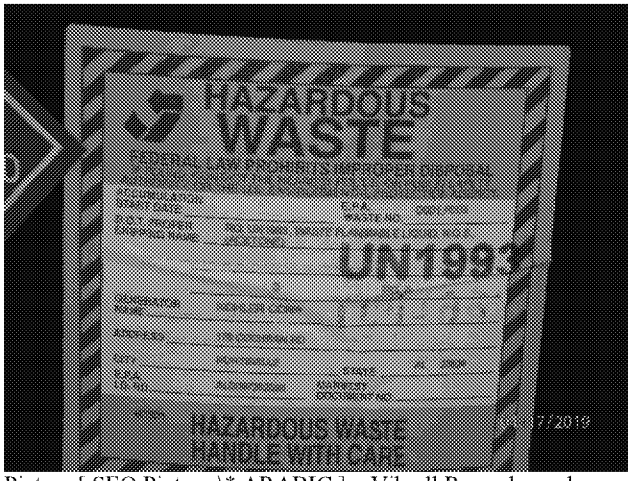
Picture [SEQ Picture * ARABIC] – Vikrell Room hazardous waste drum not labeled

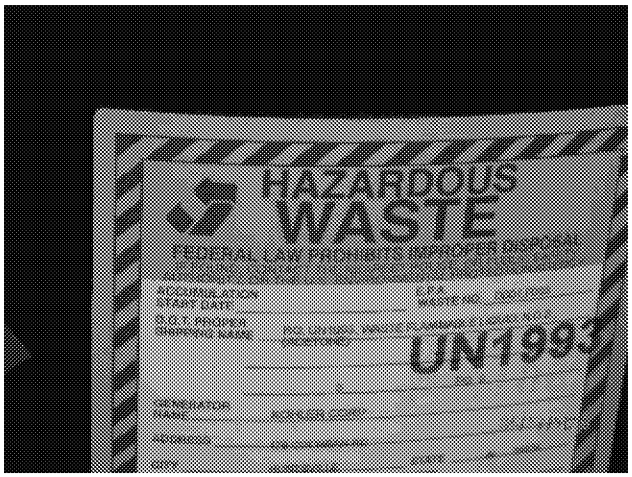
Picture [SEQ Picture * ARABIC] – Vikrell Room hazardous waste drums

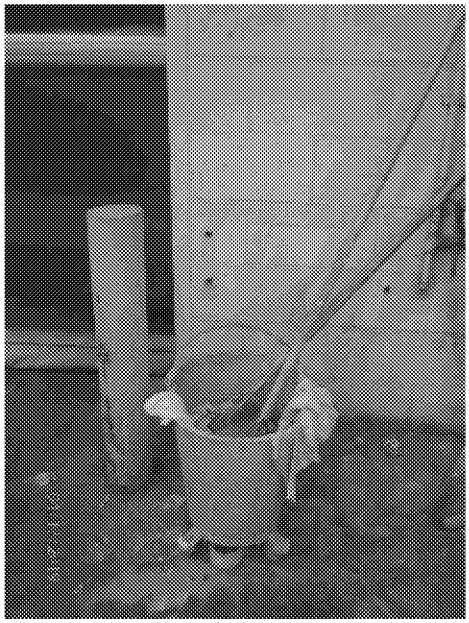
Picture [SEQ Picture * ARABIC] – Vikrell Room acetone bucket used for cleaning

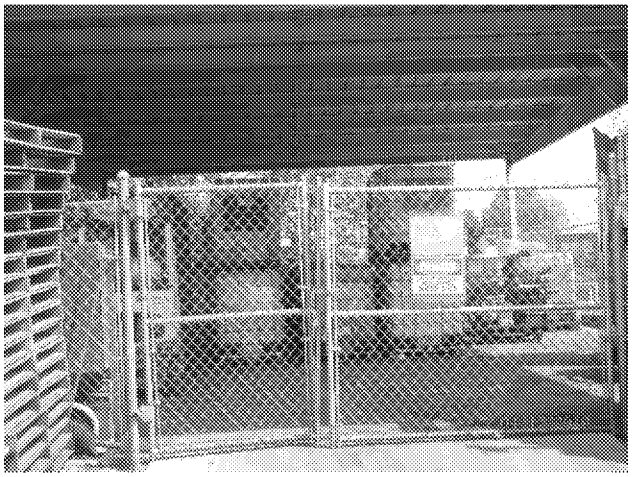
Picture [SEQ Picture * ARABIC] – HWSA

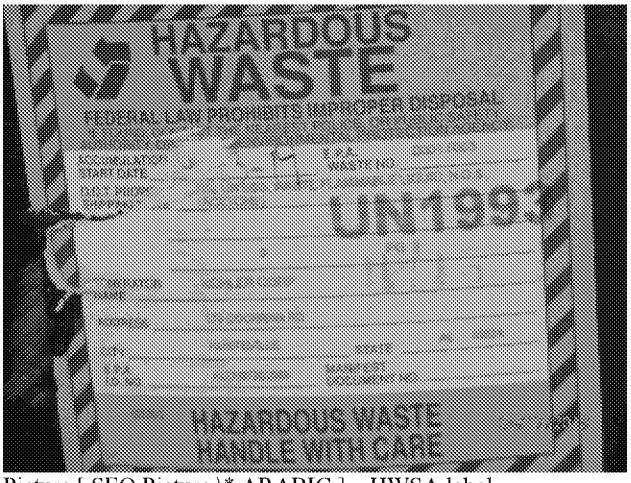
Picture [SEQ Picture * ARABIC] – HWSA drums of resin silo clean out

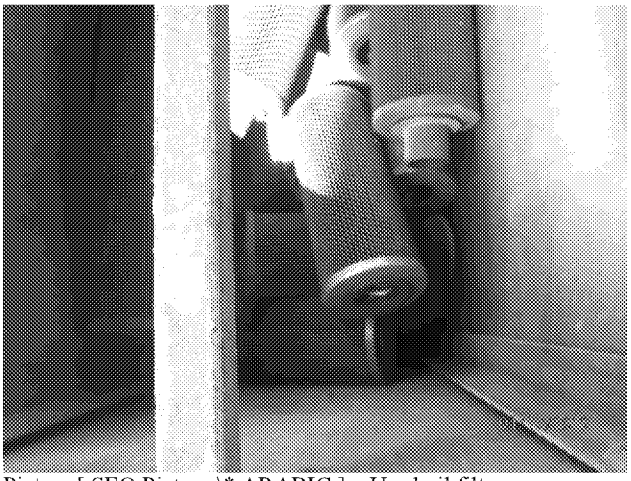
Picture [SEQ Picture * ARABIC] – Used oil storage

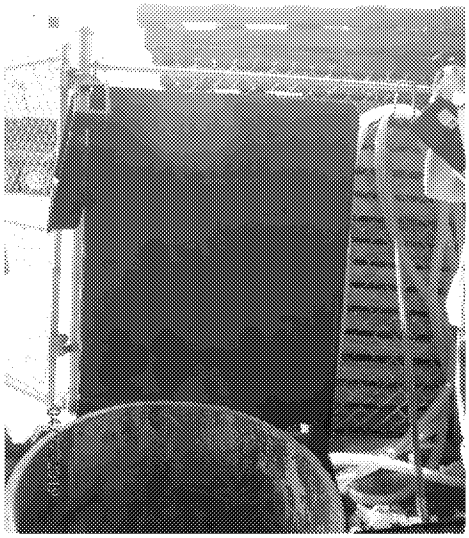
Picture [SEQ Picture * ARABIC] – Used oil storage container open

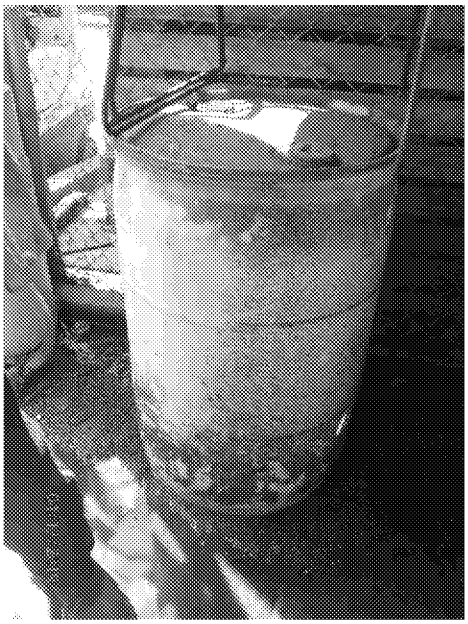
Picture [SEQ Picture * ARABIC] – Used oil storage filter station

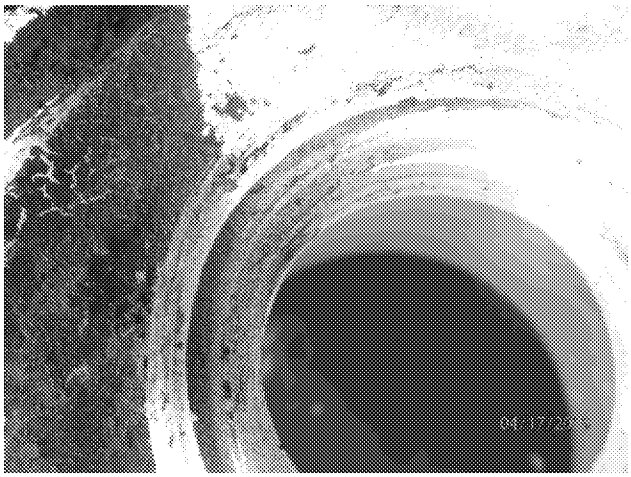
Picture [SEQ Picture * ARABIC] – Used oil storage white use oil drum open, unlabeled

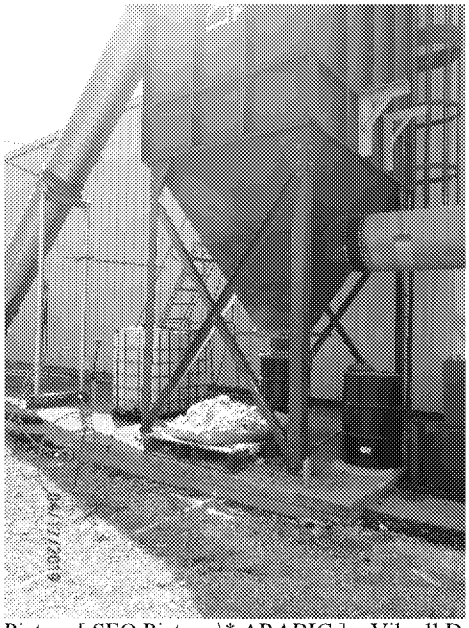
Picture [SEQ Picture * ARABIC] – Vikrell Dust Collector unknown waste drum

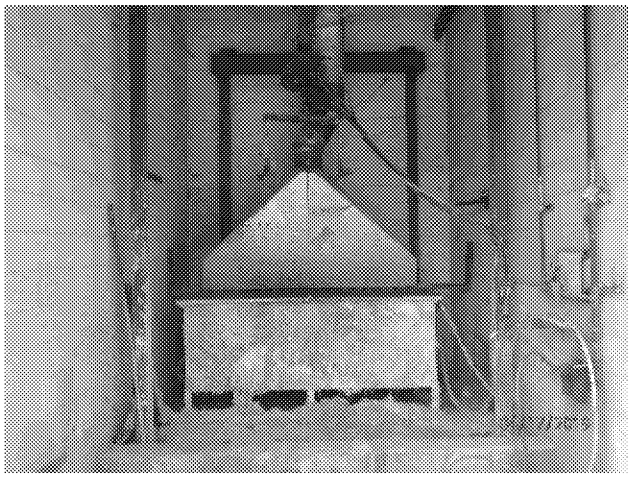
Picture [SEQ Picture * ARABIC] – Vikrell Dust Collector fiberglass waste

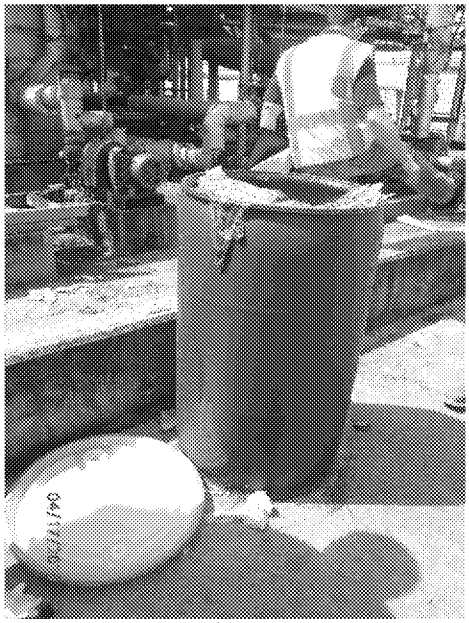
Picture [SEQ Picture * ARABIC] – Acetone Chain Cleaner building

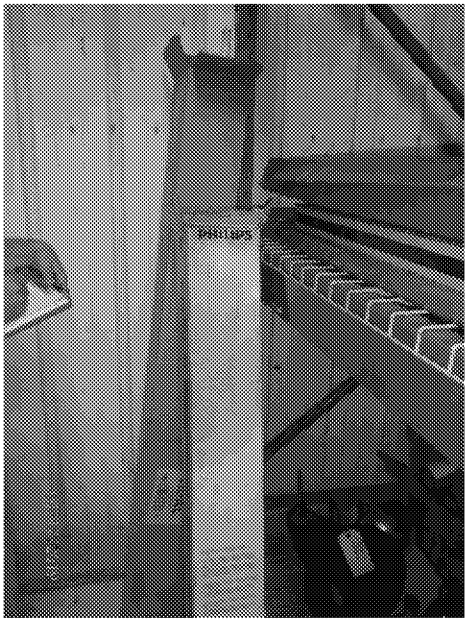
Picture [SEQ Picture * ARABIC] – Maintenance unknown drum

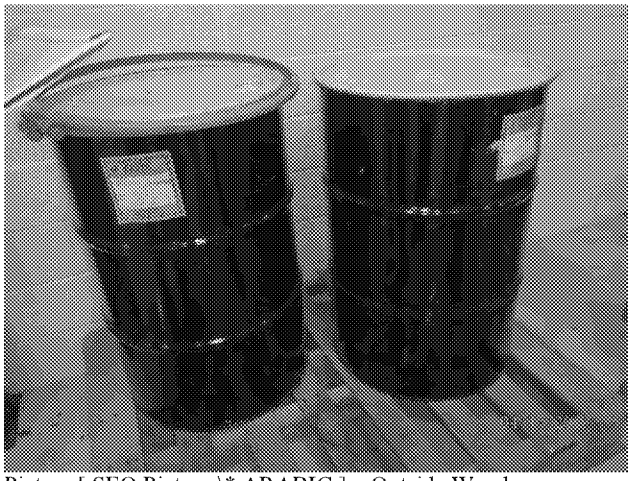
Picture [SEQ Picture * ARABIC] – Outside Warehouse (Lowes) open unlabeled SAA

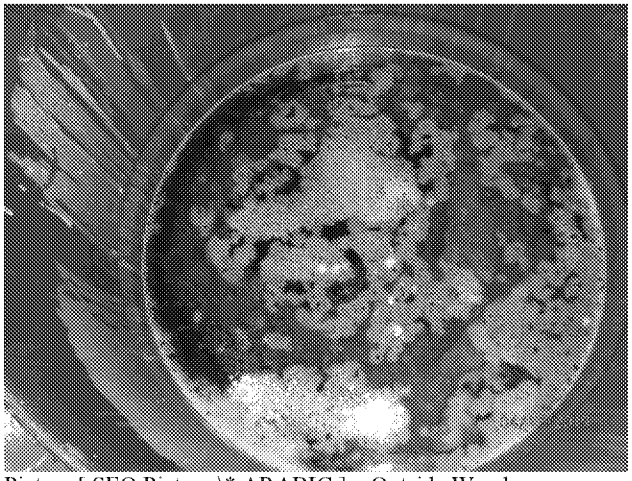
Picture [SEQ Picture * ARABIC] – Outside Warehouse (Lowes) Direct Print waste acetone SAA open

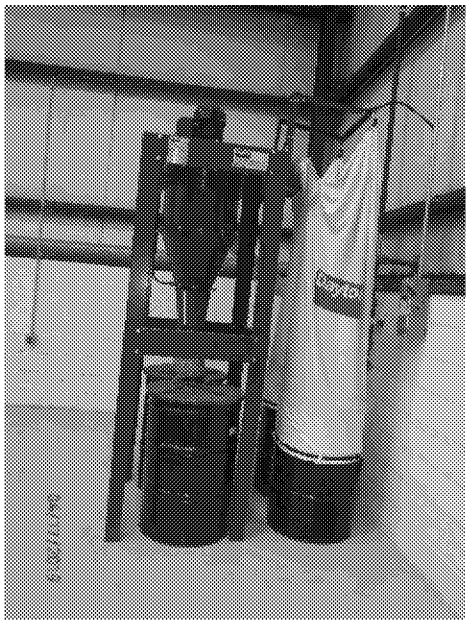
Picture [SEQ Picture * ARABIC] – Outside Warehouse (Lowes) Direct Print waste acetone SAA label
