SUBJ: RCRA Compliance Evaluation Inspection
Benjamin Moore and Company
EPA ID Number: ALD981472798

RCRA Inspection Report

Benjamin Moore and Company
109 Bamberg Drive
Pell City, Alabama 35125
St. Clair County
EPA ID: ALD981472798

June 26, 2019 at 10:00 a.m. CDT

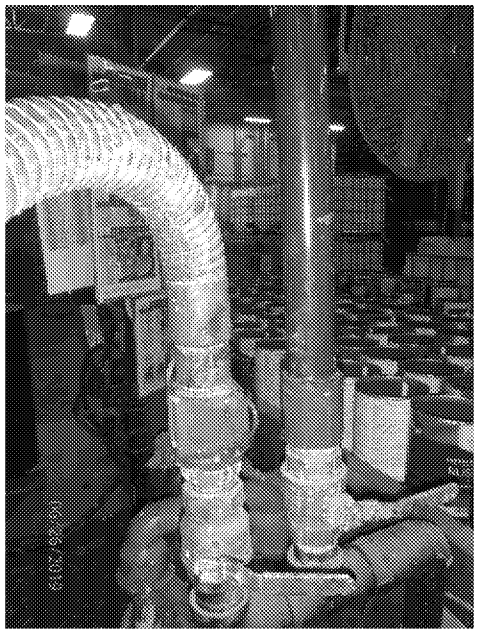
The inspectors observed that the Filling Line had four 55-gallon drums staged to capture the Alkyd fill tank flush (Picture 4). The dirty solvent flush lines were not marked (Pictures 1-3), but the lines are not currently connected to the hazardous waste tank which has been taken out of commission. Instead the dirty solvent is being piped in the 55-gallon drums. The drums were empty at the time of the inspection.

Picture [SEQ Picture * ARABIC] – Filling Line dirty solvent piping

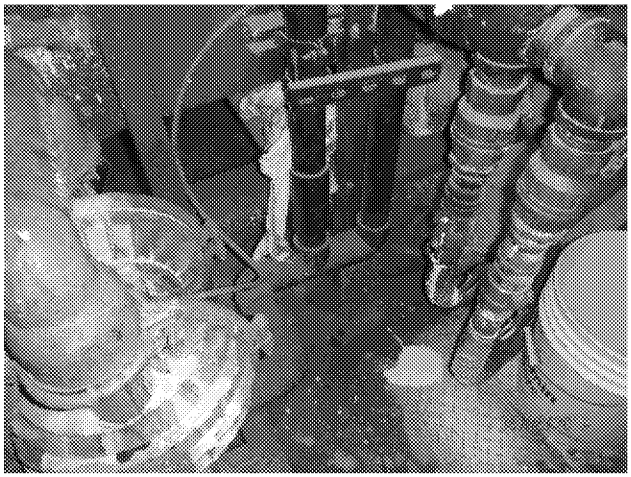
Picture [SEQ Picture * ARABIC] – Filling Line dirty solvent piping

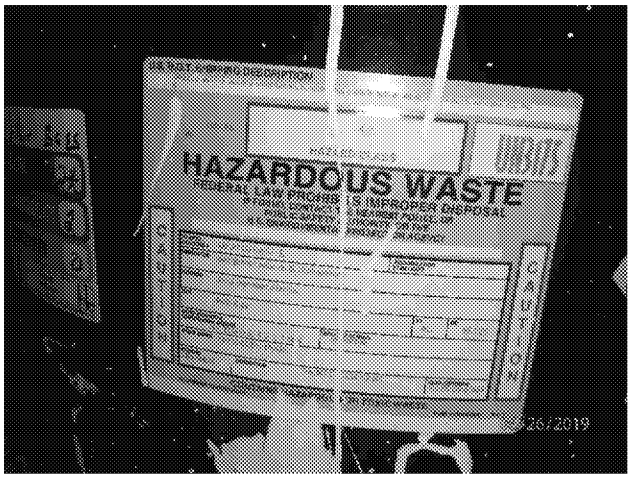
Above the Filling Line were the Fill Tower Tanks. The inspectors observed a 55-gallon satellite accumulation area (SAA) drum of hazardous waste filter bags (Pictures 5-6). The filter bags are generated from the changeover of paint formulations. The drum was closed and labeled. The inspectors also observed a 5-gallon container with a discarded hazardous waste filter bag inside (Pictures 7-8). Mr. Power explained that the 5-gallon containers are used to carry the dirty solvent filter bag to the drum and prevents releases to the area. However, the container was not labeled or closed.

Pursuant to ADEM Admin. Code r. 335-14-3-.01(5)(a)5 [40 C.F.R. § 262.15(a)(5)], which is a condition of the SAA Permit Exemption, a generator is required to mark or label its containers (i) with the words "Hazardous Waste" and (ii) with an indication of the hazards of the contents.

Picture [SEQ Picture * ARABIC] – Filling Line HW filter bag SAA label

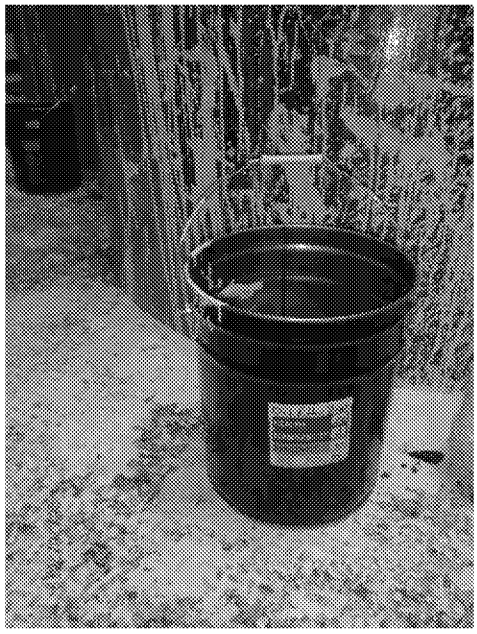
Pursuant to ADEM Admin. Code r. 335-14-3-.01(5)(a)4 [40 C.F.R. § 262.15(a)(4)], which is a condition of the SAA Permit Exemption, a generator is required to keep containers of hazardous waste closed at all times during accumulation, except when adding, removing, or

Picture [SEQ Picture * ARABIC] – Filling Line HW filter bag

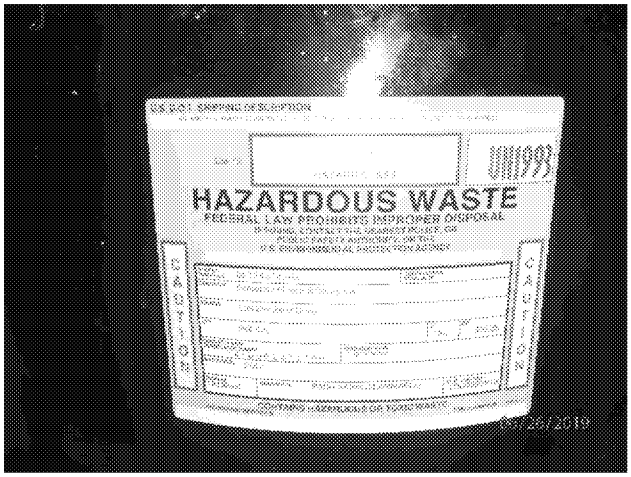
The inspectors observed the Small Batch Process, a smaller version of the main production area, that specializes in specific customer needs. The SAA contained a 55-gallon hazardous waste drum of paint filter bags and a 55-gallon hazardous waste drum of paint skins (Pictures 9-11). The drums were closed and labeled.

Picture [SEQ Picture * ARABIC] – Small Batch Process SAA

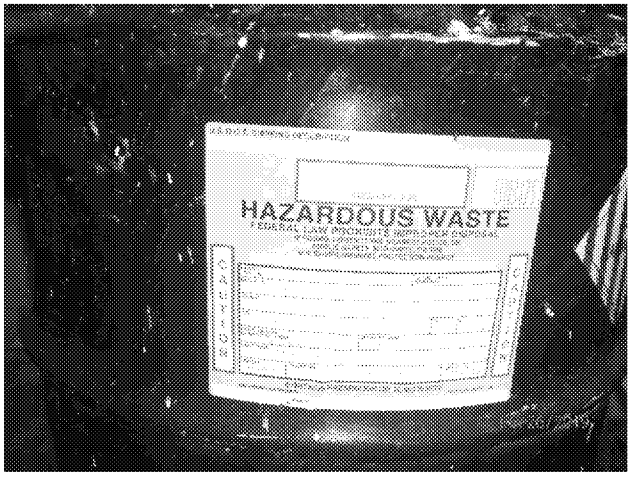
Picture [SEQ Picture * ARABIC] – Small Batch Process SAA

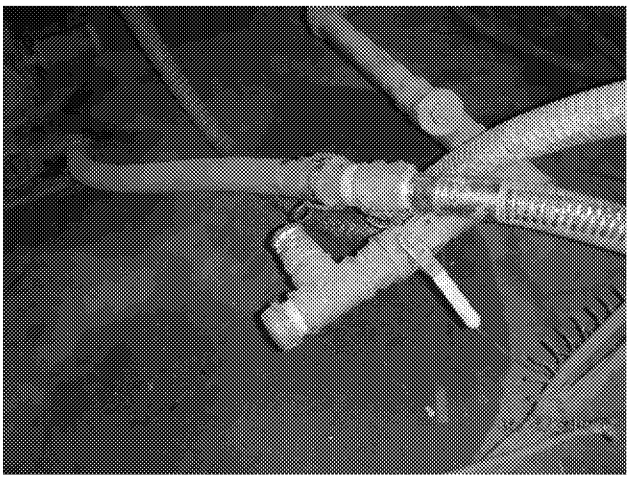
The main warehouse has final product stored in the center aisle and raw materials on the side aisles. This warehouse also houses the solvent tanks and the solvent still. The solvent recovery dirty tank, SRD1 was disconnected from all piping receiving dirty solvent (Pictures 12-16). During the December 18, 2018 RCRA inspection by ADEM, the inspector, Mr. Corey Holmes, observed that the tank and its auxiliary connections were not tagged or monitored for leak detection, daily inspections were not conducted on the tank, the tank was not labeled as hazardous waste and the tank did not have an integrity test conducted by a professional engineer.

Picture [SEQ Picture * ARABIC] – Warehouse Solvent Recovery Dirty tank piping

Mr. Power and Mr. Breckenridge explained to the inspectors that the company had a tank integrity test conducted and found that it was beneficial to discontinue use and disconnect the tank based on the engineering report. A new tank has been ordered to replace the existing tank. Mr. Power assured the inspectors that the new tank will be installed according to the RCRA tank requirements and monitored as required.

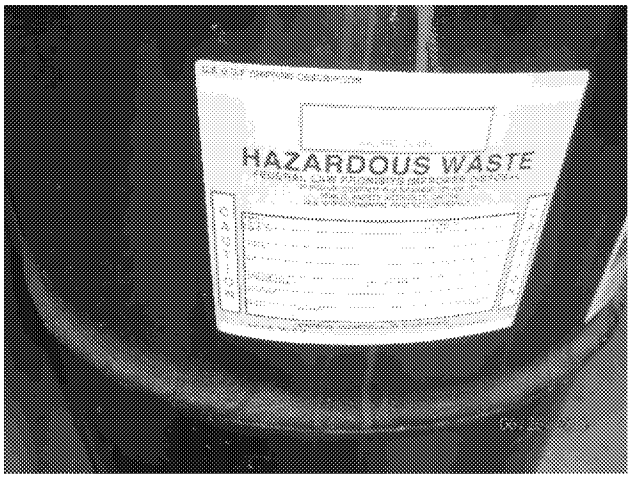
gallon container of latex waste, two silver one-gallon containers of latex waste, a black 5-gallon container of lab waste that did not have hazardous waste label (Pictures 20-22), a cart with spent aerosol cans to be punctured that were not labeled (Picture 23), and a red fire can of xylene used for cleaning paint brushes (Picture 24).

Pursuant to ADEM Admin. Code r. 335-14-3-.01(5)(a)5 [40 C.F.R. § 262.15(a)(5)], which is a condition of the SAA Permit Exemption, a generator is required to mark or label its containers (i) with the words "Hazardous Waste" and (ii) with an indication of the hazards of the contents.

Picture [SEQ Picture * ARABIC] – Low Flash Lab SAA drum label

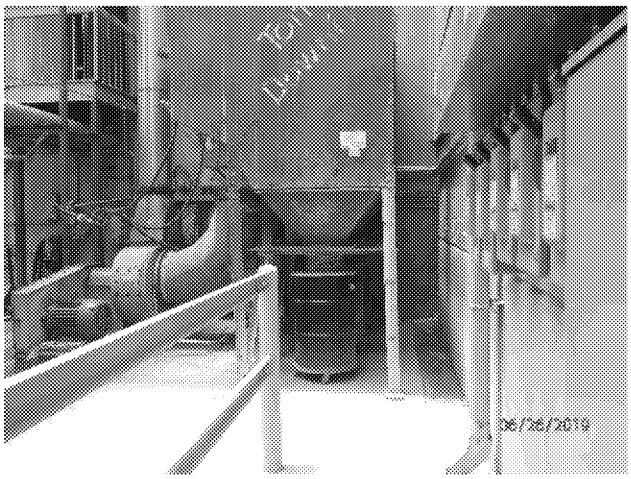
During the tour, the inspectors observed an outside baghouse. Mr. Power explained that the facility has five baghouse hoppers for pigment dust. The baghouse the inspectors observed had three hoppers with 55-gallons drums underneath (Pictures 28-29). The pigment dust is disposed of as non-hazardous waste.

The inspectors requested and reviewed the waste profile for Baghouse Pigment Dust. The Baghouse Pigment Dust waste profile was non-hazardous, but the waste profile did not specify if the determination was based on generator knowledge or sampling analyses. No sampling analyses was provided for review.

Picture [SEQ Picture * ARABIC] – Pigment Dust Baghouse and drums
