SUBJ: RCRA Compliance Evaluation Inspection
Alabama and Gulf Coast Railway
EPA ID # ALR000046706

RCRA Inspection Report

Alabama and Gulf Coast Railway
721 Hixon Road
Monroeville, Alabama 36460
Monroe County
EPA ID: ALR000046706

August 9, 2017 at 8:30 a.m. CDT

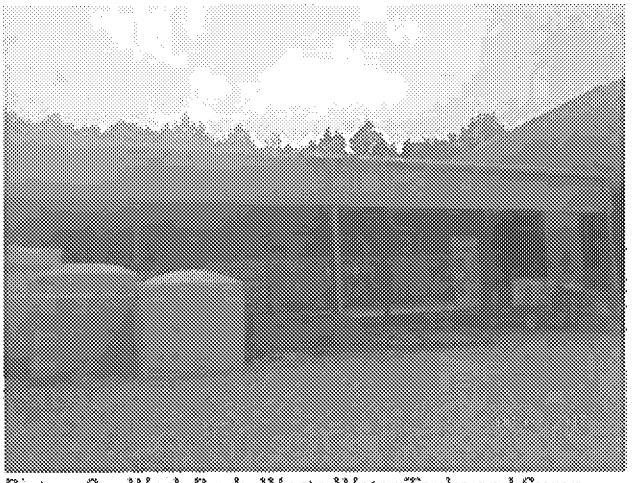
The inspectors observed three 2,500-gallon waste water tanks and an underground sump tank covered in plastic to prevent rain runoff. (Pictures 1, 2, 7, 8, and 9). The tanks receive waste water from the Railcar Wash Rack and the waste water is considered to be non-hazardous. The aboveground tanks were observed labeled and closed. Mr. Salter stated that AGR was planning to replace the tanks in the future.

Picture 1 – Wash Rack, Waste Water Tanks and Sump Tank

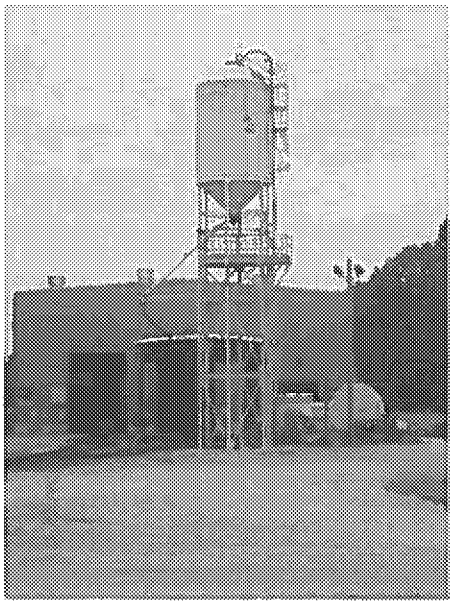
Picture 4 – Water Tank and Railcar Bays

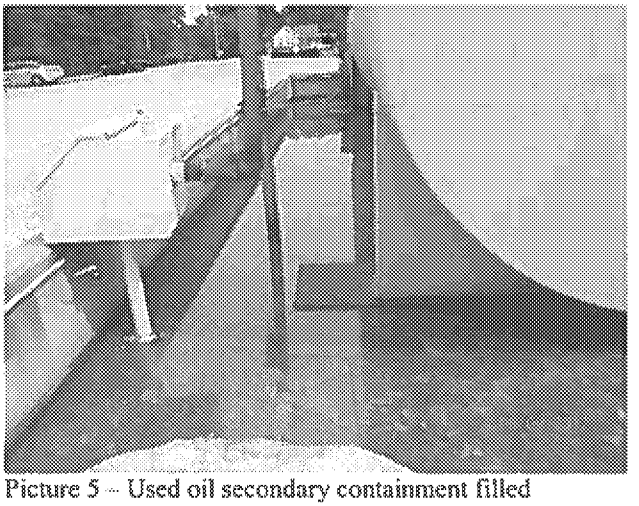
Picture 5 – Used oil secondary containment filled rainwater

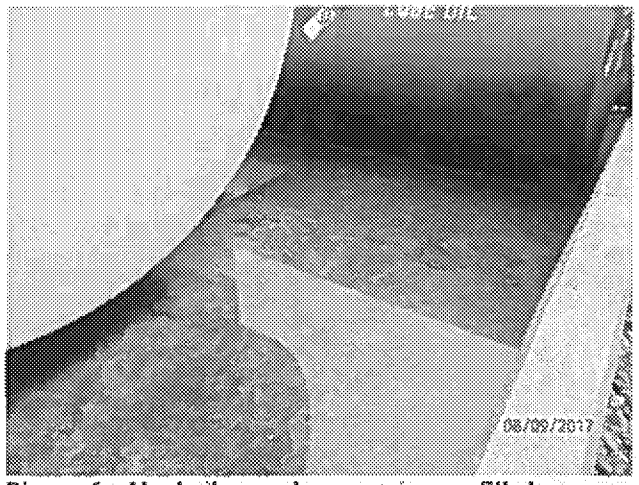
Beside the wash rack was were two fuel tanks inside secondary containment (Pictures 5-6). Due to the recent rains, the secondary containment was filled with water, algae and oily residue. The inspectors recommended cleaning out the secondary containment.

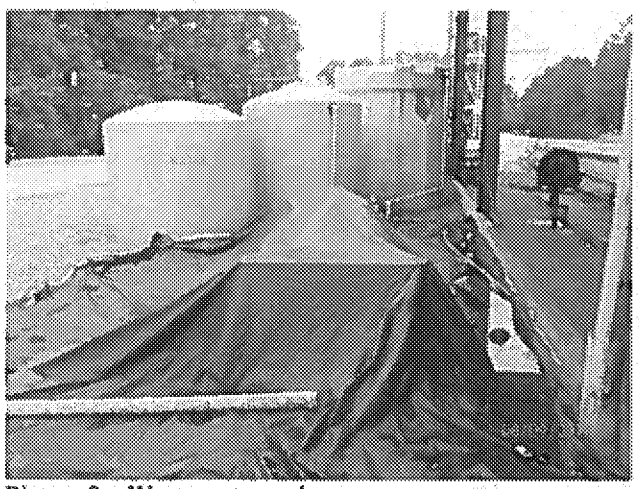
Picture 9 – Waste water tanks

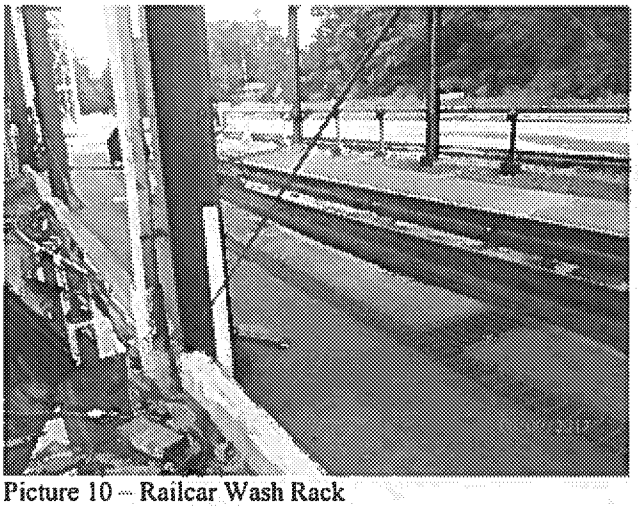
The inspectors observed a single rail line wash rack under an overhang (Pictures 10-11). The wash rack is used to clean the AGR railcars. Steam Cleaner Concentrate, manufactured by Covington Cleaner and Equipment, is used for the railcar cleaning (Picture 46). The inspectors noted that the concentrate was labeled as corrosive.

Picture 10 – Railcar Wash Rack

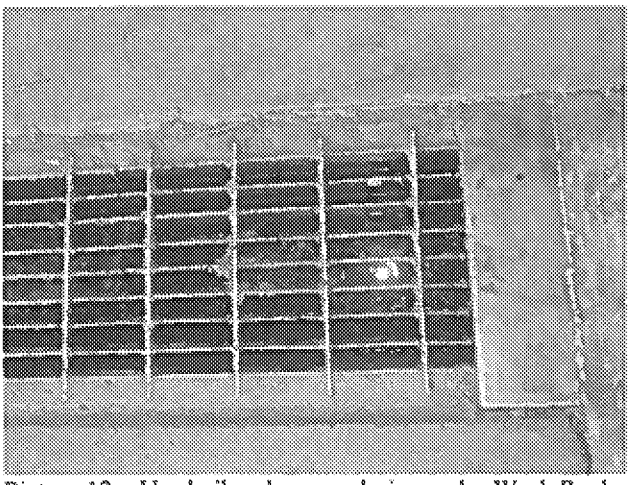
Picture 12 – Used oil and grease drains under Wash Rack

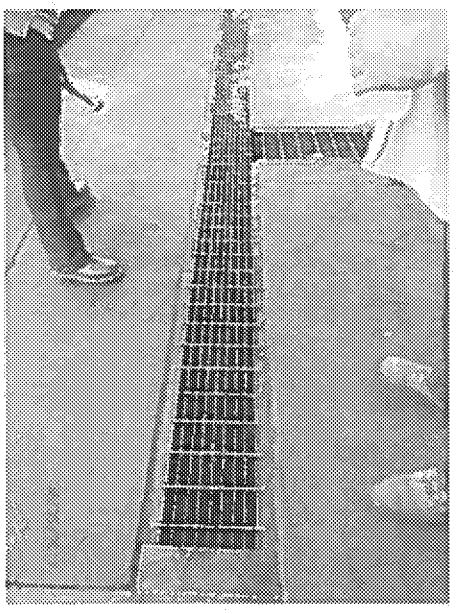
The ground around the wash rack rail was covered in oily sludge from the oil hose and the sand applied to the railcar (Pictures 15-17). Underneath the tracks is a grated drain that drains to the underground sump tank (Pictures 12-14). At the time of the inspection, the grated drain was filled with spilled oil and sand. Mr. Salter explained that the wash rack area is cleaned every three weeks.

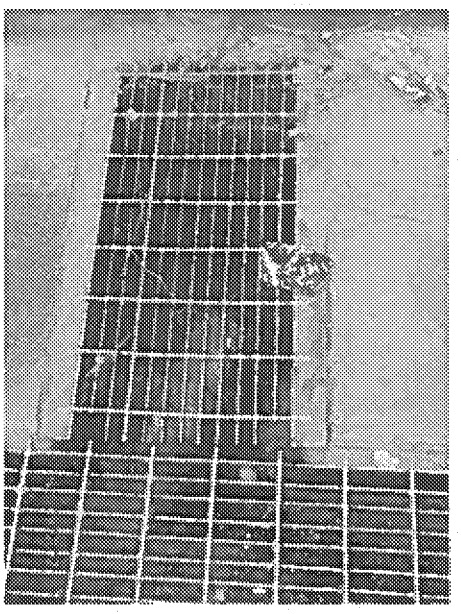
Picture 13 – Used oil/grease drains under Wash Rack

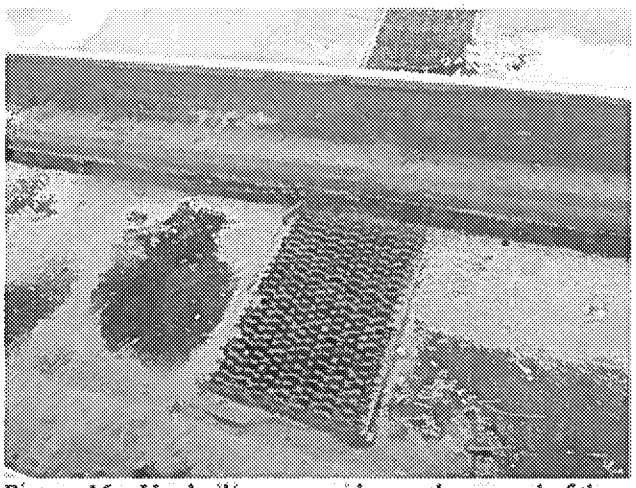
Picture 15 – Used oil/grease residue on the ground of the Wash Rack

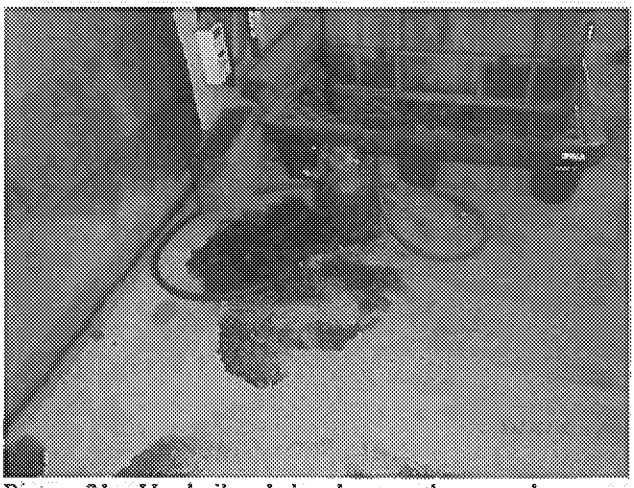
- One 300-gallon used oil tote labeled "Damaged," was not closed, half full and sitting on secondary containment. Mr. Salter explained that the tote could only be half filled because of the damage near the top of the tote (Pictures 18, 20).

Pursuant to ADEM Admin. Code r. 335-14-17-.03 (4)(a) 1., a container holding used oil must always be closed during storage, except when it is necessary to add or remove used oil.

Picture 20 – Open Used Oil Tote marked Damaged

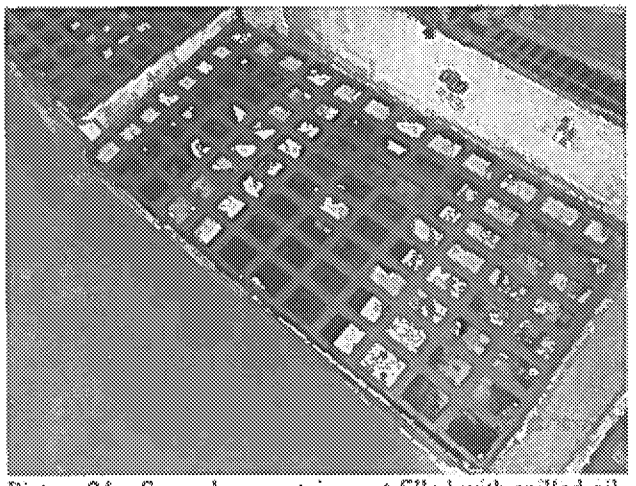
- Two secondary containments in front of the 300-gallon totes were filled with used oil and had not been labeled or cleaned out (Pictures 23-24).
- Two secondary containments underneath oil totes were filled with released oil that was not usable (Pictures 25-27). The containments were not labeled or cleaned out.

Pursuant to ADEM Admin. Code r. 335-14-17-.03(4)(d) [40 C.F.R. § 279.22(d)], upon detection of a release of used oil to the environment, the facility must clean up and manage properly the released used oil and other materials.

Picture 23 – Secondary containment filled with spilled oil

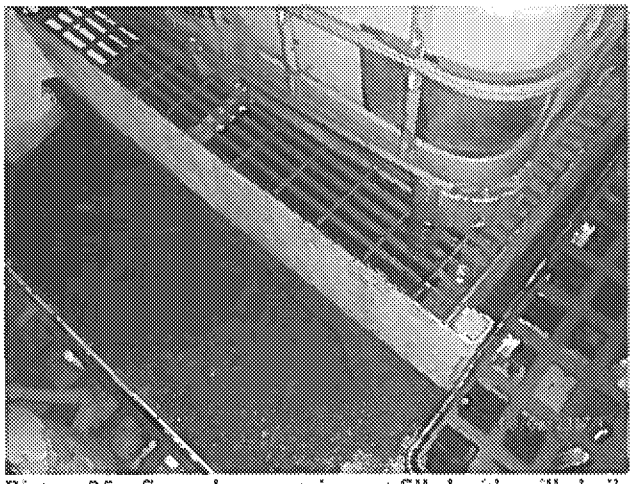
Picture 24 – Secondary containment filled with spilled oil

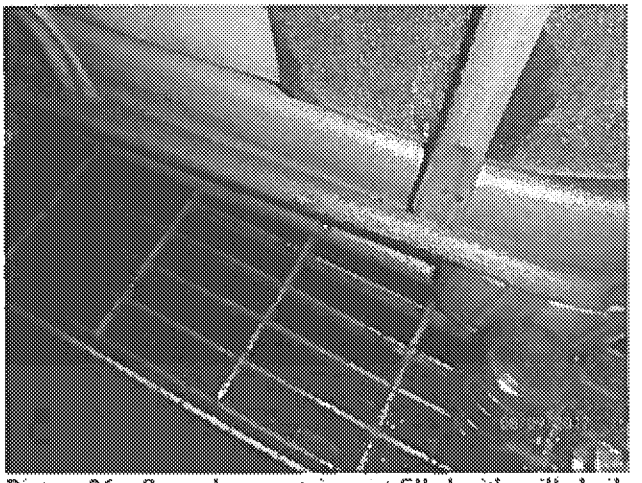
- The floor around the product oil totes was covered in spilled oil and absorbent, and had not been cleaned up (Picture 25).
- The pit area underneath the locomotives being maintained drains directly the underground sump tank.

Picture 25 – Secondary containment filled with spilled oil and used oil release/absorbent on the ground

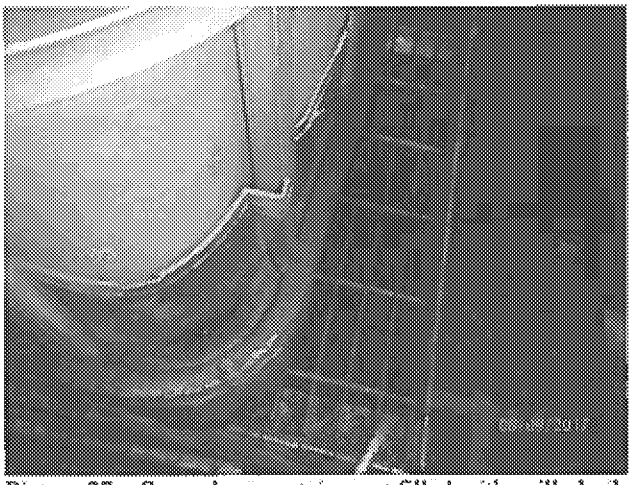
Picture 26 – Secondary containment filled with spilled oil

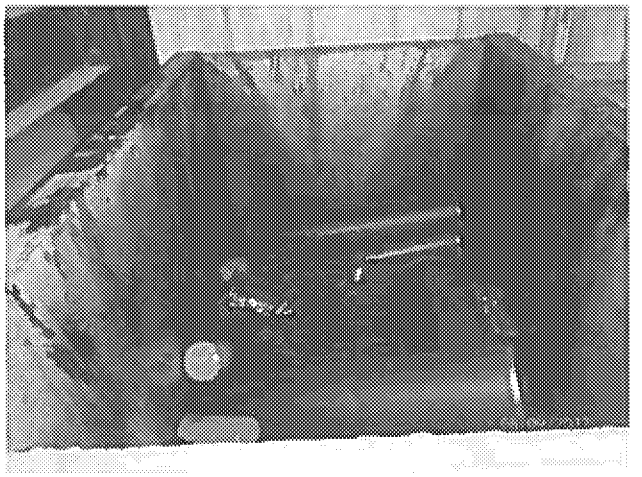
- A Heritage Crystal Clean parts washer with non-hazardous solvent (Picture 29).
- A 55-gallon satellite accumulation drum of spent aerosol can residue with a can puncture system on top (30-33). Next to the aerosol residue drum was a container for the punctured cans. The can puncture system was labeled, not closed and the drum was one-third full. Mr. Salter closed the puncture system lid during the inspection.

Picture 33 – Locomotive Shop aerosol can puncture drum

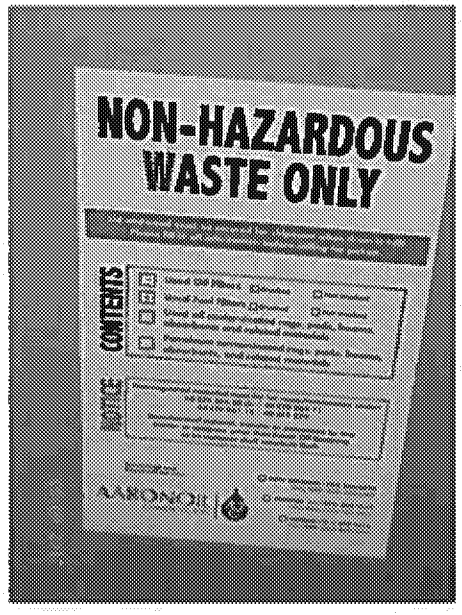
- Two yellow totes of used oil and spent diesel, and used oil and used diesel filters (Pictures 34-37, 39-42). One tote was located near the rear of the shop by the door, and the other totes was located in the middle of the shop beside a locomotive. The totes were not closed and had labels but not sufficiently marked as "Used Oil."

Picture 36 – Locomotive Shop used oil tote with filters

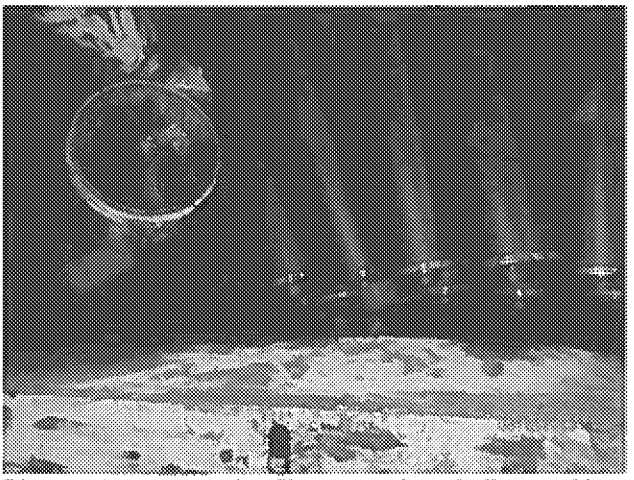
Picture 39 – Locomotive Shop second used oil tote with filters

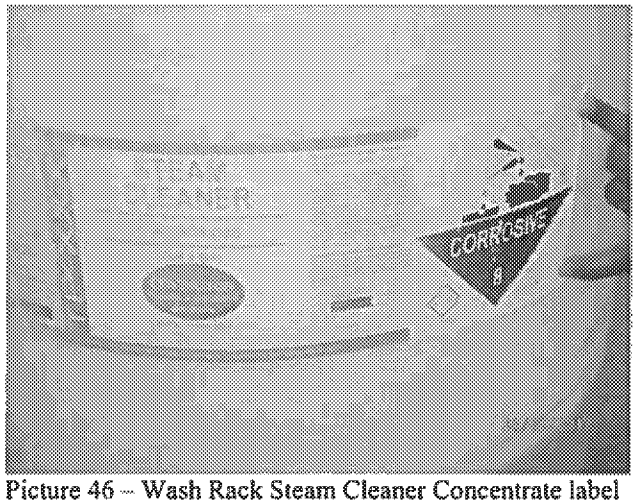
Picture 46 – Wash Rack Steam Cleaner Concentrate label

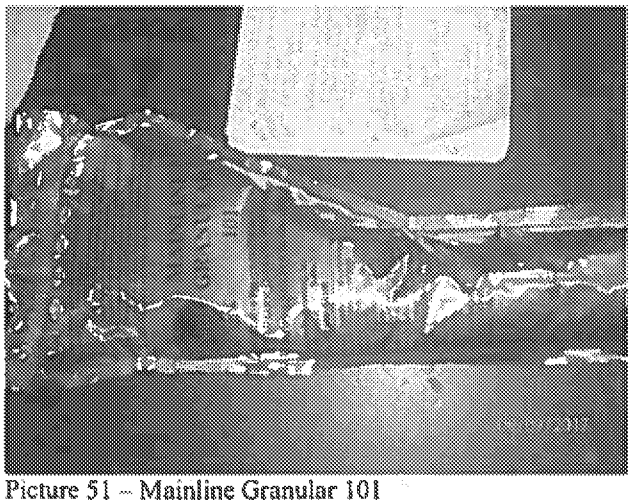
Picture 51 – Mainline Granular 101

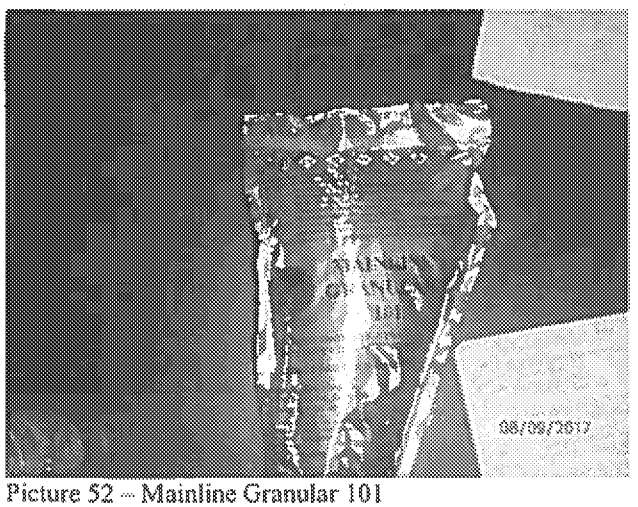
Picture 52 – Mainline Granular 101
