Defense-Related Uranium Mines Location and Status Topic Report

Final

August 2014

U.S. DEPARTMENT OF ENERGY | Legacy Management

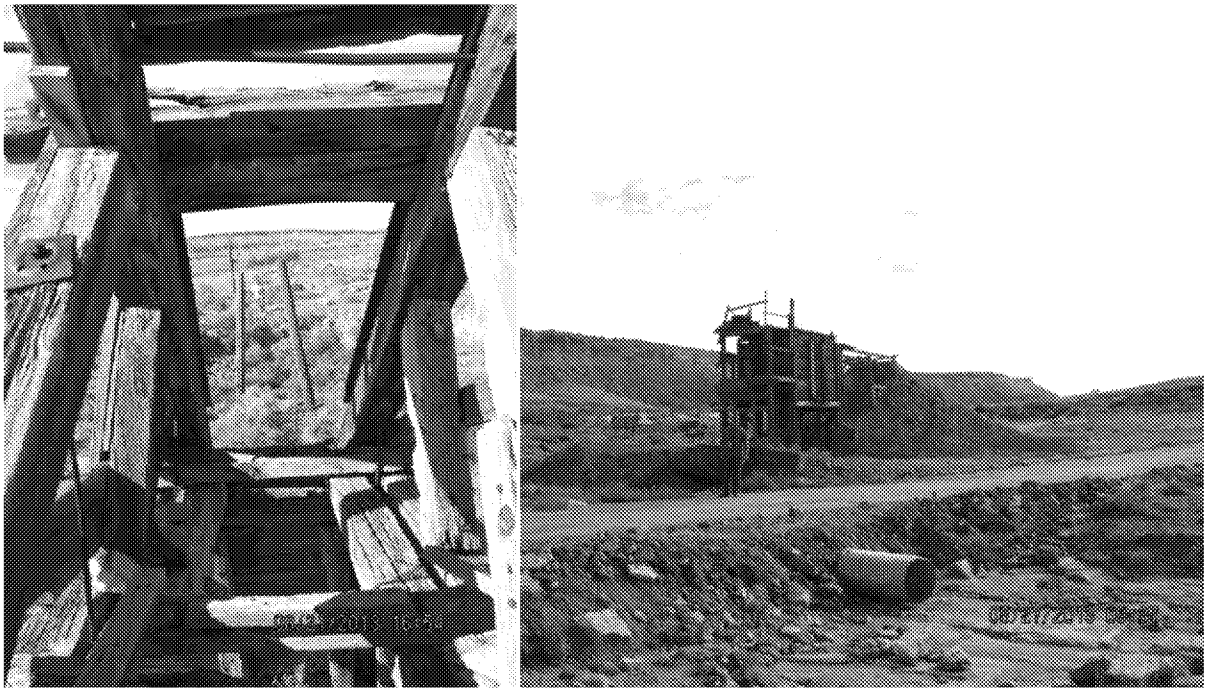
Figure 17. Grants Mineral Belt, New Mexico—Wooden Support Infrastructure (Left); Yellow Cat District, Utah—Support Infrastructure and Waste-Rock Pile (Right)

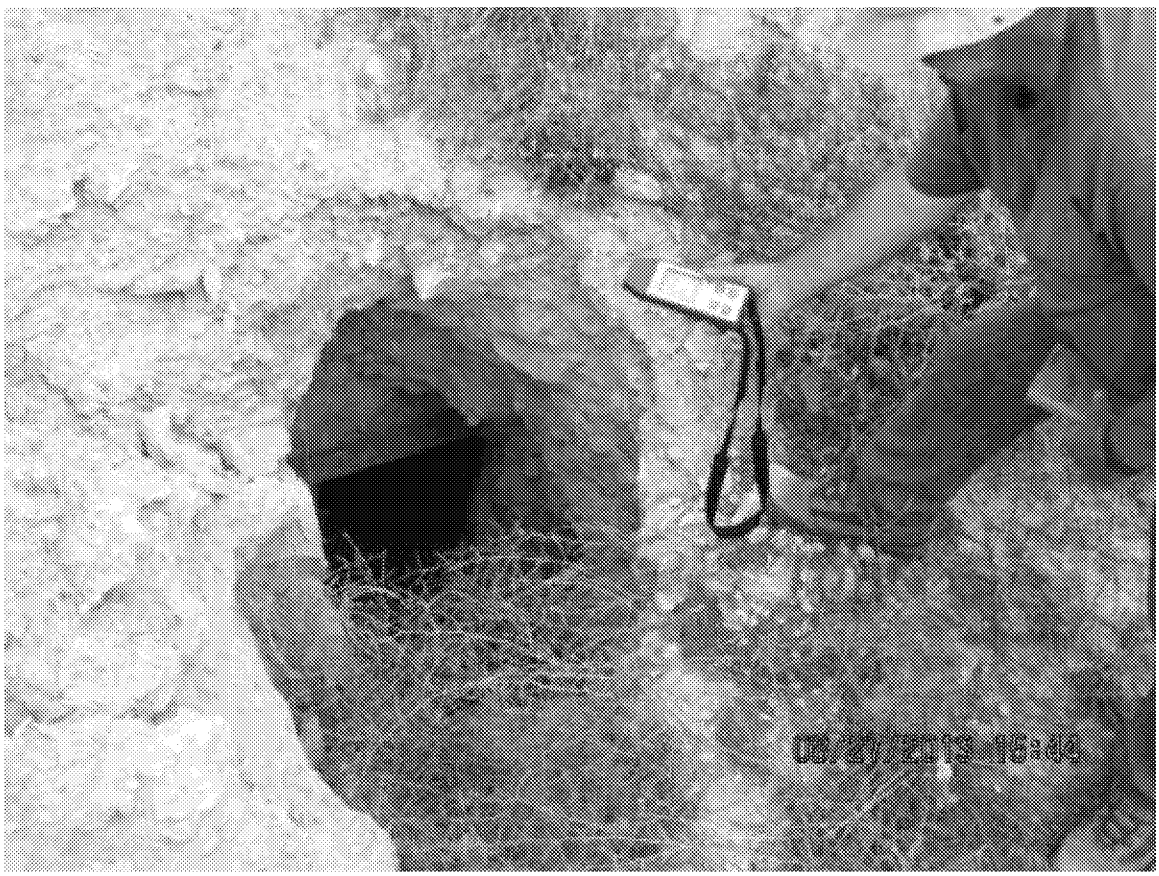
Figure 18. Collecting Gamma Measurements at Mine Opening, Yellow Cat District, Utah

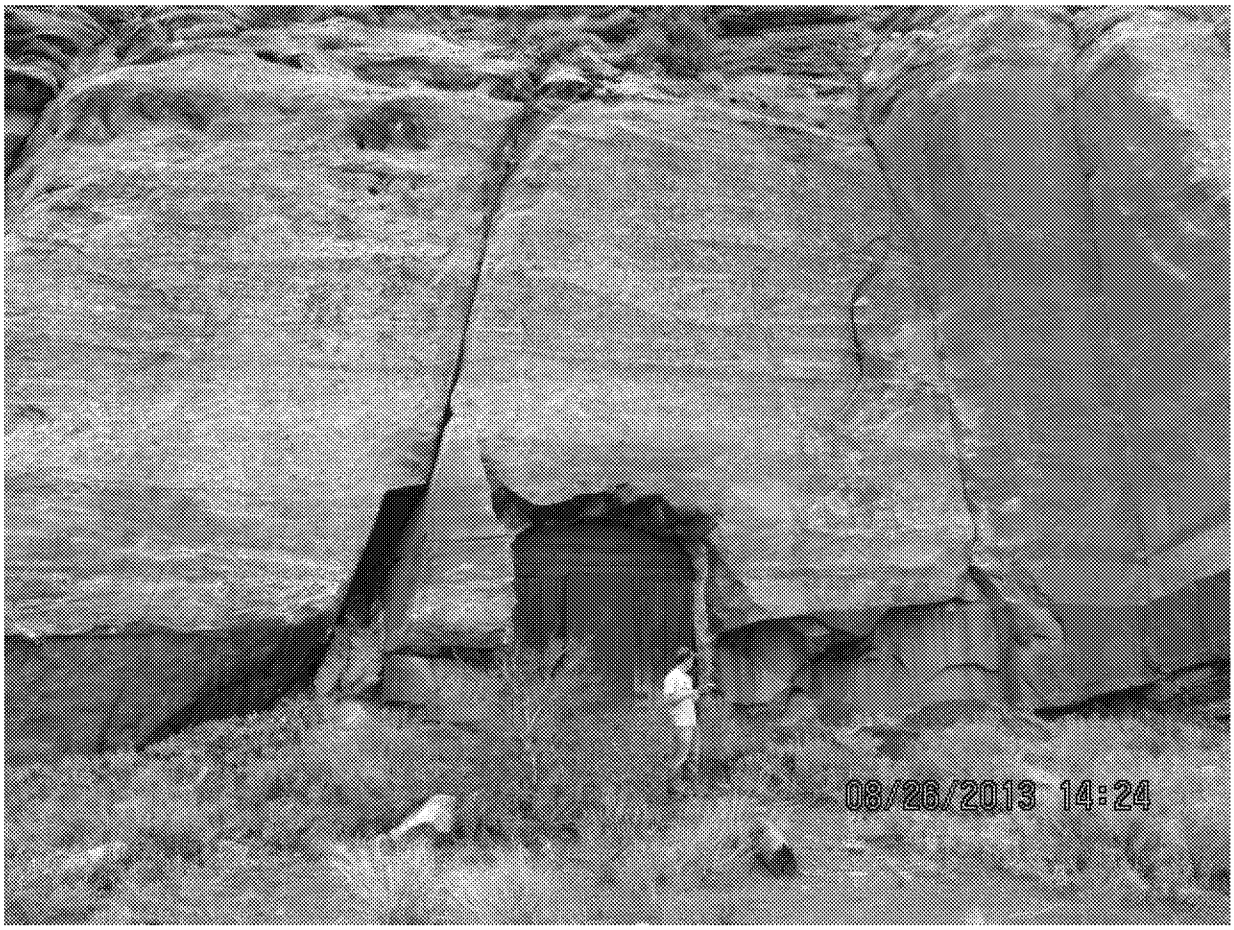
Figure 20. Mine Closure by Metal Door and Timbers. Lisbon Valley–Big Indian District, Utah

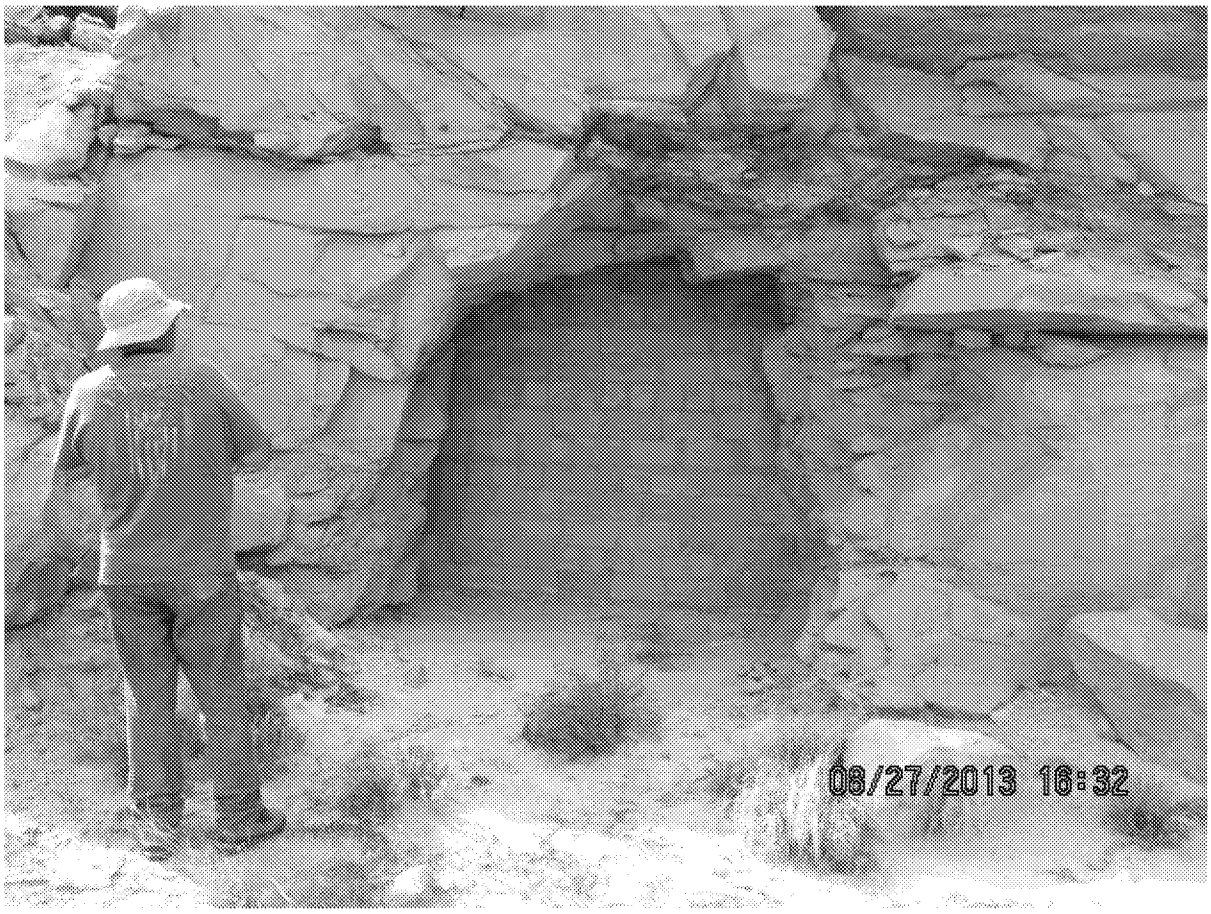
Figure 21. Mine Portal Closure by Concrete Blocks, Yellow Cat District, Utah

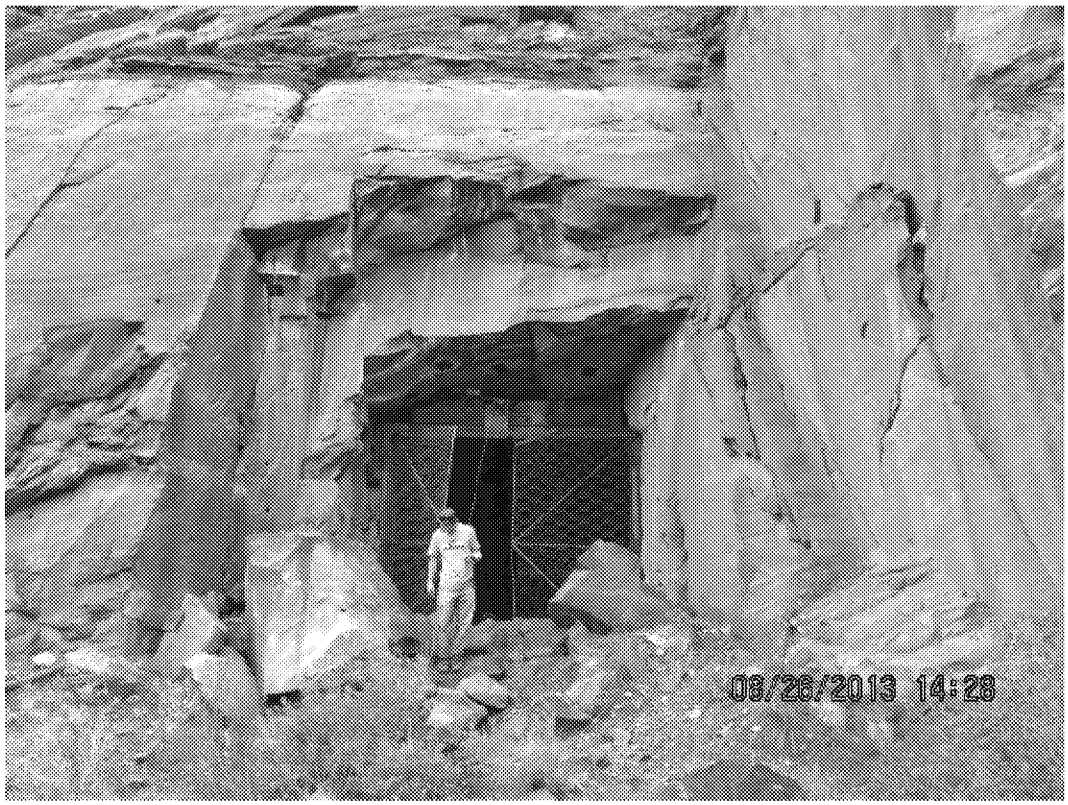
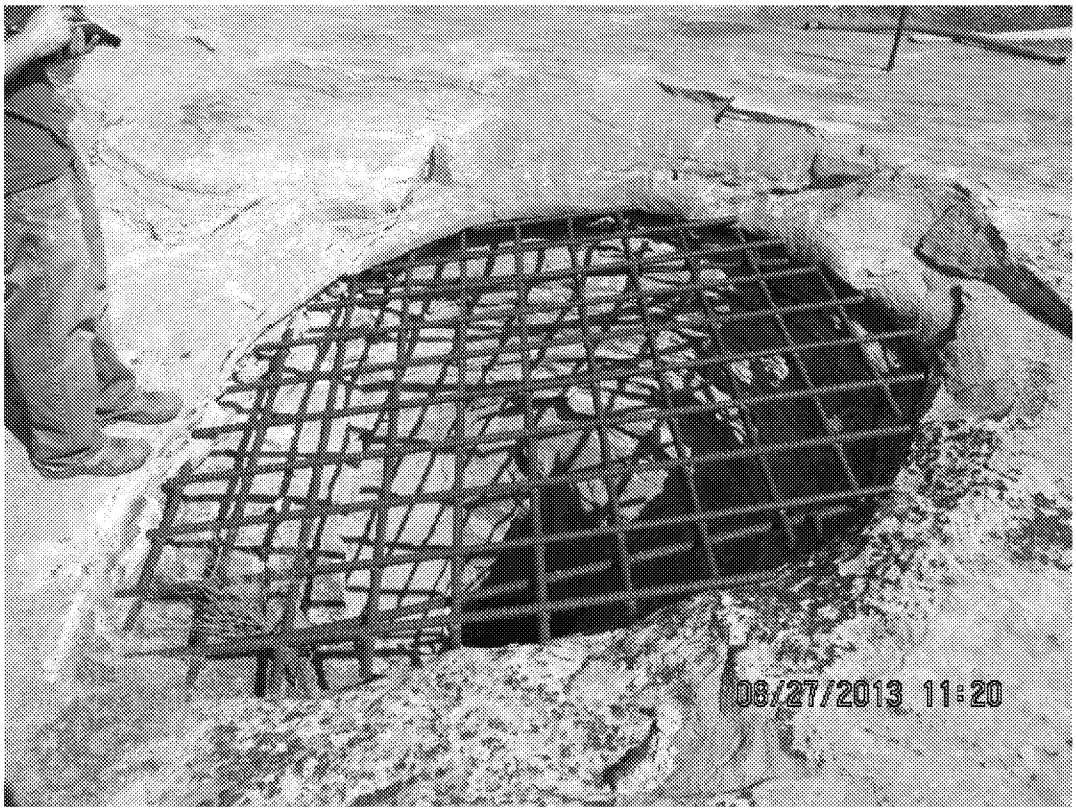
Figure 22. Top: Mine Portal Closure by Metal Gates
Bottom: Mine Vent Shaft Closure with a Large Grid Rebar Typical of "Bat Gates"

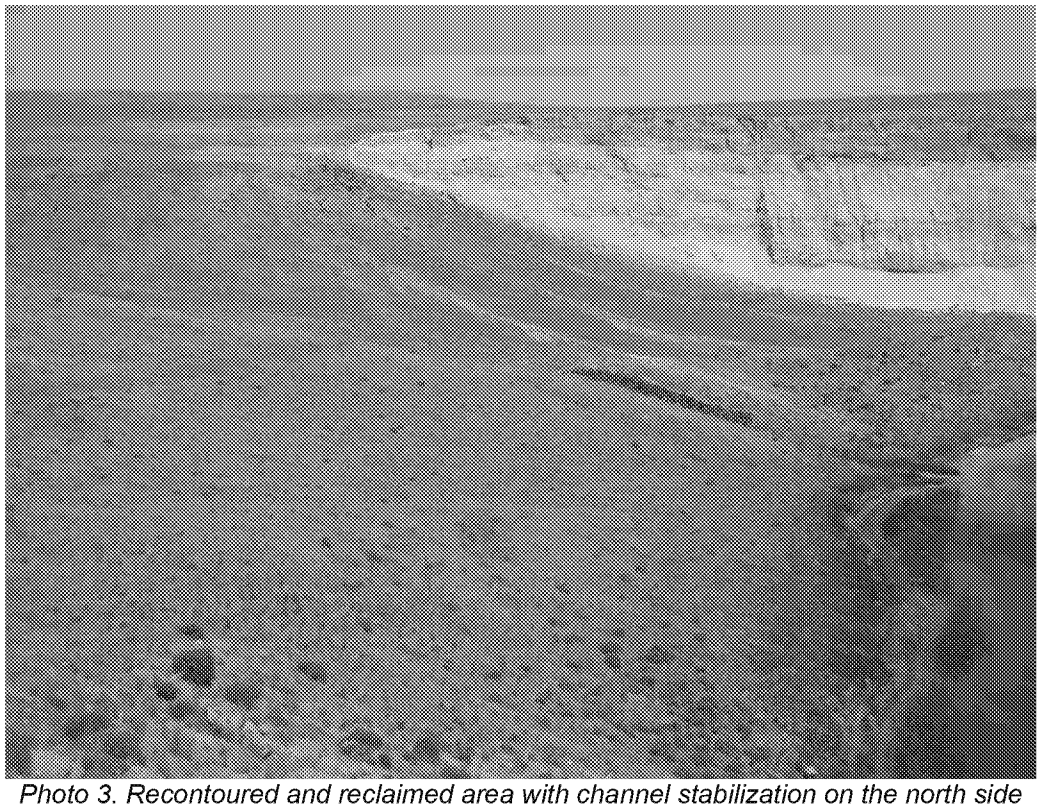
Photo 3. Recontoured and reclaimed area with channel stabilization on the north side of the Mars Group pit.

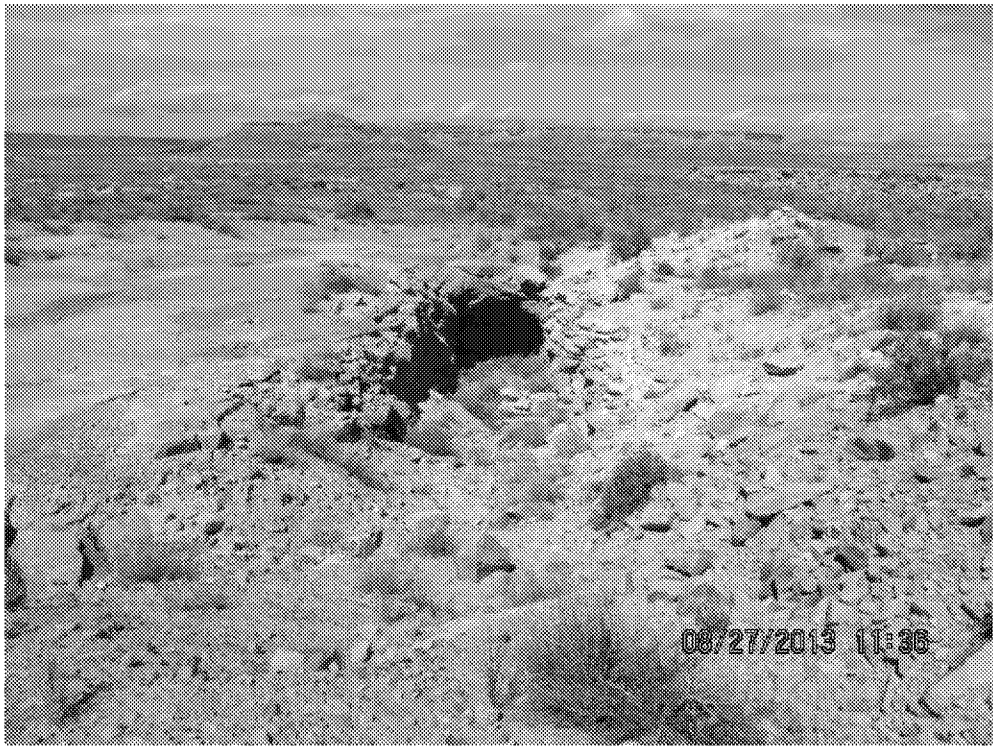
Photo 1. Paris 25 mine area portal #1 east of access road, looking west.

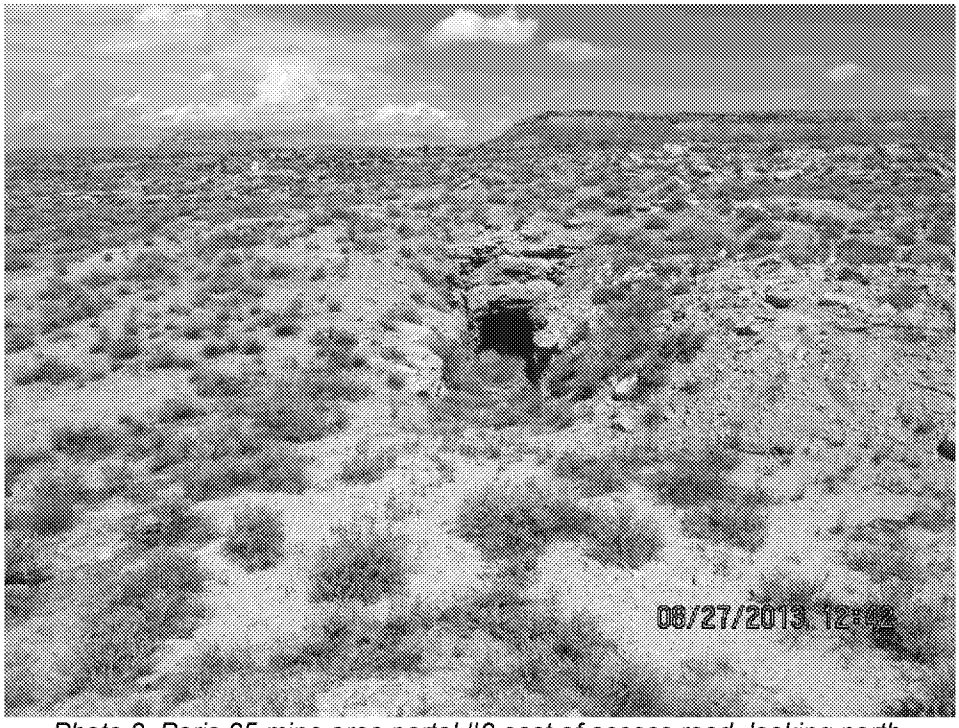
Photo 2. Paris 25 mine area portal #2 east of access road, looking north.

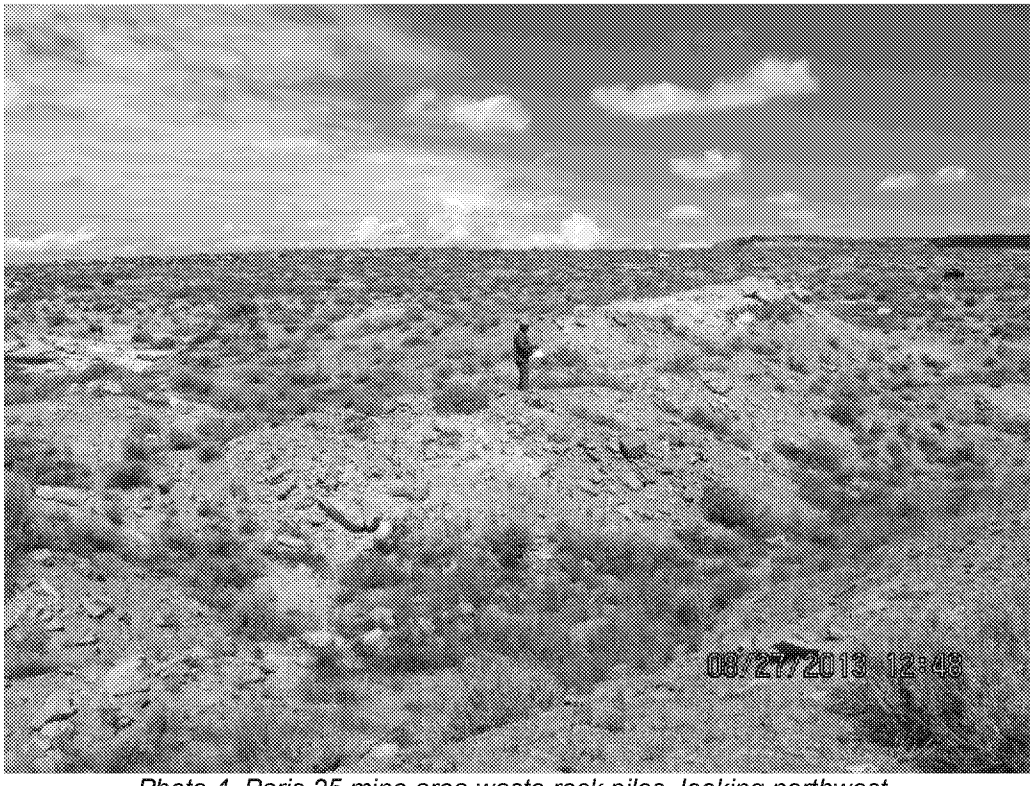
Photo 4. Paris 25 mine area waste rock piles, looking northwest.
