Alten Facility Release, Mead, NE

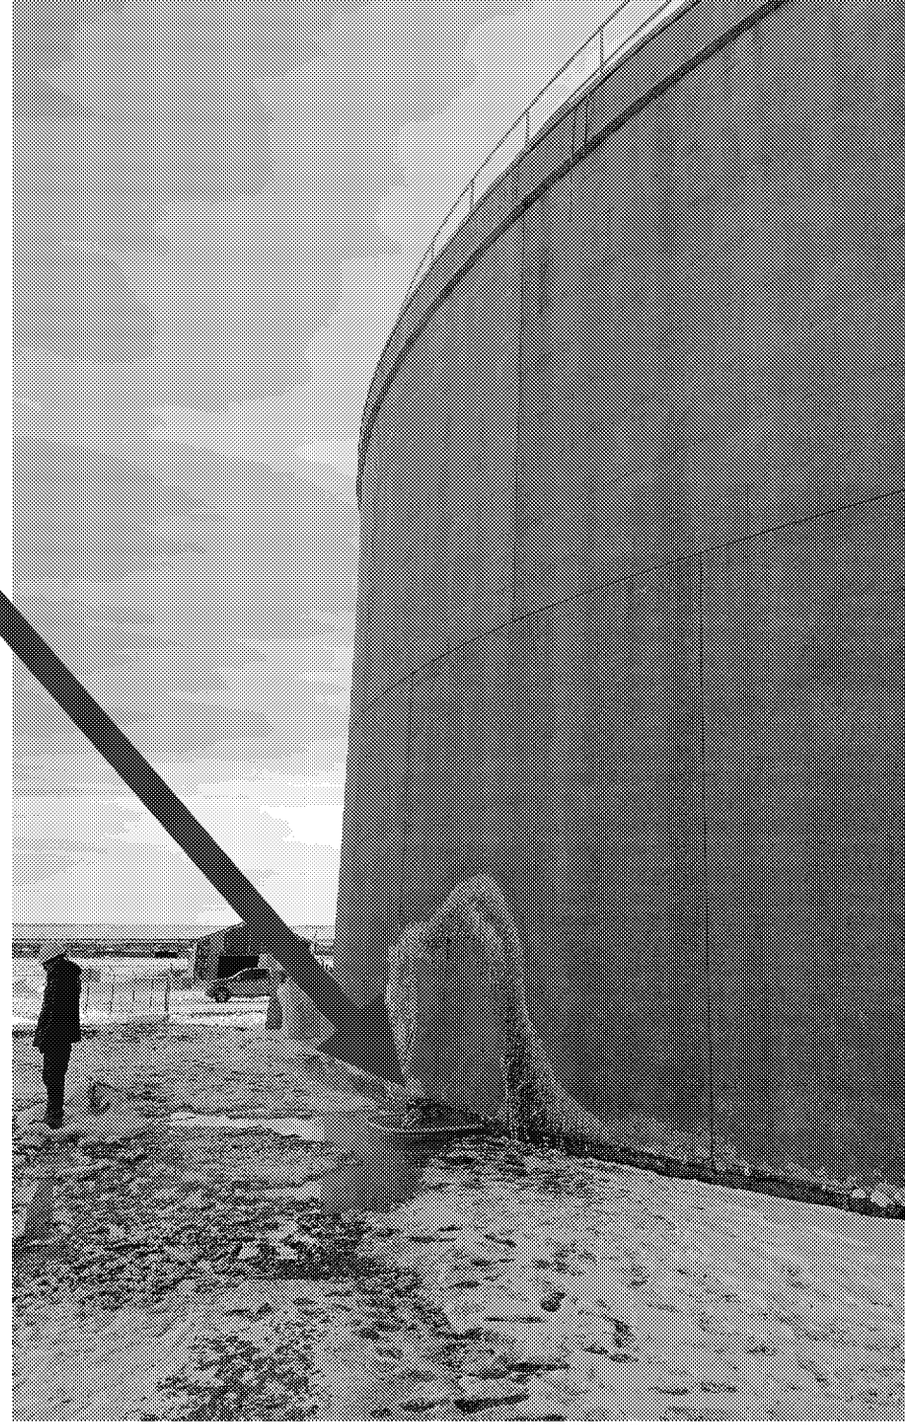
Arrow pointing to the sub-surface broken valve on the digester tank.

Pressure of the released material estimated to be 600 psi for the approximately 4M gallons released from the tank.

Crews placed insulation and a heating device on the valve at the other digester tank to reduce the likelihood of a similar failure.
