Alten Facility Release, Mead, NE

AltEn Release, Mead, NE

Response Summary
AltEn, Mead, NE Release

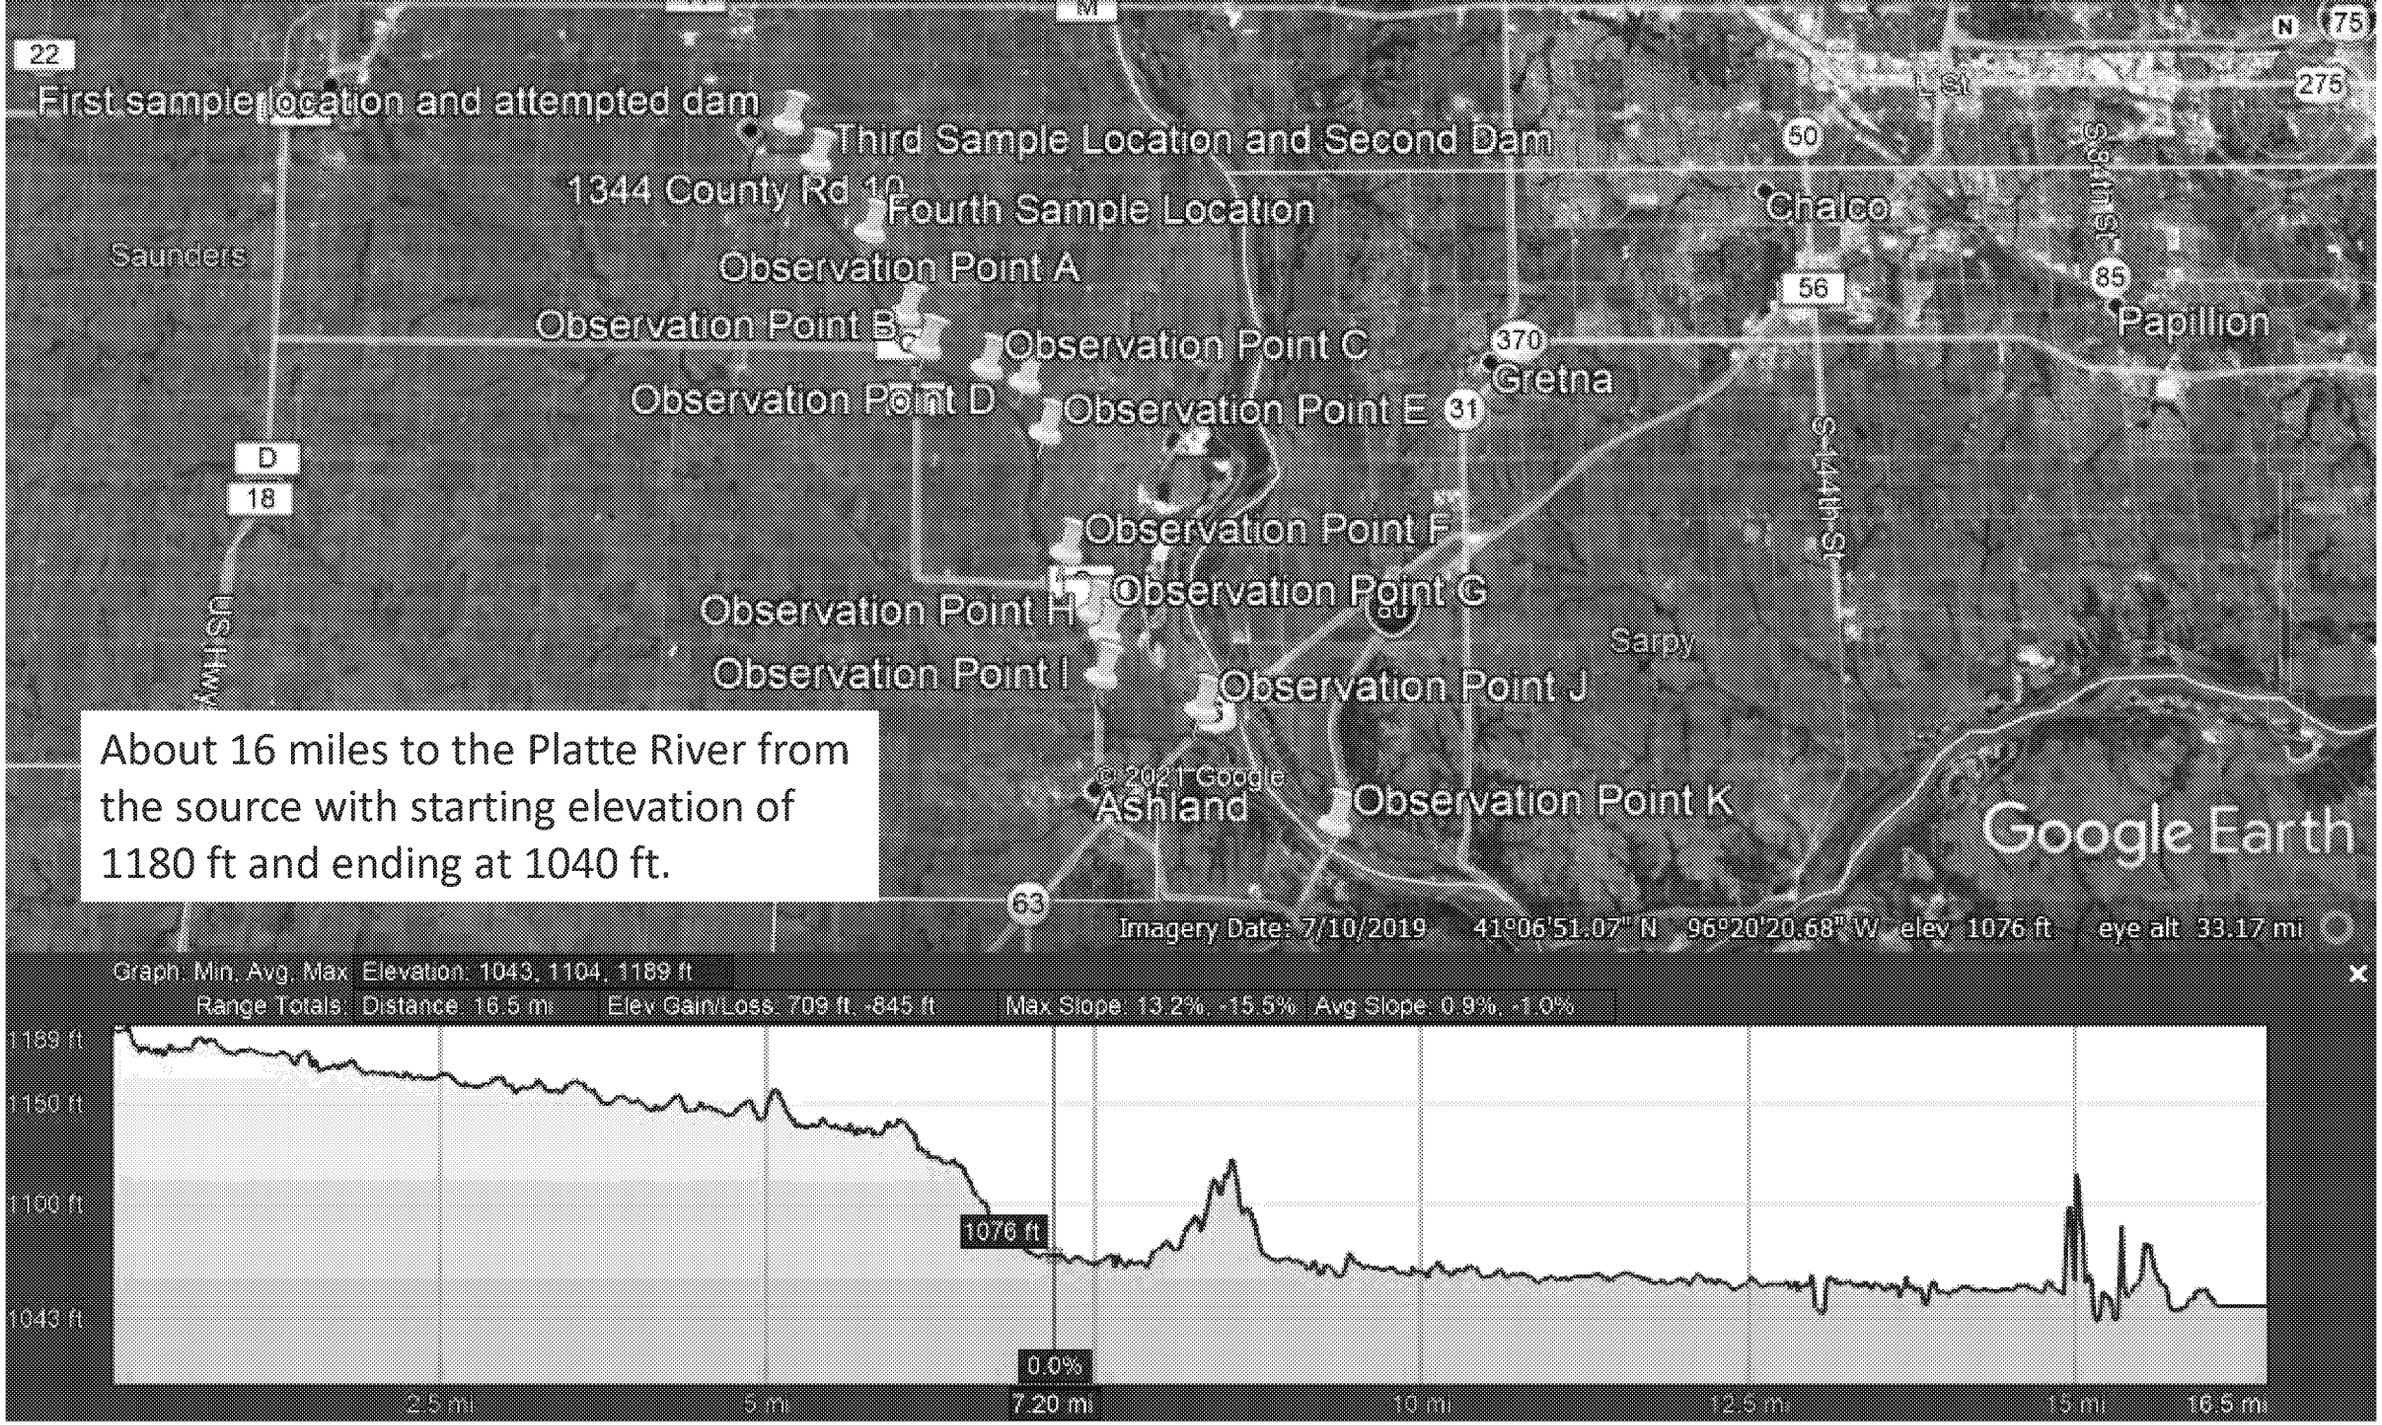
Material flow path from the tank

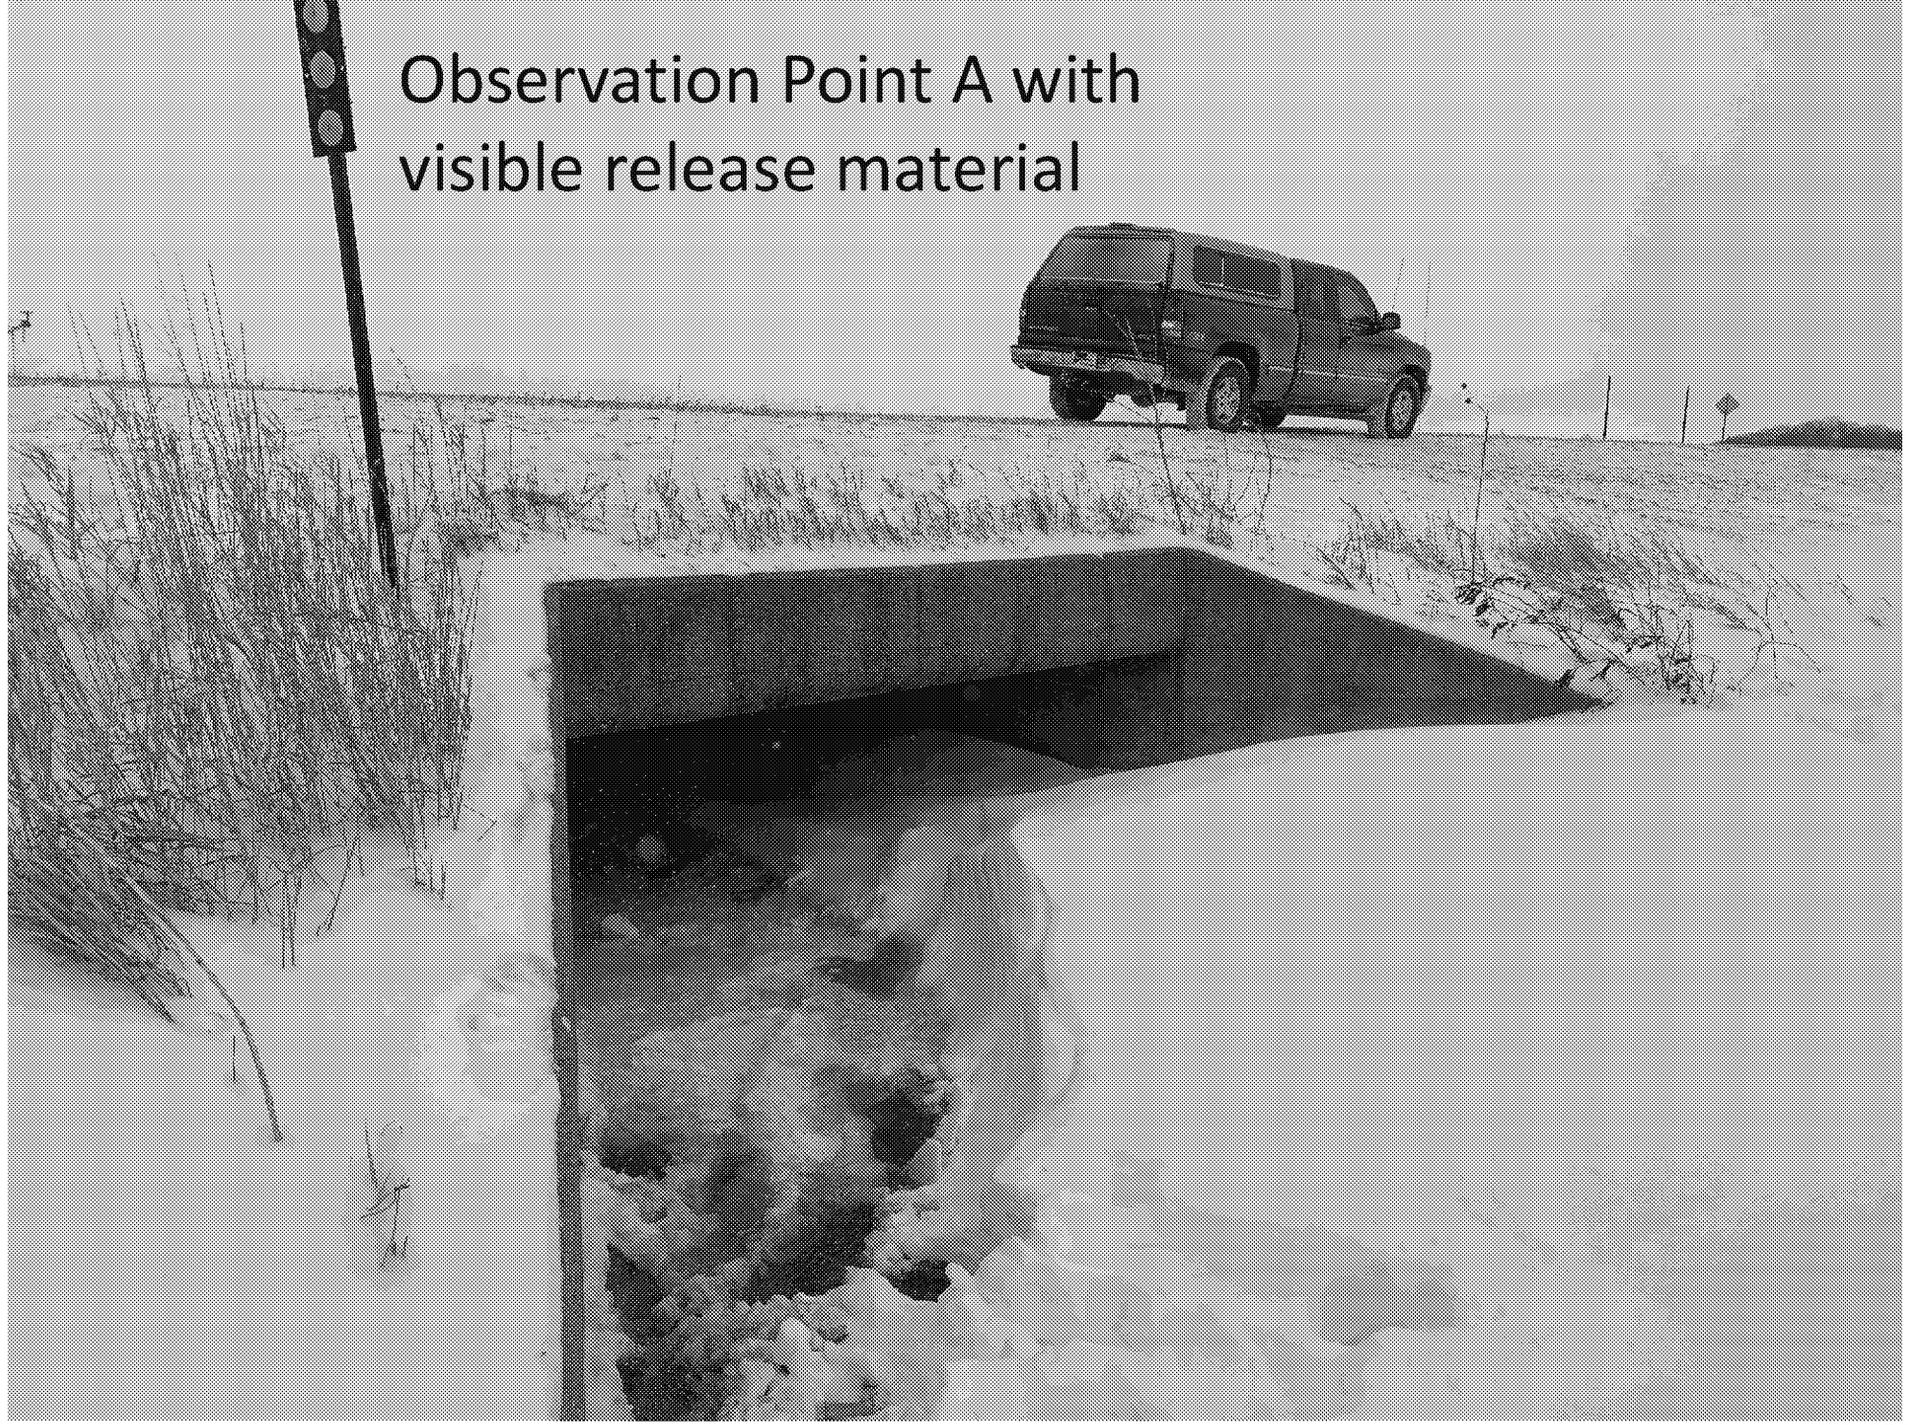
Observation Point A with
visible release material

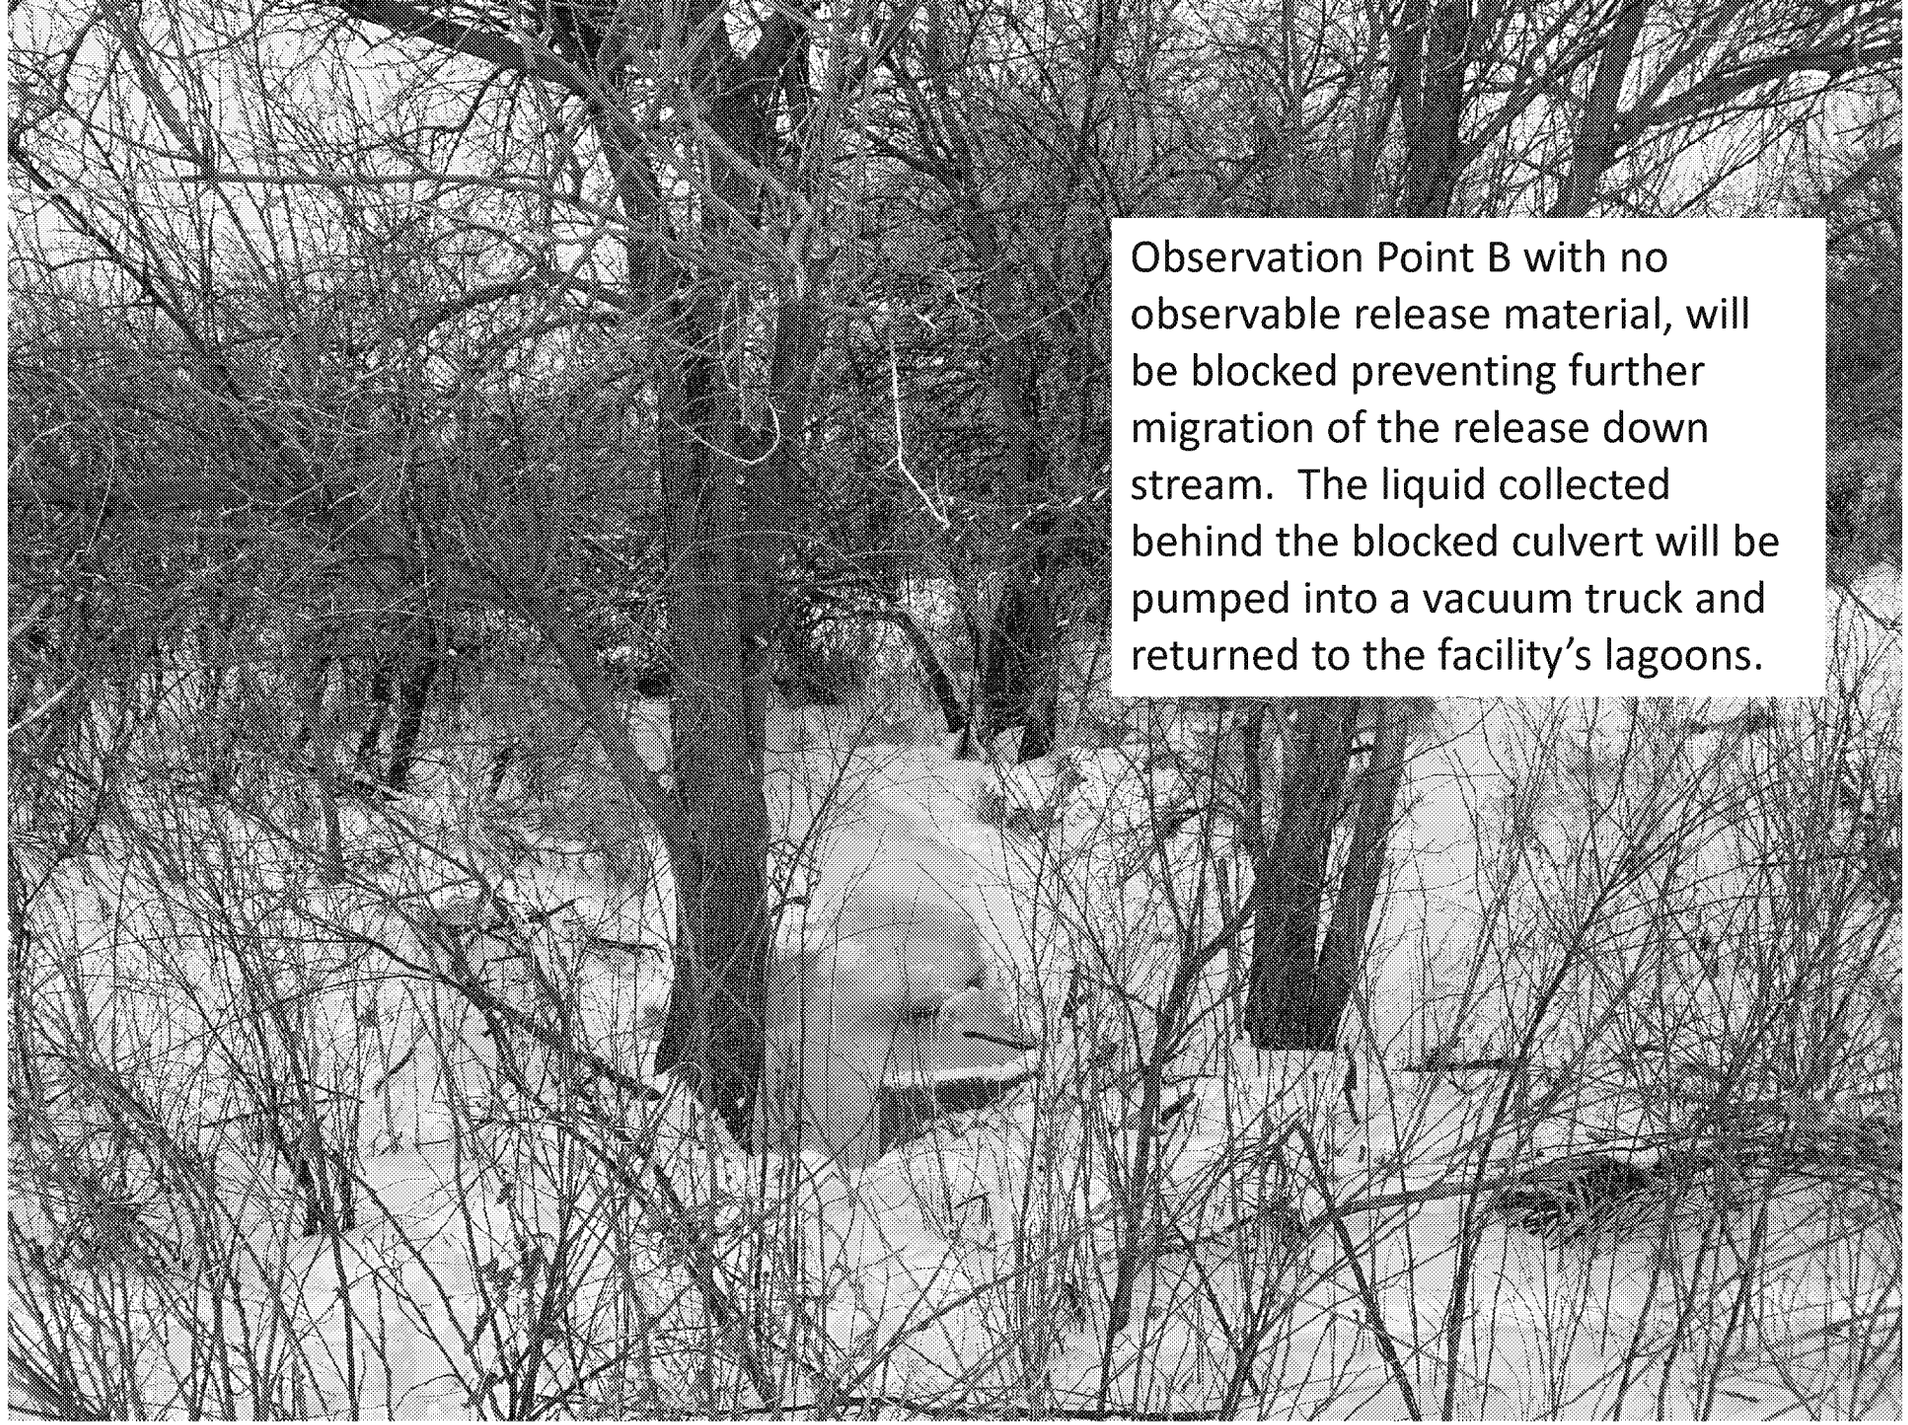
Observation Point B with no observable release material, will be blocked preventing further migration of the release down stream. The liquid collected behind the blocked culvert will be pumped into a vacuum truck and returned to the facility's lagoons.

Blocked off culvert at collection point
