Alten Facility Release, Mead, NE

AltEn Release, Mead, NE

Response Summary
AltEn, Mead, NE Release

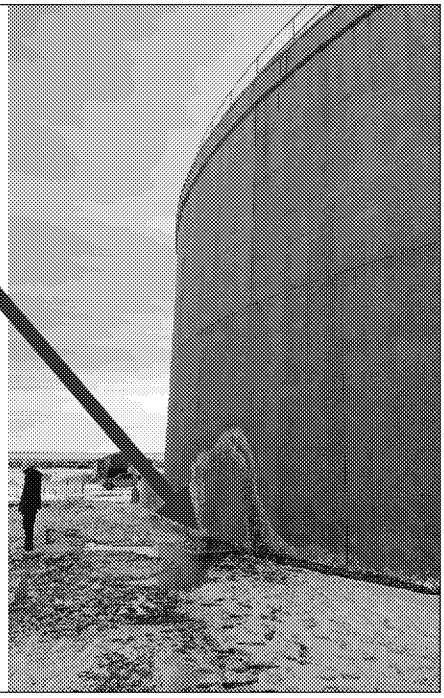
Arrow pointing to the sub-surface broken valve on the digester tank.

Pressure of the released material estimated to be 600 psi for the approximately 4M gallons released from the tank.

Crews placed insulation and a heating device on the valve at the other digester tank to reduce the likelihood of a similar failure.

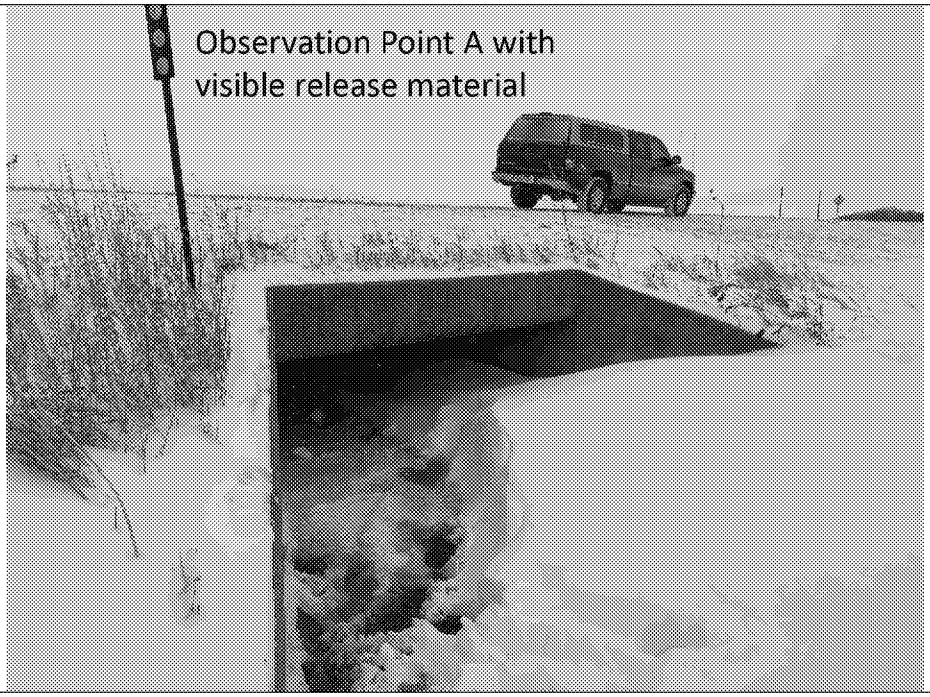
Observation Point A with
visible release material

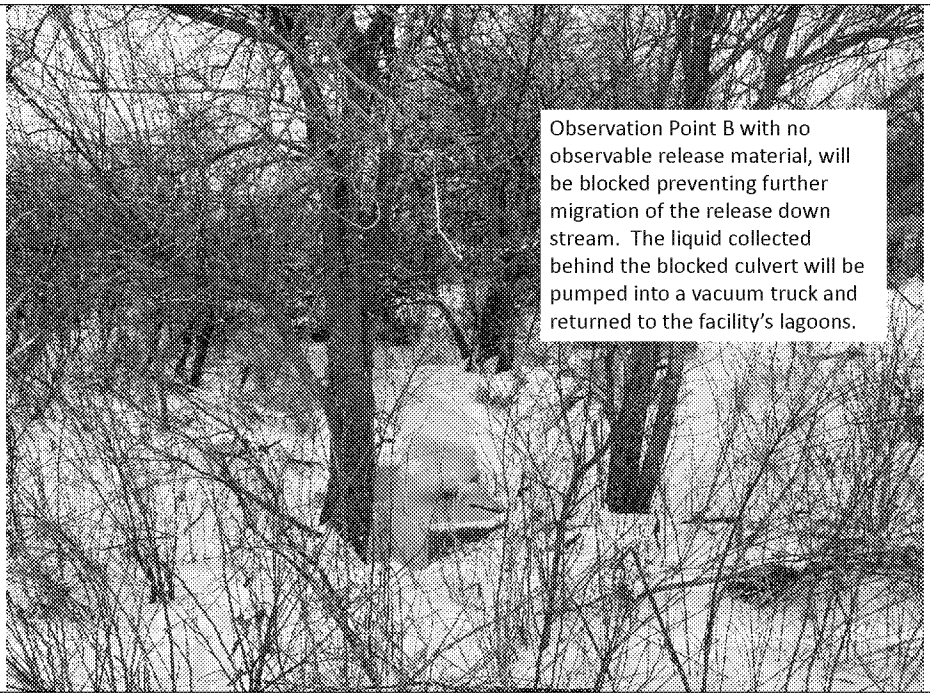
Observation Point B with no observable release material, will be blocked preventing further migration of the release down stream. The liquid collected behind the blocked culvert will be pumped into a vacuum truck and returned to the facility's lagoons.
