DATE: February 21, 2021 **INVESTIGATOR: D. Bubb**

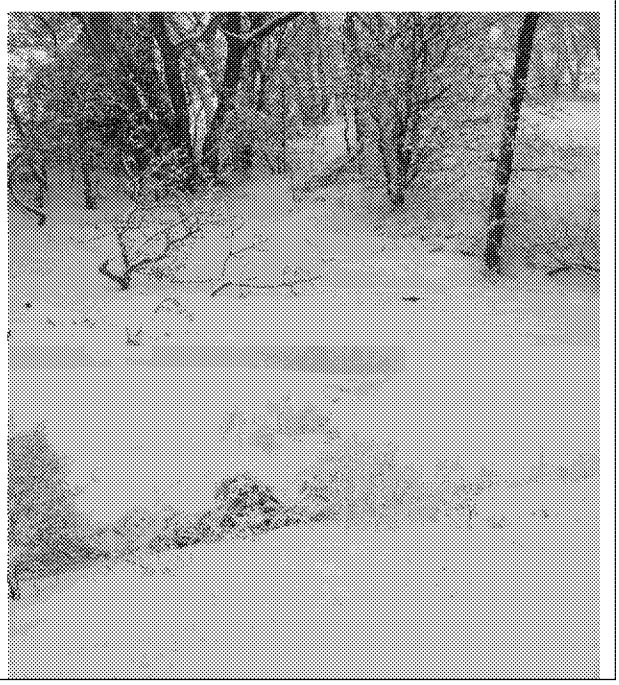
STOP 1 – HIGHWAY 66 WEST of ASHLAND GUN CLUB Open stream. Current heavy snow and fog. No noticeable discolored water or odor.	
STOP 2 – North of the Intersection of COUNTY ROADS 6 & F Current snow and fog. Stream covered in snow/ice.

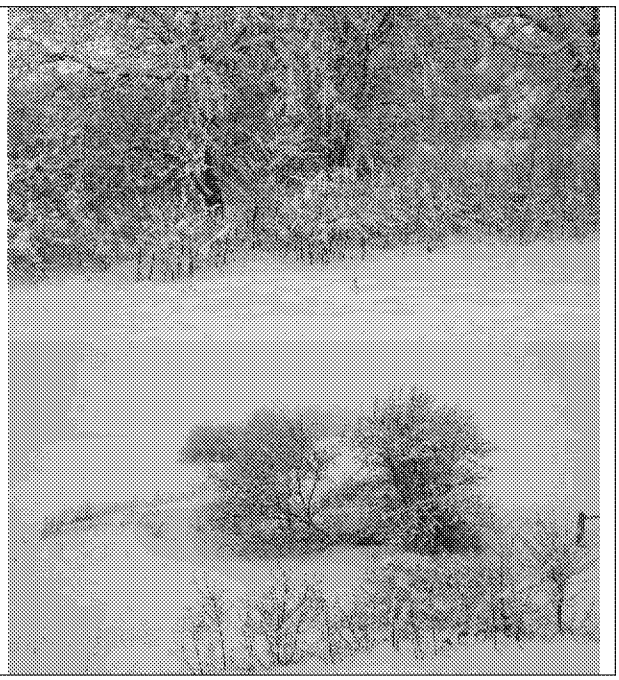
STOP 3 – Road 7/Highway 66

Current snow and fog.

Did not want to pull too far off the road as slick conditions would have allowed vehicle to slide down the side slope. Also, due to very heavy fog, did not want to leave vehicle on the road while out taking pictures as possible oncoming cars may have been coming and visibility was less than 1/8 to ¼ mile. Pictures taken very rapidly while getting out of the vehicle momentarily.

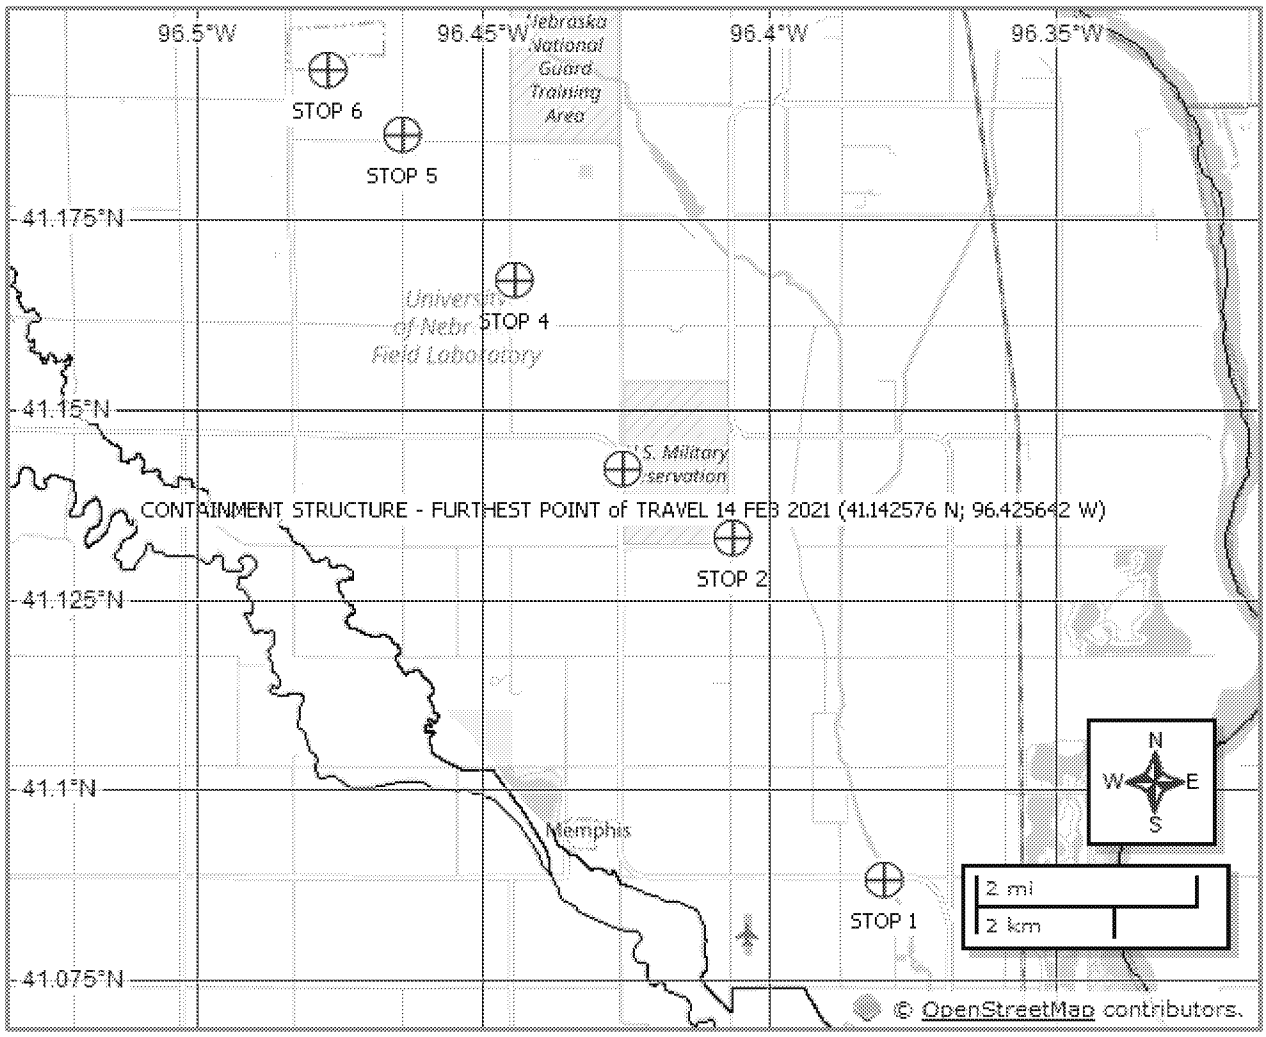
STOP 5 – UN-L Eastern Extension – North of County Roads 9 & J Current snow and fog. Water is open to slush covered upstream. Water appeared to be dark. Tractor/PTO set up to pump water from the stream.	
STOP 6 – ALTEN LLC FACILITY DIGESTERS Current snow and fog. Water trickling from a digester causing a large ice cycle. Damage to insulation on one of the digesters.
