CONSTRUCTION STORMWATER GENERAL PERMIT INSPECTION REPORT

State of Washington Department of Ecology

The Electron Hydro LLC Intake project is covered under the State of Washington's Construction Stormwater General Permit (CSWGP). The CSWGP is a National Pollutant Discharge Elimination System (NPDES) and a State Waste Discharge permit for discharge of construction-related stormwater. The purpose of this inspection is to conduct a compliance inspection and to provide technical assistance as appropriate. Ecology had previously been to the site previously: July 2017 (JARPA review for the then proposed re-construction); 11 August 2020; 17 August 2020; 21 September 2020, 30 September 2020, and on 19 October 2020.

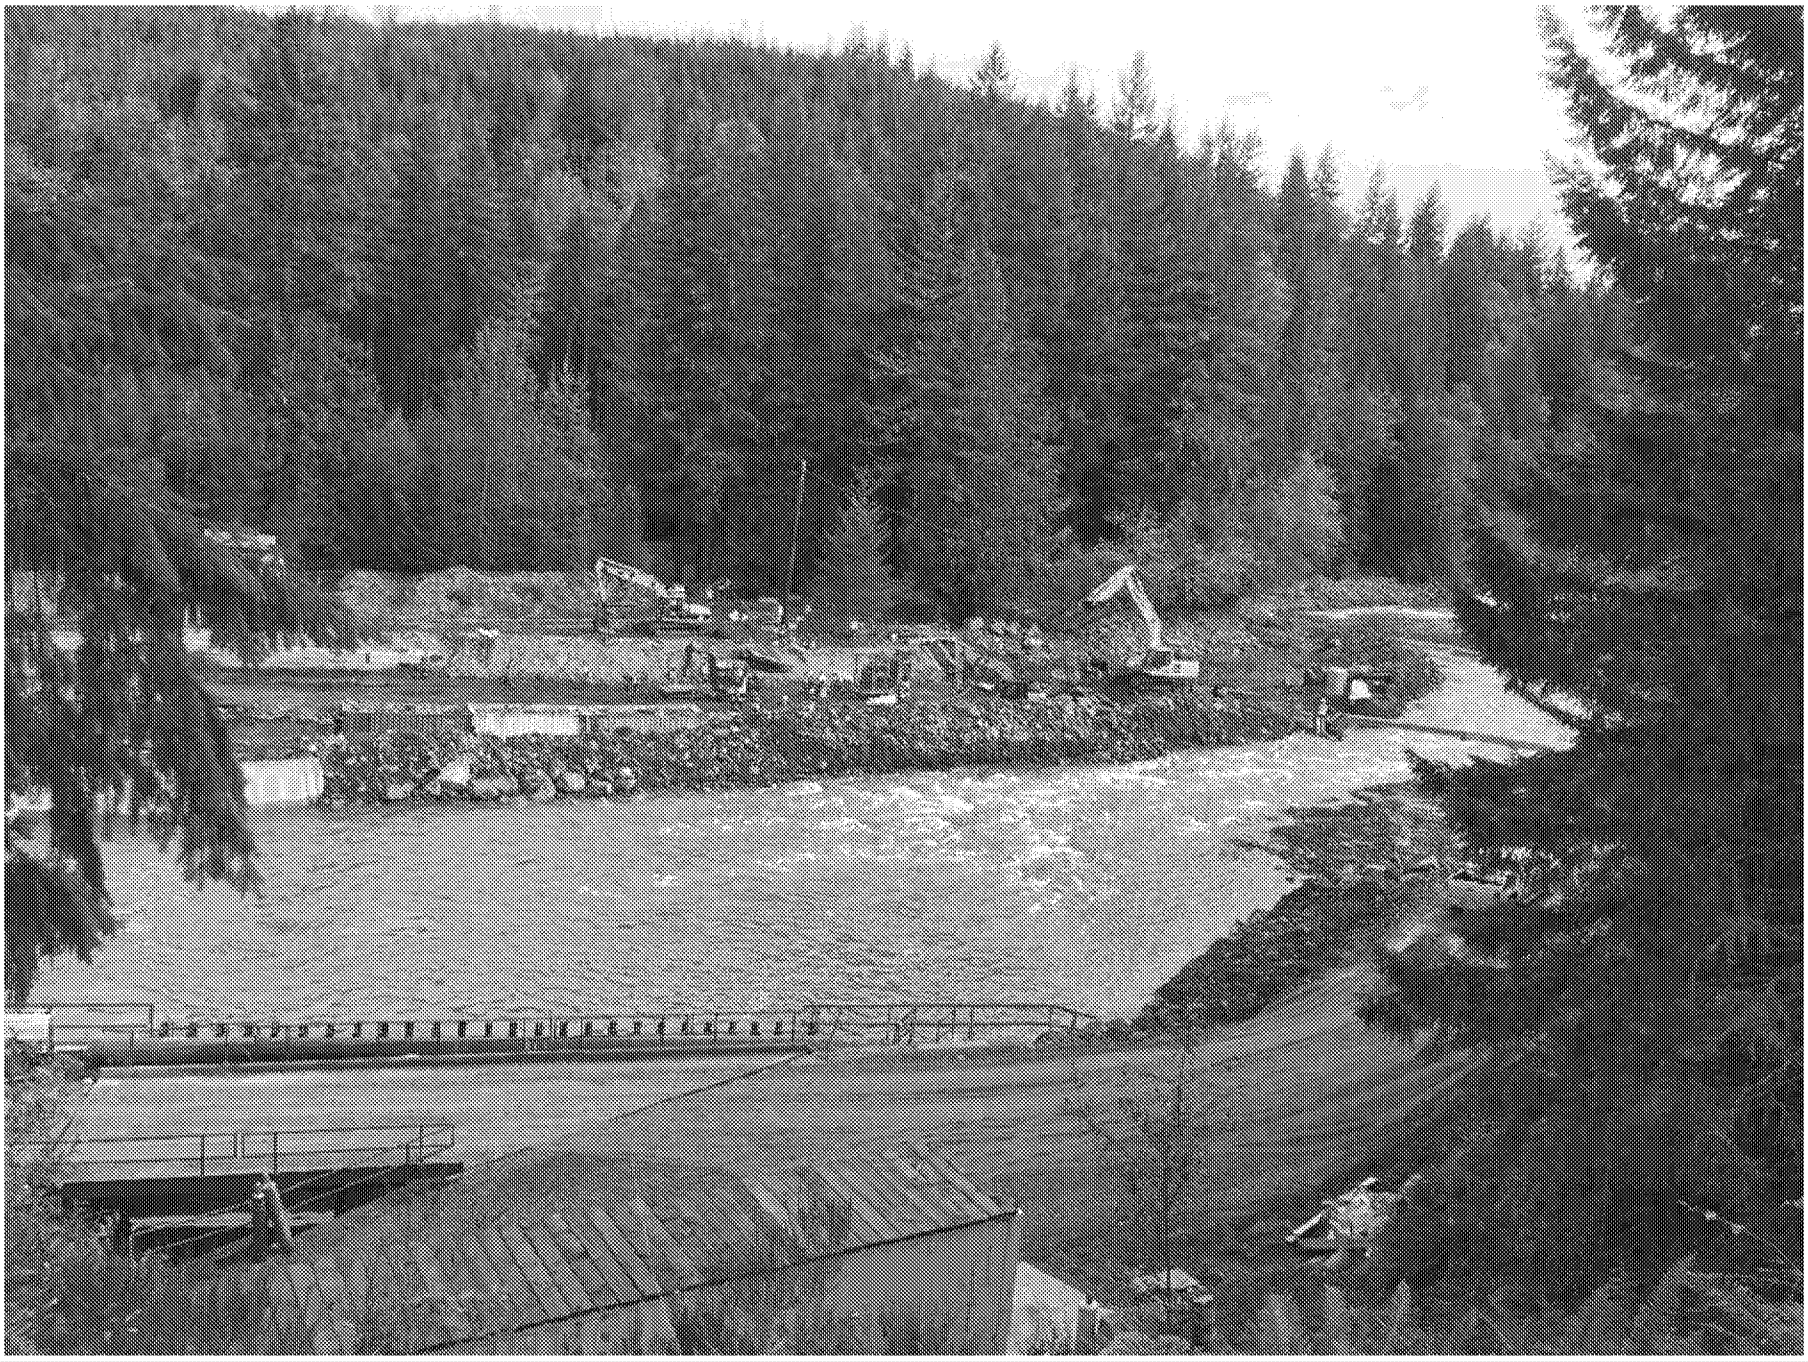
Photo 2

Photo Description: General view of in-water work

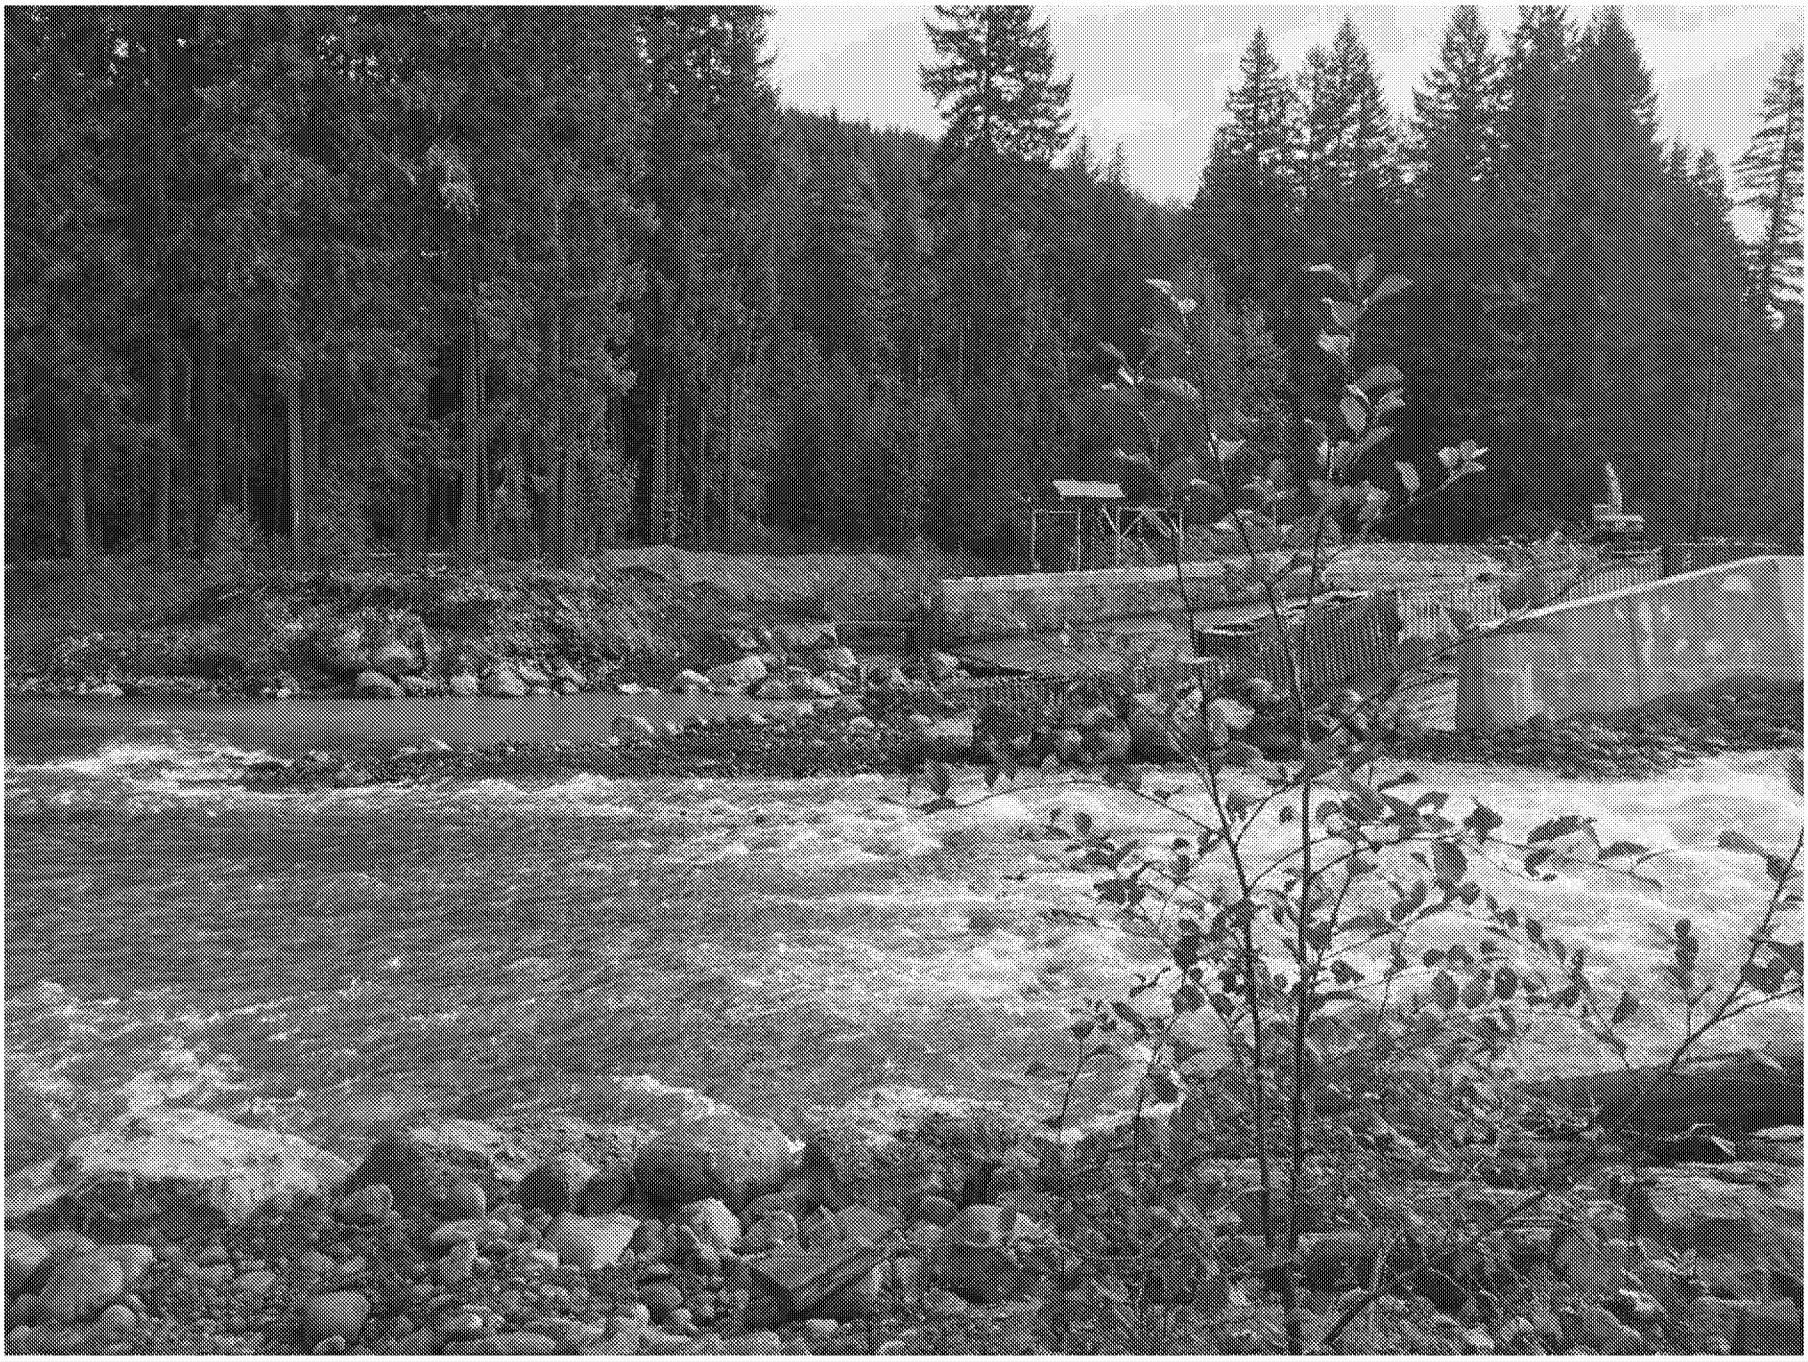
Photo 3

Photo Description: General view of in-water work; note turbidity plume in back eddy adjacent to the wooden structure

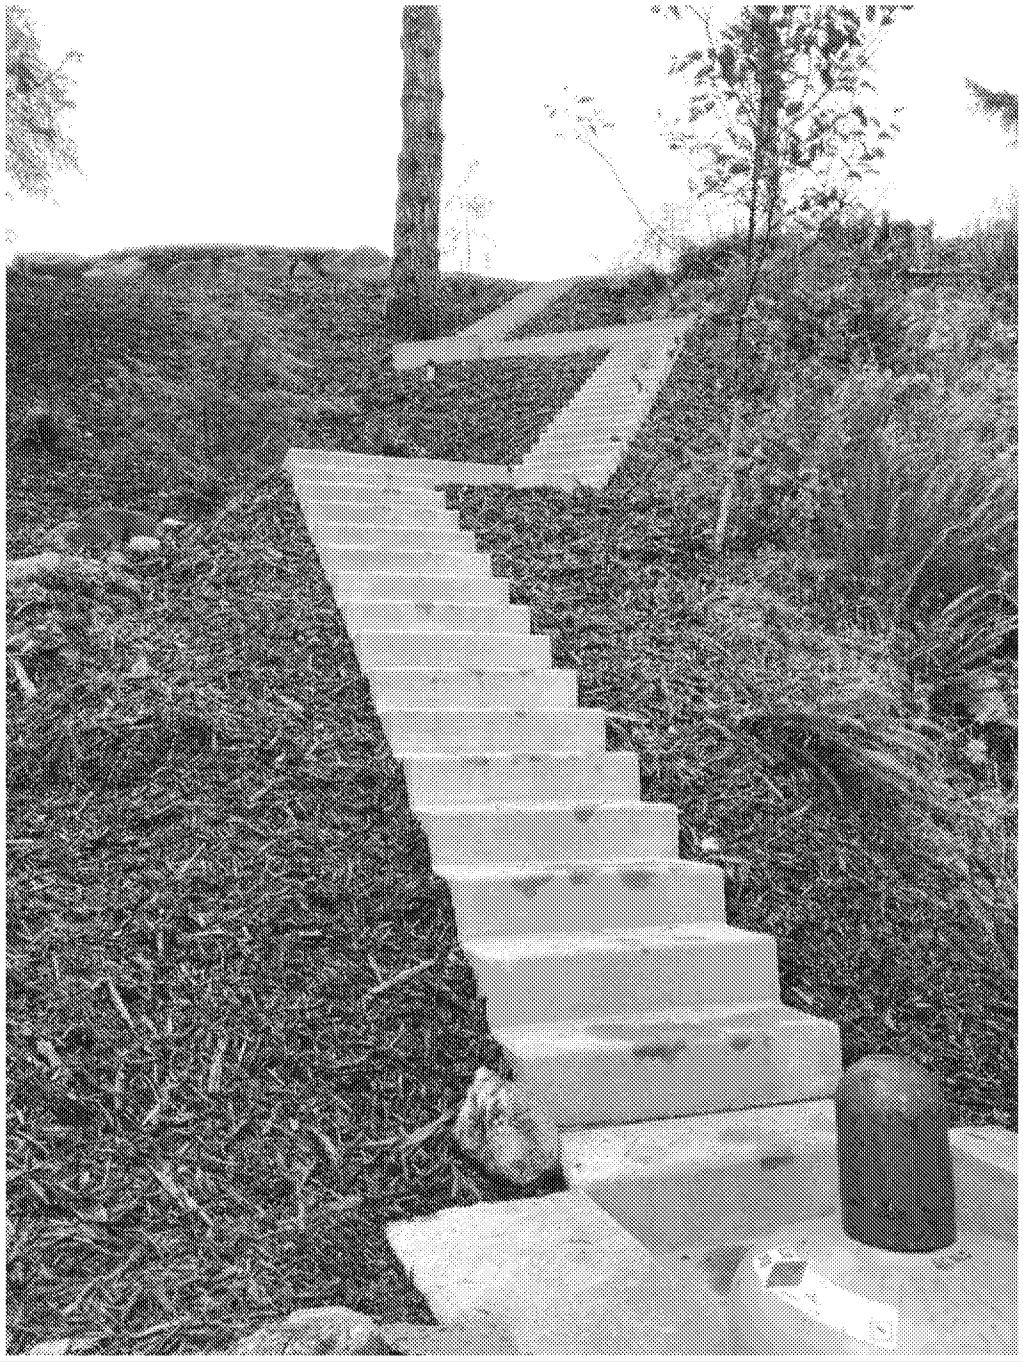
Photo 5

Photo Description: Concrete stairs from uplands CSWGP area, to in-water hydro operation work

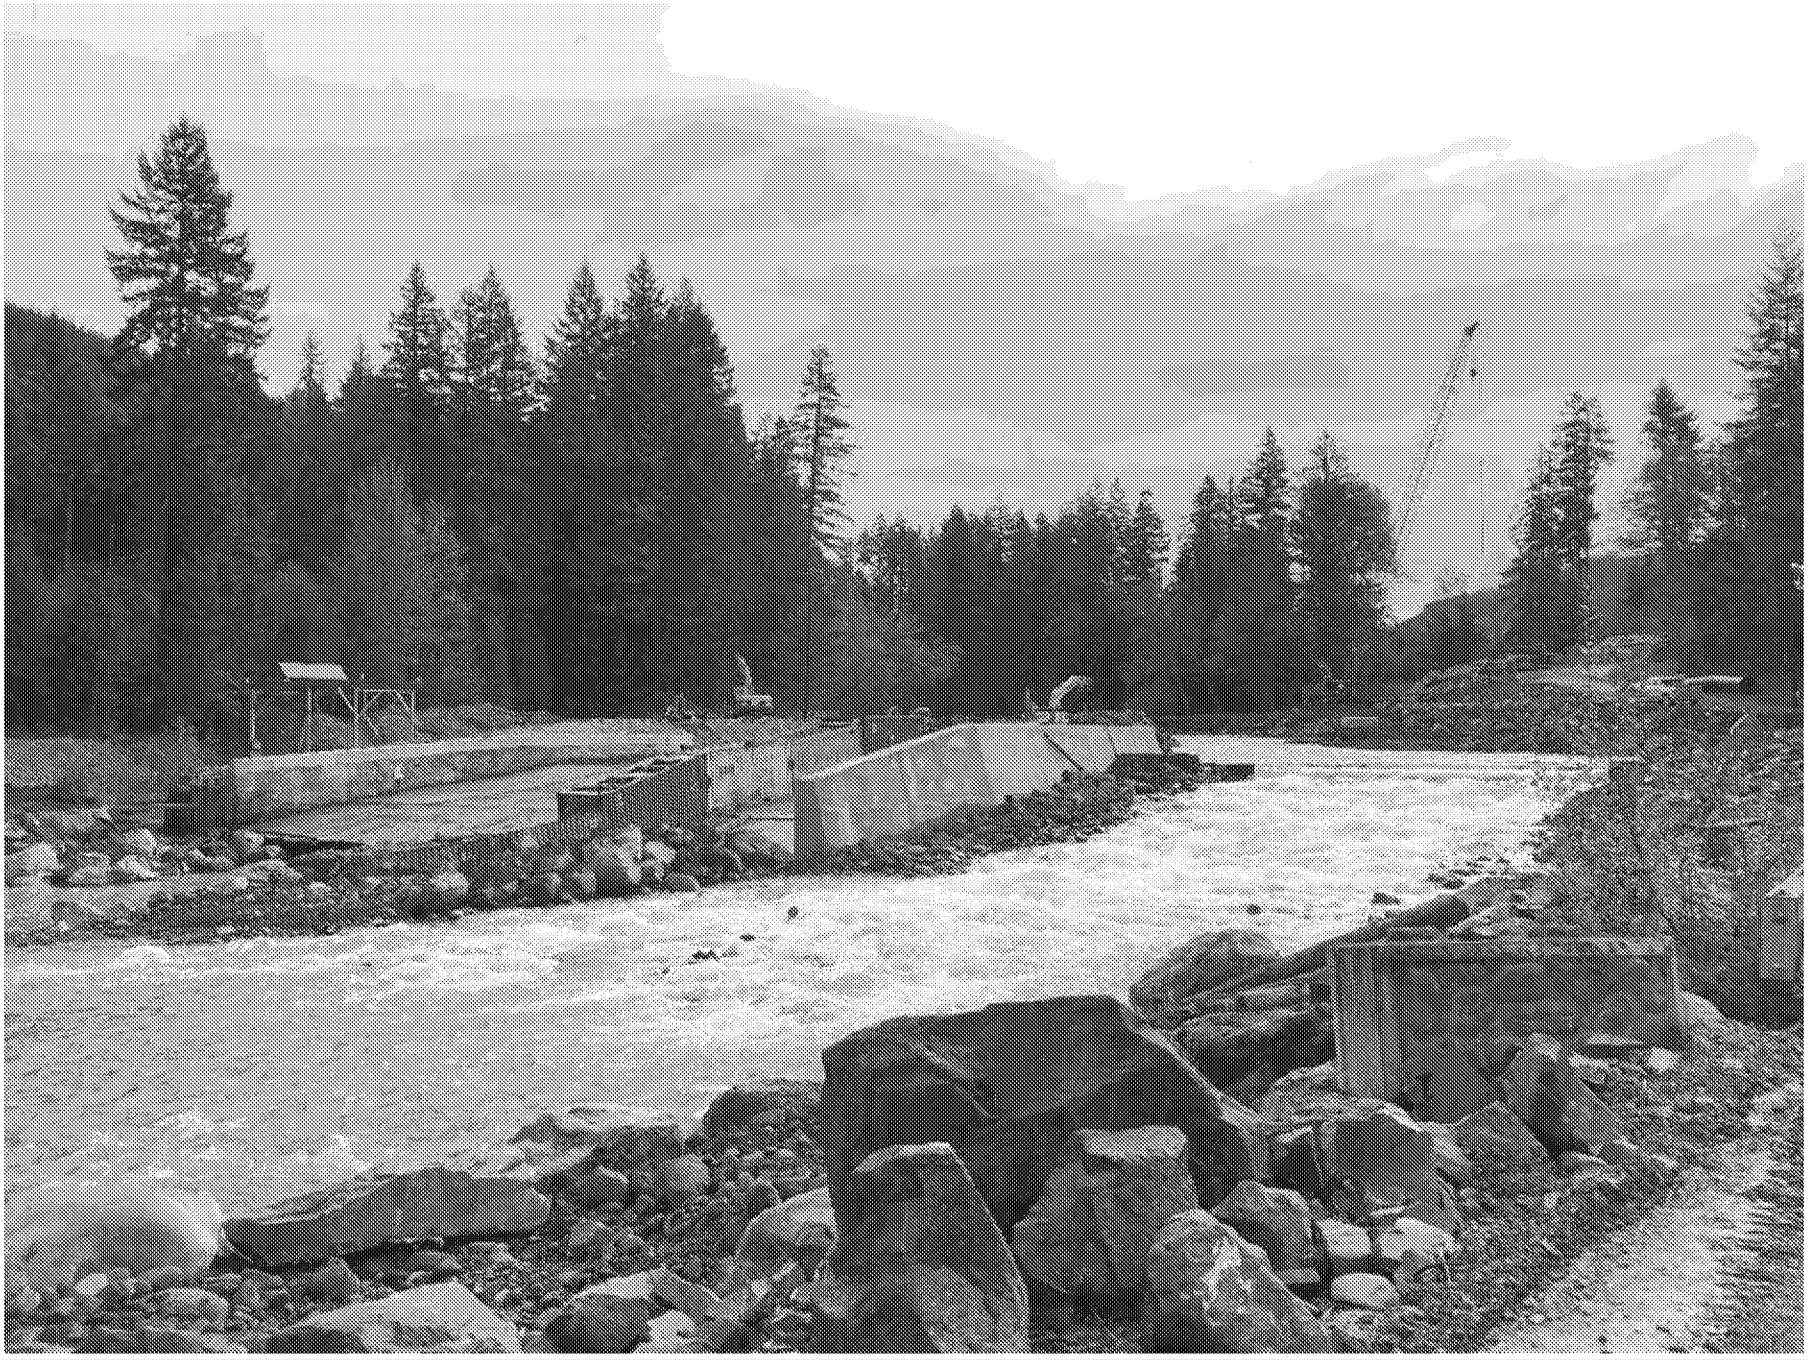
Photo 6

Photo Description: Flow being re-directed in order to clean-up remaining crumb rubber

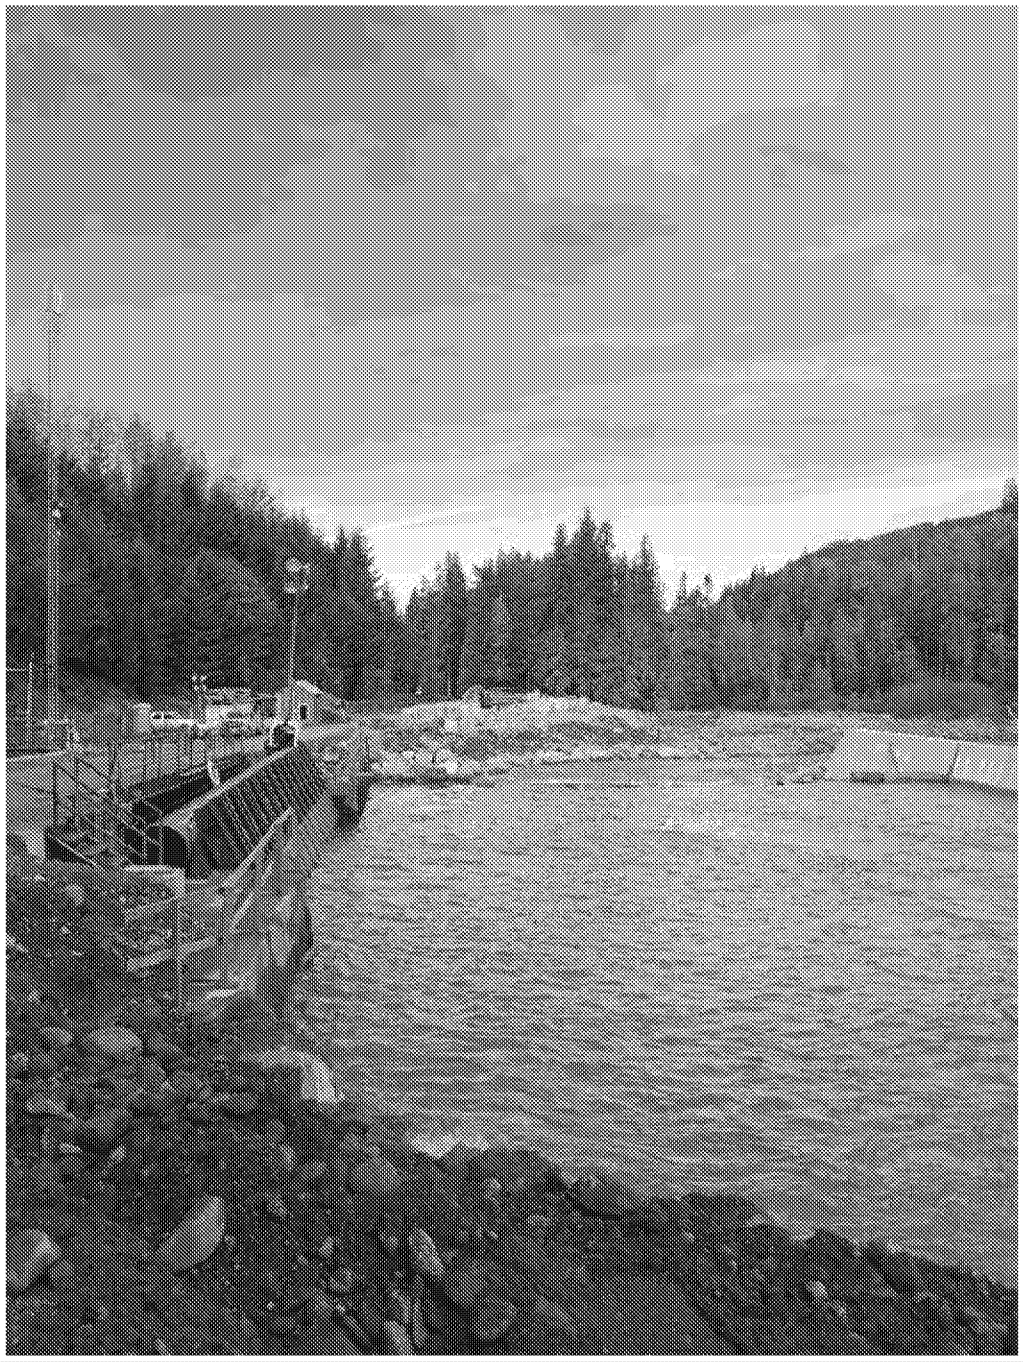
Photo 7

Photo Description: View downstream from western bank; intake structure has metal sheeting on top of trash rack; river meanders to right where construction road was located.

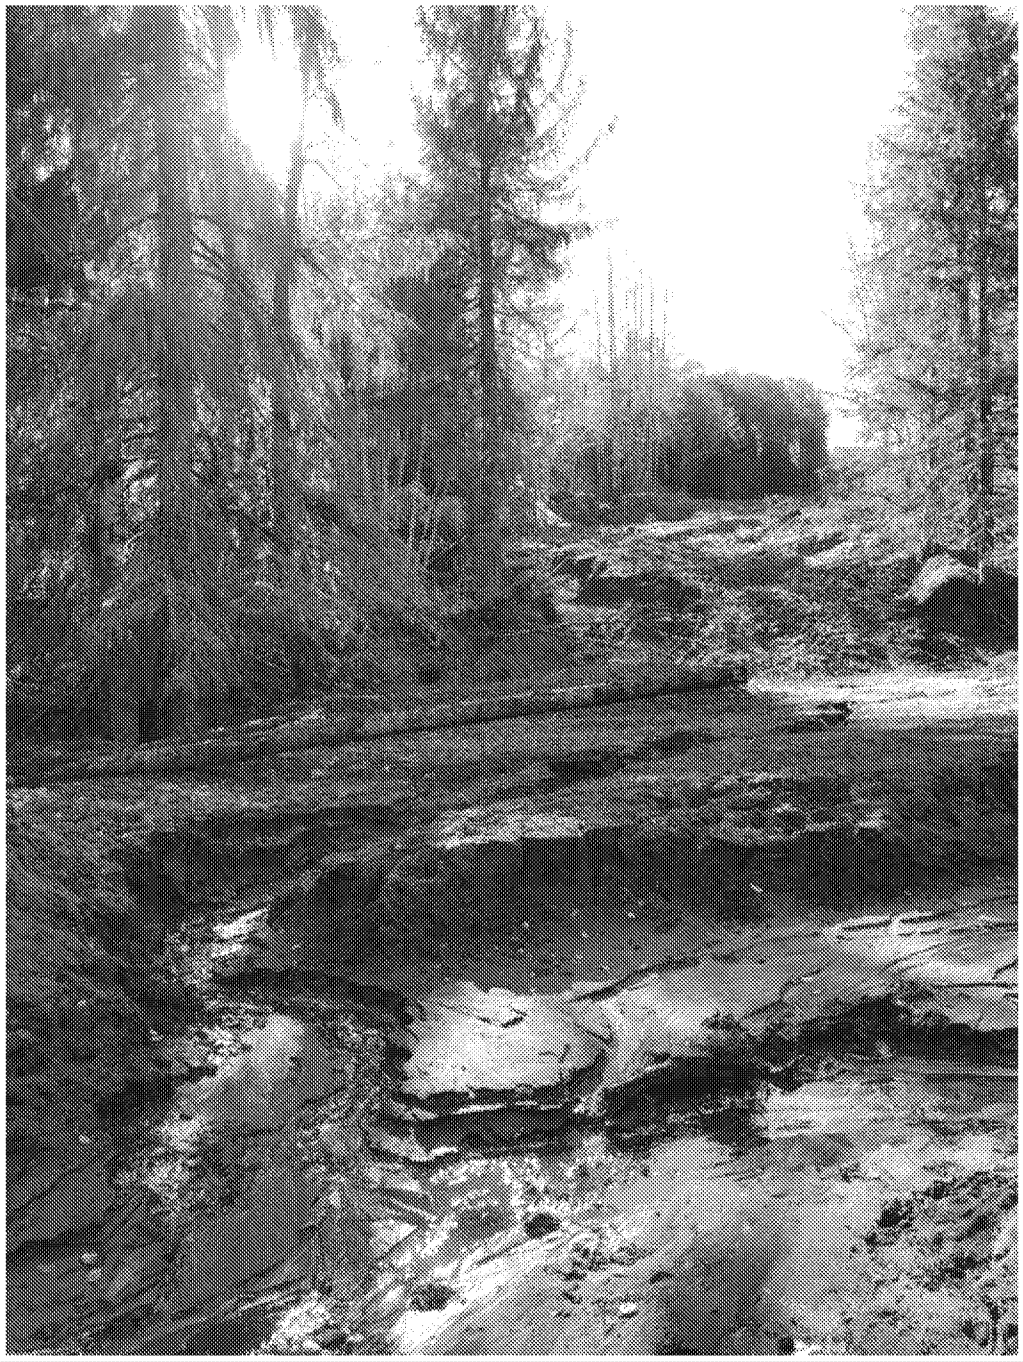
Photo 14

Photo Description: Landslide area at settling basin
