RESOLUTION CONSULTANTS

Subject: **Well Inventory Memorandum – Navy-Owned Wells, NWIRP Bethpage**

Date: October 2020

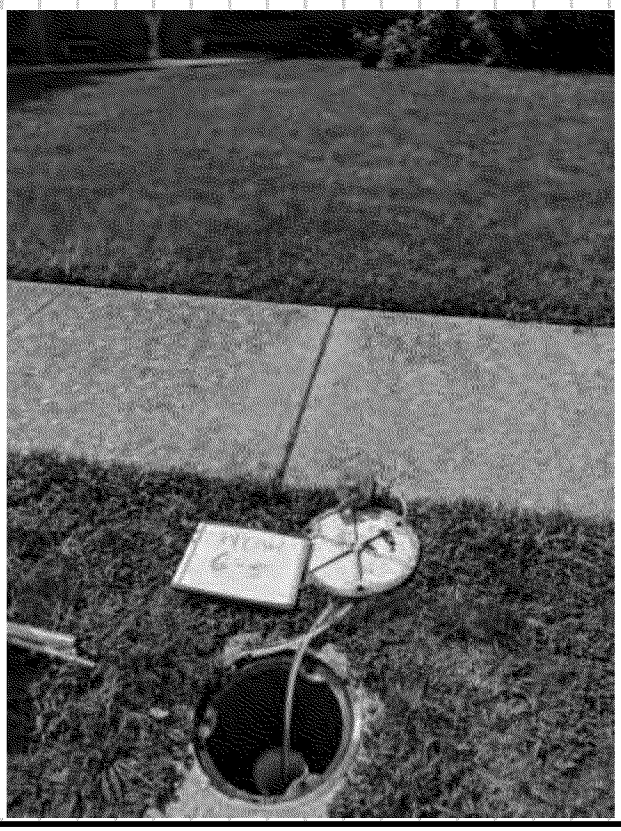
GIS Map Label:	BPOW6-6
Client:	Navy CLEAN	**Northing:**	194045.49
Project #:	60266526	**Easting:**	1128178.28
Facility:	NWIRP Bethpage & OU2	**Well Status:**	In Use (Confirmed)
Project:	Monitoring Well Inventory	**Top of Screen:**	770
Location:	Bethpage, New York	**Bottom of Screen:**	795

BPOW6-6	GOOD	7/16/18	18.92	799.32	800	770	795	BPOW 6-6 is in good condition. There is a bladder pump assembly present in the well.	1128178.28	194045.49
BPS1-FW-MW01	GOOD	7/24/18	58.64	63.70	64	48.5	63.5	BPS1-FW-MW01 is in good condition.	1124962.14	213962.72
BPS1-FW-MW02	GOOD	7/24/18	59.28	64.10	64	49	64	BPS1-FW-MW02 is in good condition. There is tubing present in the well.	1124790.00	214004.00
BPS1-FW-MW03	GOOD	7/24/18	57.79	67.30	64	52	67	BPS1-FW-MW03 is in good condition. There is tubing present in the well.	1124733.42	213978.52
GM-15D	GOOD	7/23/18	49.22	341.20	N/A	332	342	GM-15D is in good condition. There is a bladder pump assembly present in the well.	1127065.47	210601.69
GM-15D2	GOOD	7/23/18	51.19	554.20	N/A	536	556	GM-15D2 is in good condition. There is a bladder pump assembly present in the well.	1127031.00	210537.00
GM-15S	FAIR	7/23/18	47.39	77.80	N/A	70	80	GM-15S is in fair condition. 22% of the screen is silted. There is tubing present in the well.	1126473.73	211463.53

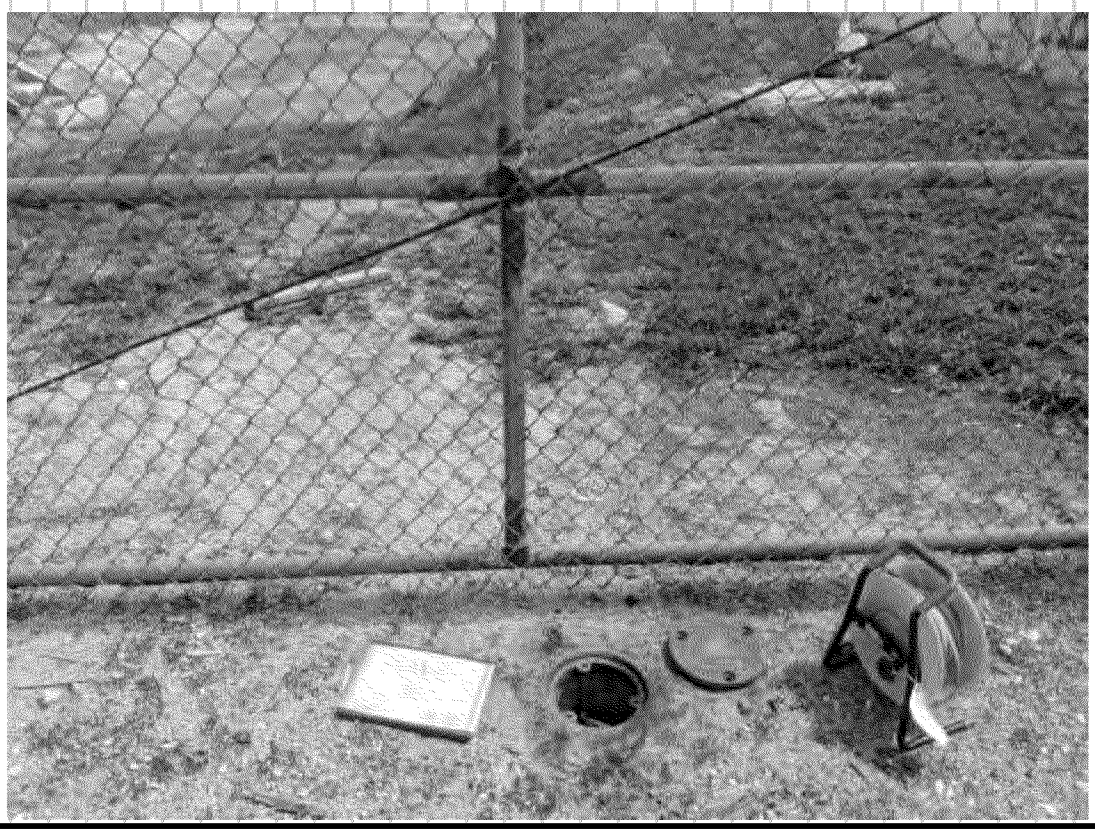
GIS Map Label:	GM-17I
Client:	Navy CLEAN	**Northing:**	211341.70
Project #:	60266526	**Easting:**	1122830.00
Facility:	NWIRP Bethpage & OU2	**Well Status:**	In Use (Confirmed)
Project:	Monitoring Well Inventory	**Top of Screen:**	100
Location:	Bethpage, New York	**Bottom of Screen:**	120

GM-17D	GOOD	7/23/18	49.56	297.60	N/A	278	298	GM-17D is in GOOD condition	1122841.80	211333.60
GM-17I	FAIR	7/23/18	46.26	118.9	N/A	100	126	GM-17I is in fair condition. 27% of the screen is silted.	1122830.00	211341.70
GM-18D	FAIR	7/23/18	46.32	NA	N/A	290	300	GM-18D is in fair condition. GM-18D is missing one bolt.	1123543.00	210320.00

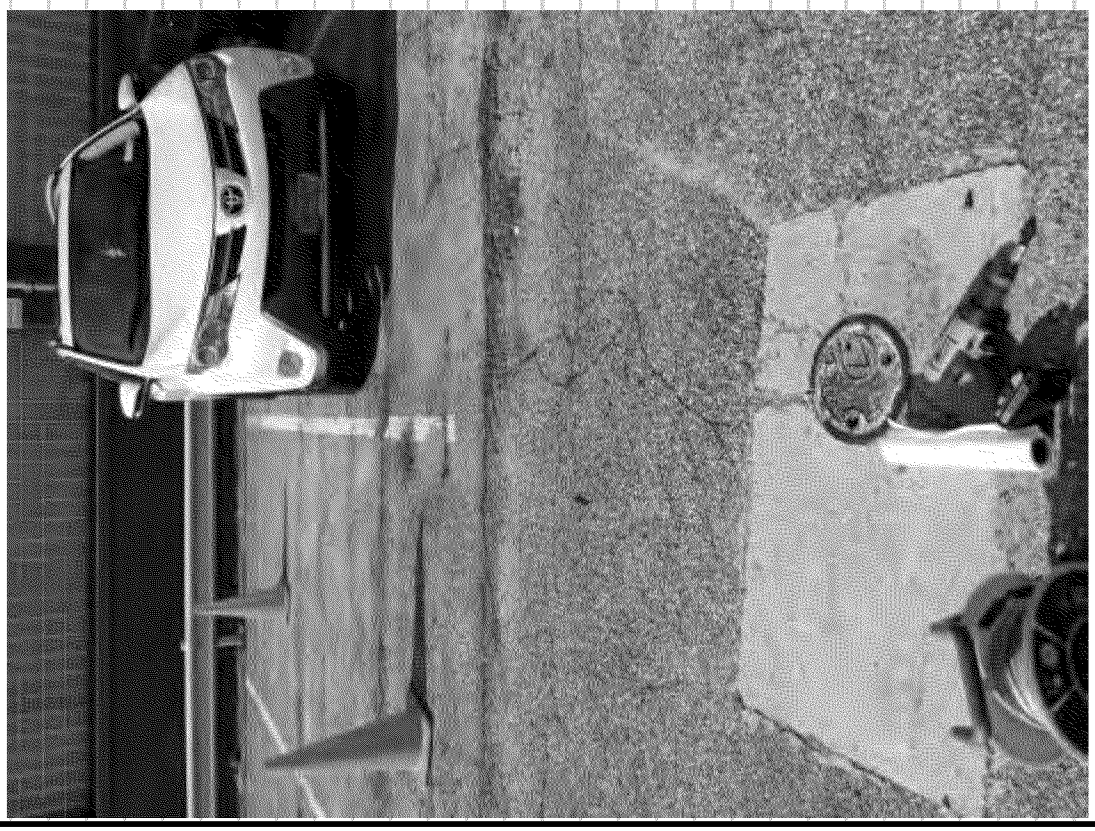
GIS Map Label:	MW08		
Client:	Navy CLEAN	**Northing:**	213932.10
Project #:	60266526	**Easting:**	1123576.06
Facility:	NWIRP Bethpage & OU2	**Well Status:**	In Use (Confirmed)
Project:	Monitoring Well Inventory	**Top of Screen:**	52
Location:	Bethpage, New York	**Bottom of Screen:**	62

Well	Category July 2018	Date Measured	DTW (ft) 2018	DTB (ft) 2018	Depth of Well Installed (ft)	Top of Screen Installed (ft)	Bottom of Screen Installed (ft)	Well Condition	X Coordinate (Easting)	Y Coordinate (Northing)
MW03	GOOD	7/24/18	54.44	64.60	65.5	45.5	65.5	MW-03 is in good condition. There is a bailer present in the well.	1123680.11	214136.78
MW04	FAIR	7/24/18	55.03	66.00	66	46	66	MW-04 is in fair condition. MW-04 is missing 2 bolts. There is tubing present in the well.	1123645.16	214018.53
MW05					67	47	67	Abandoned as of May 2014 Well Inventory.	1123702.57	214173.91
MW06	FAIR	7/24/18	50.63	61.90	62	52	62	MW-06 is in fair condition. MW-06 is missing 1 bolt.	1123745.67	213898.45
MW07	FAIR	7/24/18	50.34	61.75	62	52	62	MW-07 is in fair condition. MW-07 is missing 1 bolt and the pad is cracked.	1123660.55	213883.97
MW08	FAIR	7/24/18	51.10	61.80	62	52	62	MW-08 is in fair condition. MW-08 is missing 3 bolts.	1123576.06	213932.10

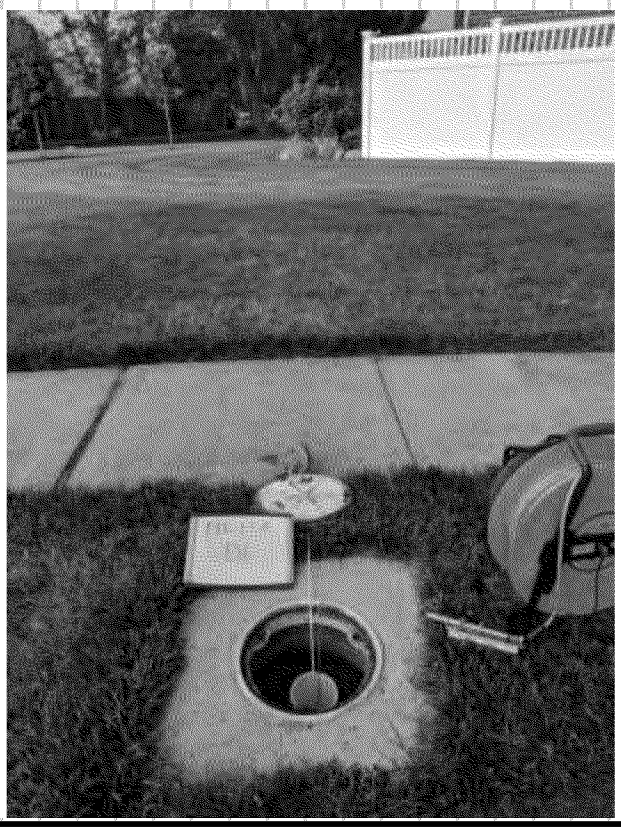
GIS Map Label:	RE117D2
Client:	Navy CLEAN	**Northing:**	196455.23
Project #:	60266526	**Easting:**	1125332.71
Facility:	NWIRP Bethpage & OU2	**Well Status:**	In Use (Confirmed)
Project:	Monitoring Well Inventory	**Top of Screen:**	780
Location:	Bethpage, New York	**Bottom of Screen:**	805

RE117D2	GOOD	7/17/18	24.85	805.91	58	780	805	RE117D2 is in good condition. There is tubing present in the well.	1125332.71	196455.23
RE118D1	GOOD	7/17/18	28.44	798.80	795	765	790	RE118D1 is in good condition. There is tubing present in the well.	1126290.80	197298.81
RE119D1	GOOD	7/17/18	23.81	741.35	745	715	740	RE119D1 is in good condition. There is tubing present in the well.	1128694.84	197245.89
RE120D1	FAIR	7/18/18	38.96	654.11	655	630	650	RE120D1 is in fair condition. RE120D1 missing 1 bolt.	1125060.70	204590.37
RE120D2	FAIR	7/18/18	38.85	711.80	713	690	710	RE120D2 is in fair condition. RE120D2 missing 1 bolt. There is tubing present in the well.	11205060.08	204576.78
RE120D3	FAIR	7/18/18	38.41	761.90	765	740	760	RE120D3 is in fair condition. RE120D3 missing 1 bolt. There is tubing present in the well.	11205061.88	204618.12
RE121D1	GOOD	7/18/18	34.94	571.10	575	550	570	RE121D1 is in good condition. There is tubing present in the well.	1126707.85	203062.13

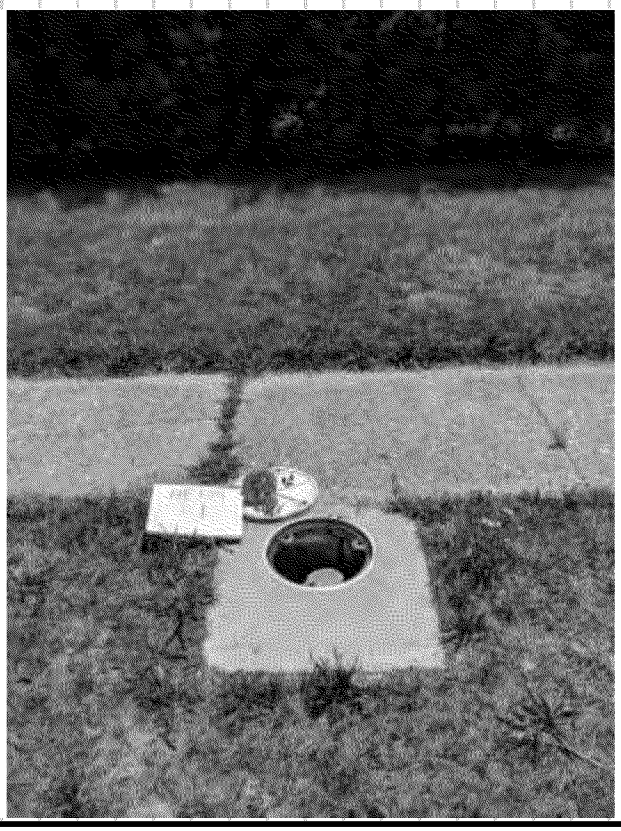
GIS Map Label:	RE129D2
Client:	Navy CLEAN	**Northing:**	196073.15
Project #:	60266526	**Easting:**	1124074.20
Facility:	NWIRP Bethpage & OU2	**Well Status:**	In Use (Confirmed)
Project:	Monitoring Well Inventory	**Top of Screen:**	805
Location:	Bethpage, New York	**Bottom of Screen:**	825

Well	Category July 2018	Date Measured	DTW (ft) 2018	DTB (ft) 2018	Depth of Well Installed (ft)	Top of Screen Installed (ft)	Bottom of Screen Installed (ft)	Well Condition	X Coordinate (Easting)	Y Coordinate (Northing)
RE129D2	GOOD	7/16/18	24.89	826.30	830	805	825	RE129D2 is in good condition.	1124074.20	196073.15
RE130D1	GOOD	7/16/18	25.12	576.90	580	555	575	RE130D1 is in good condition.	1122360.37	197584.59
RE130D2	GOOD	7/16/18	25.25	664.25	665	640	660	RE130D2 is in good condition.	1122370.25	197604.41
RE131D1	FAIR	7/18/18	37.96	450.00	455	430	450	RE131D1 is in fair condition.RE131D1 missing 1 bolt.	1123114.27	204367.45
RE131D2	FAIR	7/18/18	38.84	589.30	594.22	565	590	RE131D2 is in fair condition. RE131D2 missing 3 bolts.	1123099.42	204359.42
RE131D3	FAIR	7/18/18	39.35	683.52	684.8	660	680	RE131D3 is in fair condition. RE131D3 missing 2 bolts.	1123115.19	204350.99
RE133D1	GOOD	7/16/18	24.14	582.31	585	560	580	RE133D1 is in good condition. There is tubing present in the well.	1126227.64	193975.82

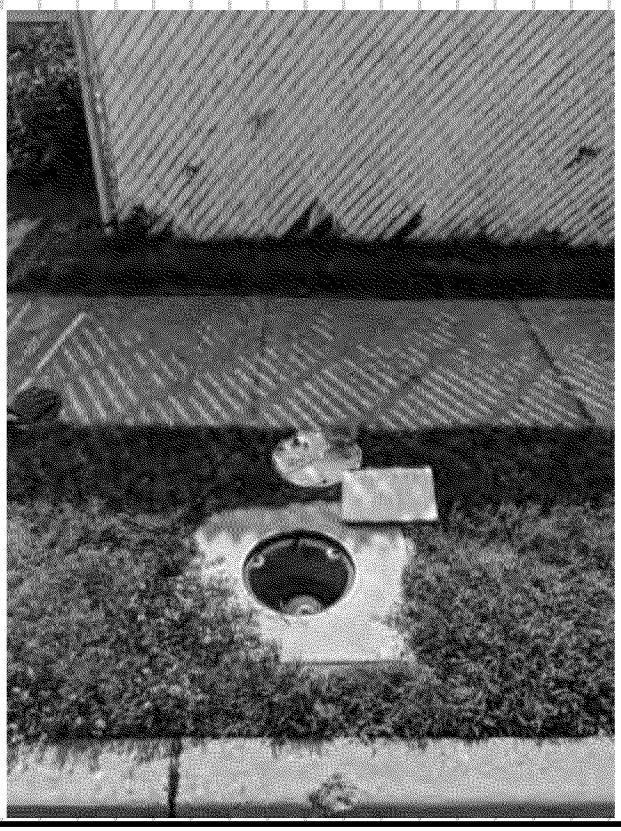
GIS Map Label:	RE133D2
Client:	Navy CLEAN	**Northing:**	193991.82
Project #:	60266526	**Easting:**	1126227.06
Facility:	NWIRP Bethpage & OU2	**Well Status:**	In Use (Confirmed)
Project:	Monitoring Well Inventory	**Top of Screen:**	780
Location:	Bethpage, New York	**Bottom of Screen:**	800

RE133D2	GOOD	7/16/18	25.33	800.85	805	780	800	RE133D2 is in good condition. There is tubing present in the well.	1126227.06	193991.82
RE137	FAIR	7/19/18	39.28	749.45	750	630	745	RE137 appears in fair condition. RE137 has no lock.	1125692.43	204415.54
RW1-MW1	FAIR	7/23/18	39.52	NA	N/A	395	435	RW1-MW1 is in fair condition. RW1-MW1 has a pvc cap with sampling ports.	1129581.00	206067.00
RW1-MW2	FAIR	7/23/18	40.80	NA	N/A	395	435	RW1-MW2 is in fair condition. RW1-MW-2 missing bolt. RW1-MW1 has a pvc cap with sampling ports.	1129739.00	206080.00
RW1-MW3	GOOD	7/23/18	31.62	436.11	N/A	395	435	RW1-MW3 is in good condition. There is tubing present in the well.	1130076.00	206503.00
RW2-MW1	FAIR	7/20/18	39.96	512.90	No log	470	510	RW2-MW1 is in fair condition. RW2-MW1 is missing 1 bolt and 1 tab. Tubing is present in well.	1129257.08	206443.35
RW3-MW1	GOOD	7/23/18	39.59	350.50	No log	330	350	RW3-MW1 is in good condition. There is tubing present in the well.	1128424.49	206582.12
