PHASE I / PHASE II ENVIRONMENTAL ASSESSMENT
CLINTON ENGINES PROPERTY
605 EAST MAPLE STREET
MAQUOKETA, IOWA

CITY OF MAQUOKETA
201 East Pleasant Street
Maquoketa, Iowa 52060

October 15, 1999
C99E028

RE: Phase I / Phase II Environmental Assessment
Clinton Engines Property
605 East Maple Street
Maquoketa, Iowa
MSA No. C99E028

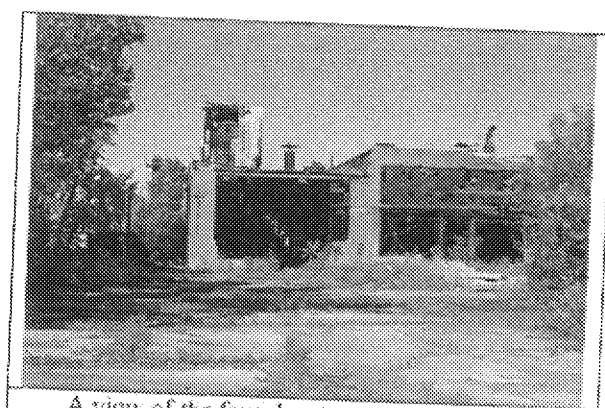
A view of the foundry structure facing west.

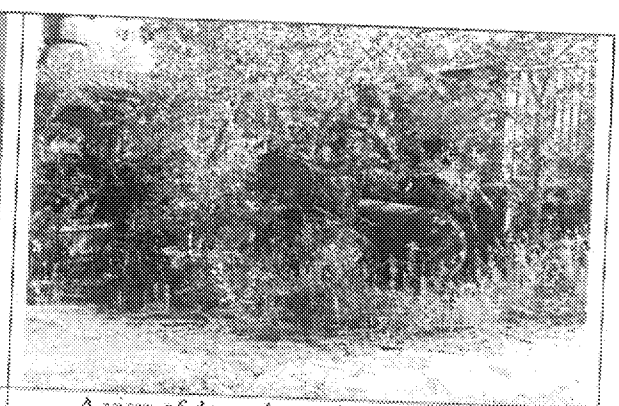
A view of drums located on the south side of the easterly building.

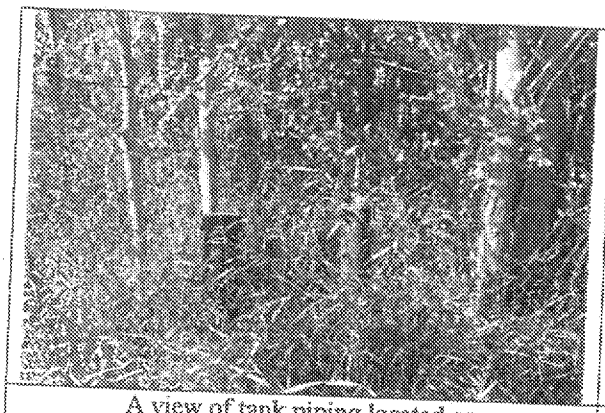
A view of tank piping located on the east side of the metal shed.

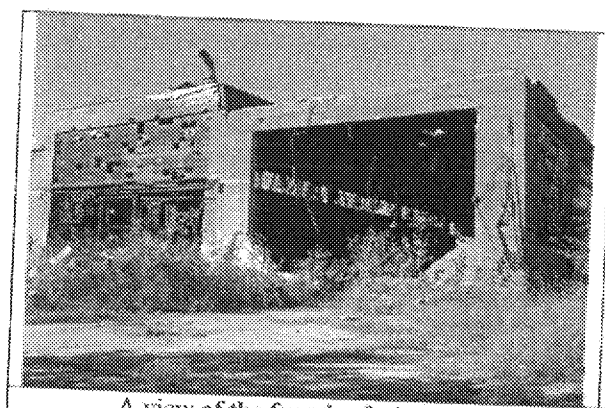
A view of debris located on the north side of the shipping area.

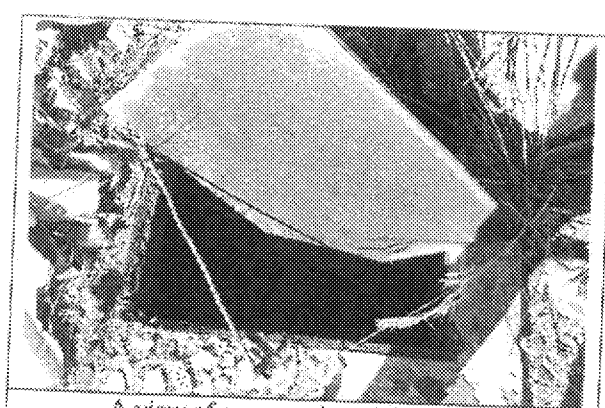
Concrete debris located immediately east of the foundry structure.
