PHASE I / PHASE II ENVIRONMENTAL ASSESSMENT
CLINTON ENGINES PROPERTY
605 EAST MAPLE STREET
MAQUOKETA, IOWA

October 15, 1999
C99E028

RE: Phase I / Phase II Environmental Assessment
Clinton Engines Property
605 East Maple Street
Maquoketa, Iowa
MSA No. C99E028

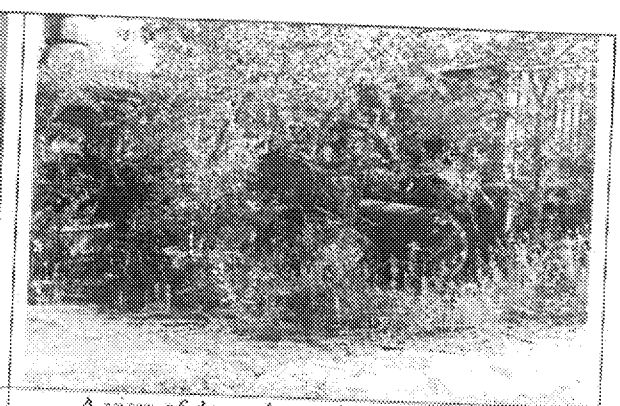
A view of drums located on the south side of the easterly building.

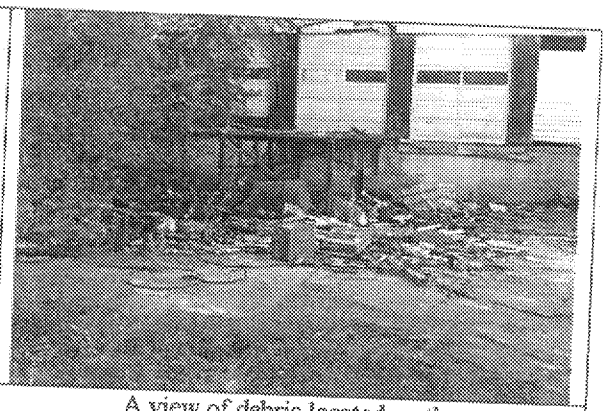
A view of debris located on the north side of the shipping area.

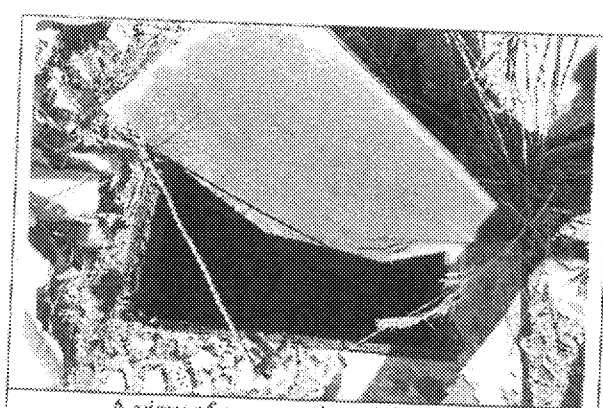
A view of a sump pit and lid located immediately east of the foundry structure.
