PHASE I / PHASE II ENVIRONMENTAL ASSESSMENT
CLINTON ENGINES PROPERTY
605 EAST MAPLE STREET
MAQUOKETA, IOWA

CITY OF MAQUOKETA
201 East Pleasant Street
Maquoketa, Iowa 52060

MISSMAN, STANLEY & ASSOCIATES, P.C.
2415 18th Street, Suite 203
Bettendorf, Iowa
(319) 344-0260

October 15, 1999
C99E028

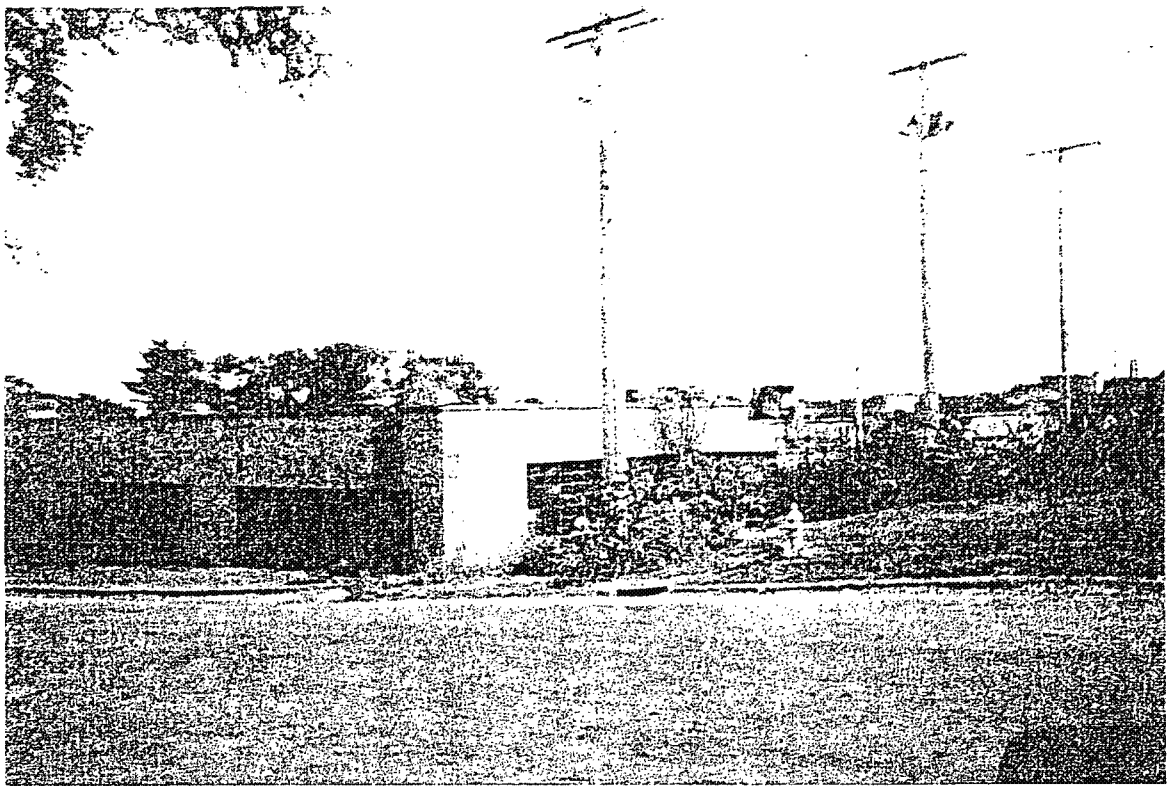
A view of the subject property facing northeast.

A view of the office building facing south.

Looking south at the eastern portion of subject property. Specifically a concrete pad formerly used for drain storage.

Stressed vegetation located on the north side of the main structure.

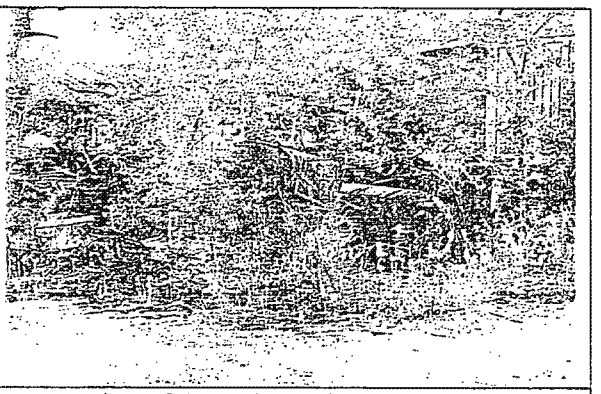
A view of drums located on the south side of the easterly building.

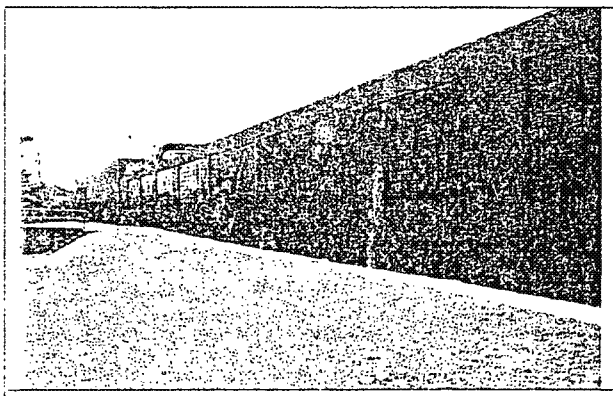
A view of the main structure facing east.

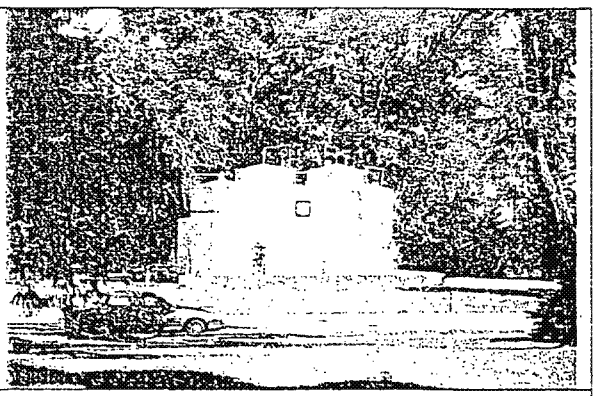
A view of Maple Street and the adjacent property to the north.

A view of tank piping located on the east side of the metal shed.

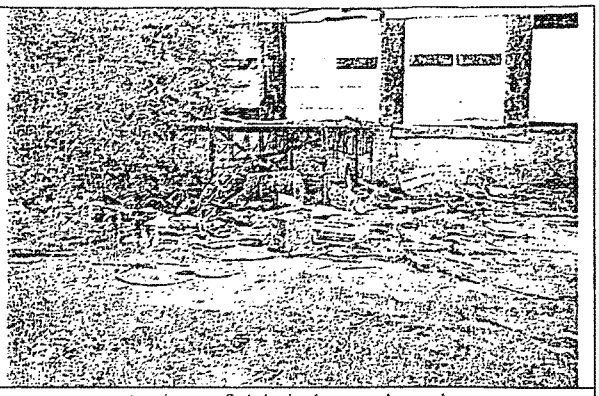
A view of debris located on the north side of the shipping area.

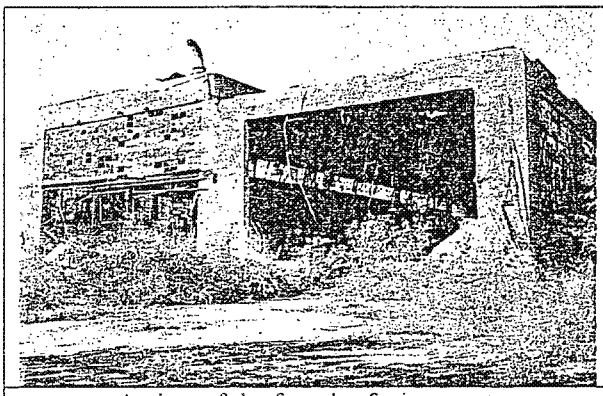
- The presence of the historic foundry on the site. Foundries typically generate waste sand and slag that was potentially disposed on the site, as evidenced by review of historic aerial photographs of the property.

A view of the foundry facing west.

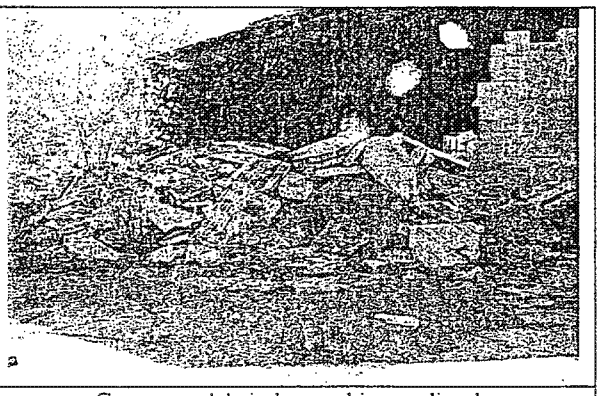
Concrete debris located immediately east of the foundry structure.

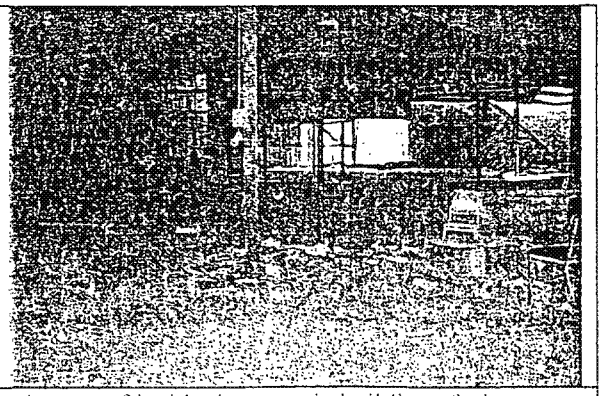
- Several areas inside the structure contained residual solid material and staining associated with the historic operations on the facility. Due to the concrete floors in the facility, it is unlikely that soil or groundwater may have been impacted by the noted staining and residual material, however, it is recommended that an inventory of existing materials be performed prior to demolition of the structures. Further, a potential exists for some areas of soil impact to exist below the concrete floor,

A view of inside the easterly buildings facing east.
