September 23, 2020

City of Kodiak
Office of the Harbor Master
Attn: Michael Sarnowski
710 Mill Bay Road
Kodiak, AK 99615

Subject: **Limited Hazardous Material Survey of Suspect Materials – M/V Wild Alaskan**

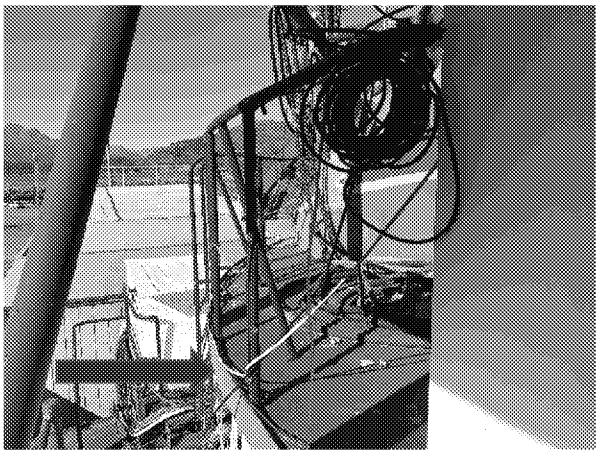
Sample 240	Stairs from Pilot to Deck, Blue Handrail

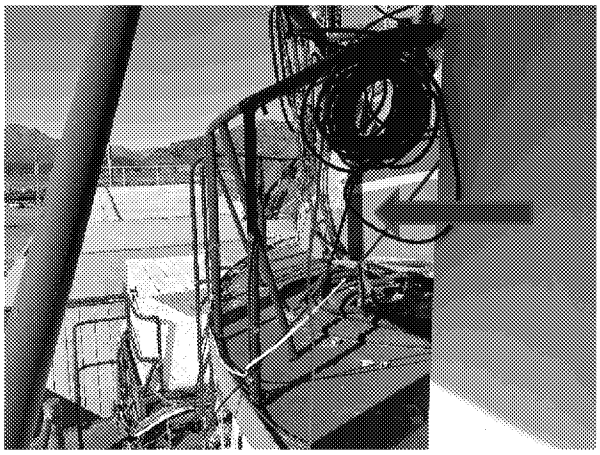
Sample 241	Stairs from Pilot to Deck, Blue Trim

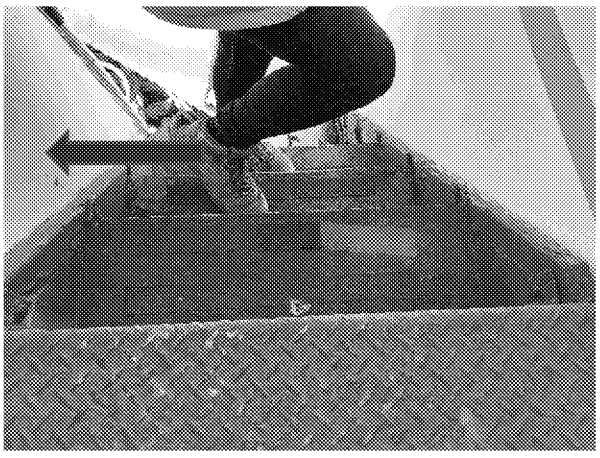
Sample 242,287, 288	Stairs from Pilot to Deck, Blue Wall, and Exhaust Hood

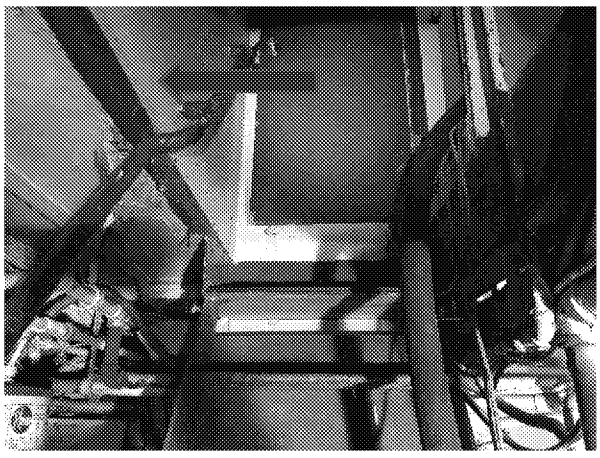
Sample 238, 249	Stairs-Pilot, Red and Black and White Walls

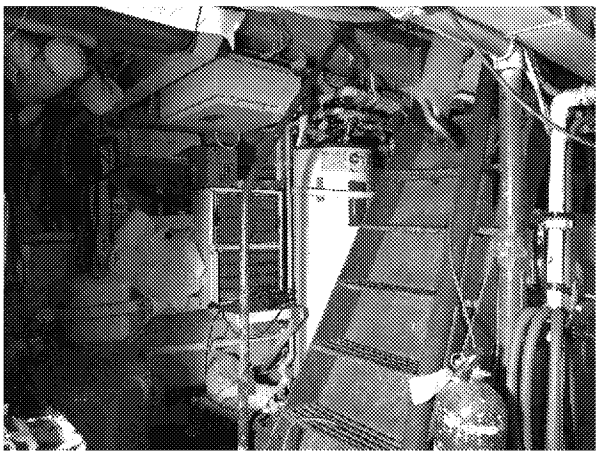
Sample 250	Engine Room Stairs, White Wall

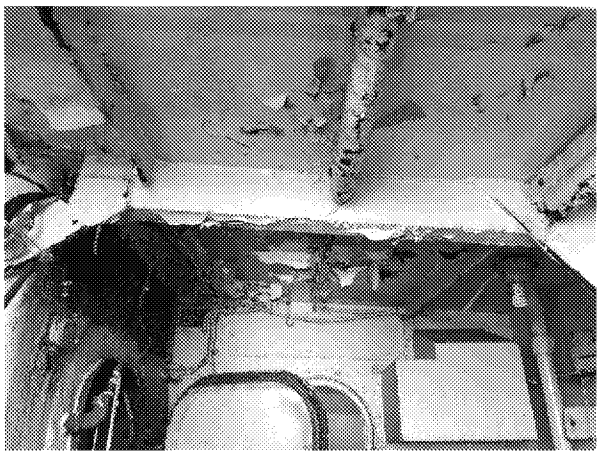
Sample 253,255	Engine Room Stairs, Red Stairs

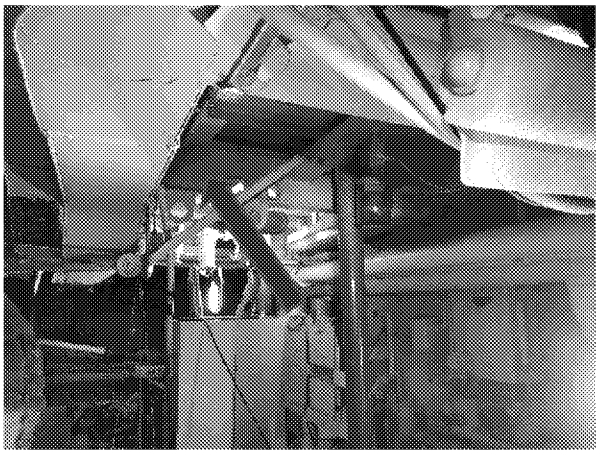
Sample 213-215	Hydraulic Control Room

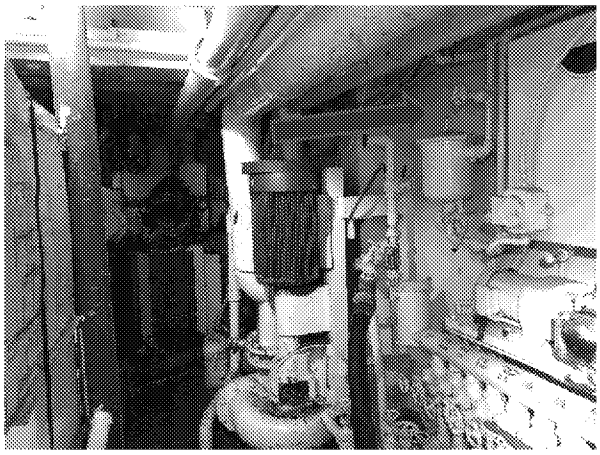
Sample 257,259,	Engine Room, White on Structural Components

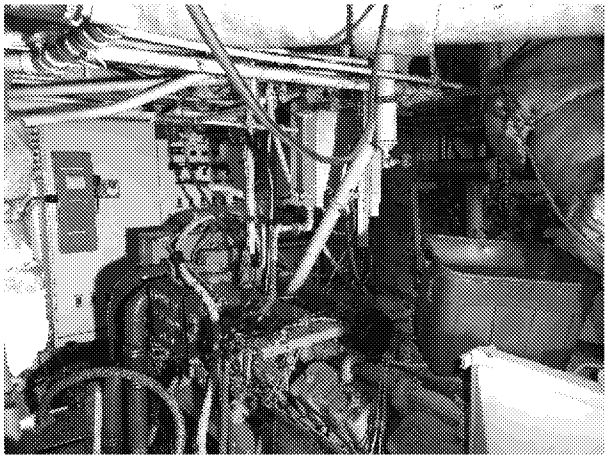
Sample 260,261, 276	Engine Room, White on Structural Components, Bulkhead

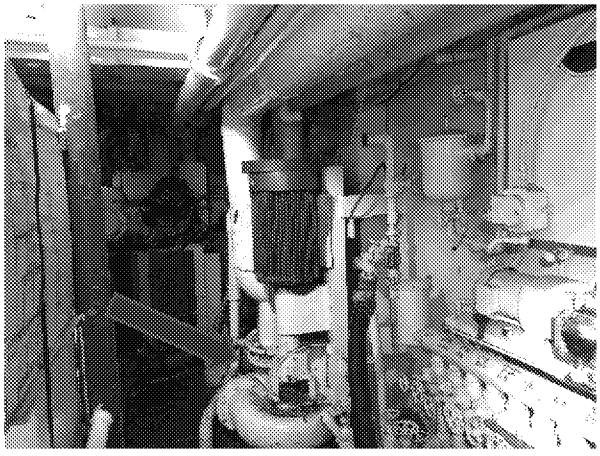
Sample 265,266	Engine Block - Exhaust Assembly, Yellow

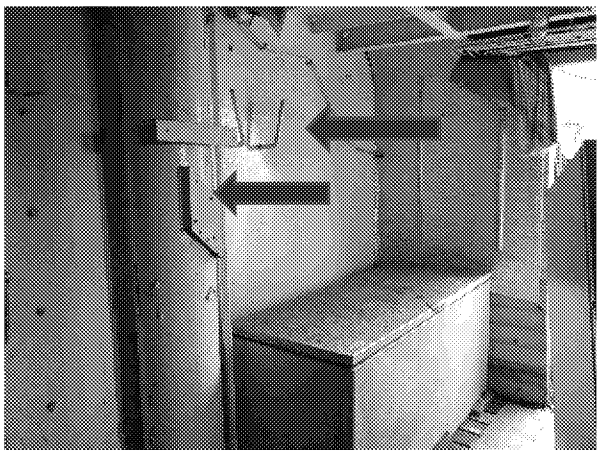
Sample 270,273	Engine Room, White Pipe Valve Flange
