September 23, 2020

City of Kodiak
Office of the Harbor Master
Attn: Michael Sarnowski
710 Mill Bay Road
Kodiak, AK 99615

Subject: **Limited Hazardous Material Survey of Suspect Materials – M/V Wild Alaskan**

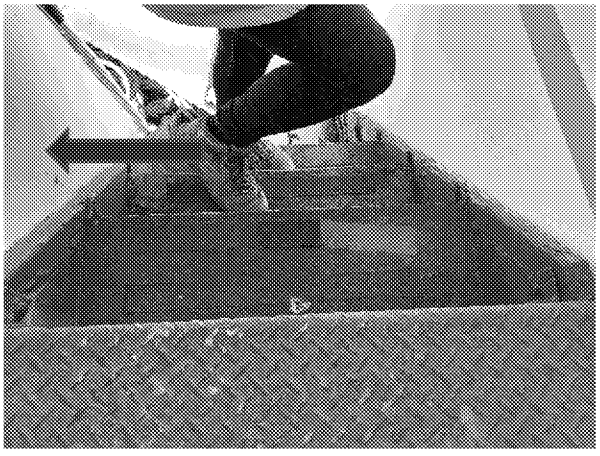
Sample 242,287, 288	Stairs from Pilot to Deck, Blue Wall, and Exhaust Hood

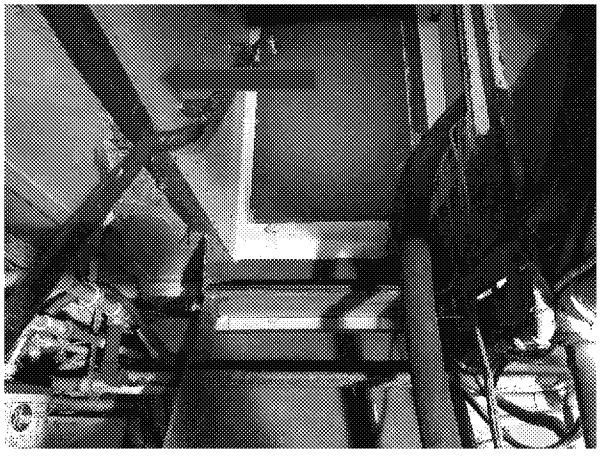
Sample 238, 249	Stairs-Pilot, Red and Black and White Walls

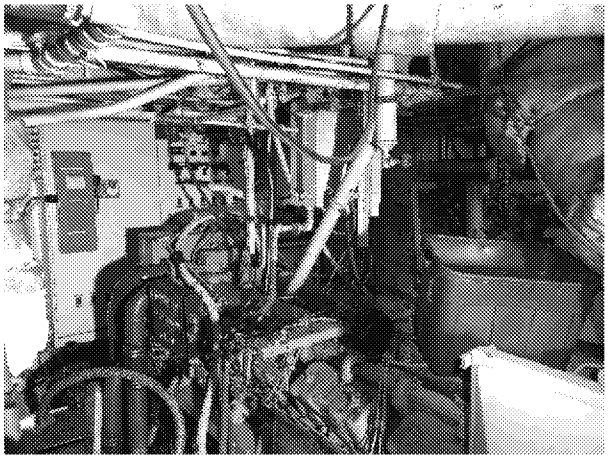
Sample 260,261, 276	Engine Room, White on Structural Components, Bulkhead

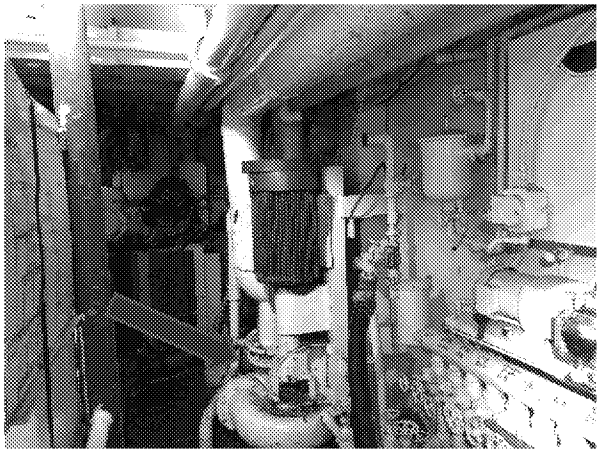
Sample 265,266	Engine Block - Exhaust Assembly, Yellow
