PRELIMINARY ASSESSMENT REPORT

Lake Conestee
Greenville, Greenville County, South Carolina

Final

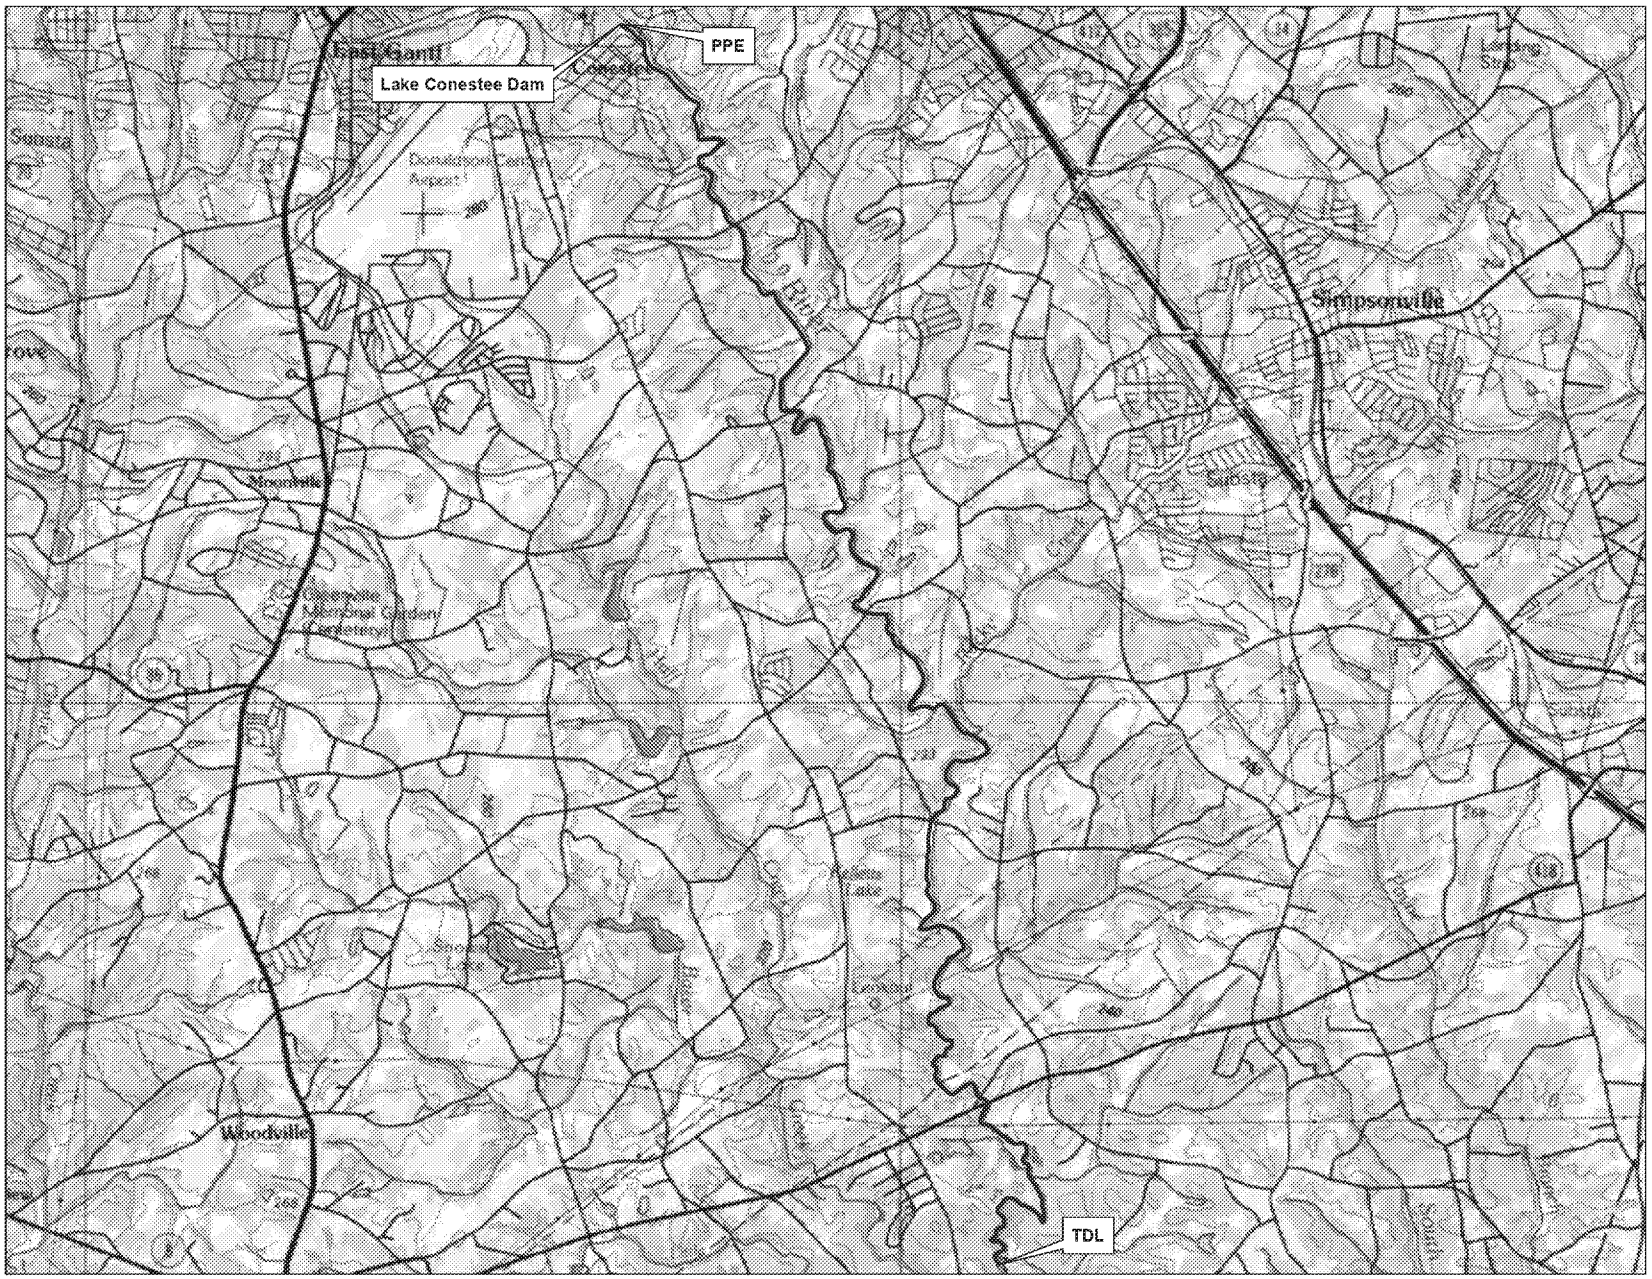
FIGURE 3
15-MILE SURFACE WATER
PATHWAY MAP

No state or federally listed threatened or endangered species are known to occur within the Lake Conestee site. The South Carolina Threatened and Endangered Species Inventory has recorded no listed species within a 5-mile radius of the site (Ref. 7, p. 19). Wetland frontage totaling approximately 27 miles is present along both sides of the 15-mile TDL of the site (see Figure 3).
