Metropolitan Transit Authority (MTA) Building B36
Milepost 136, 103 Kisco Avenue (C001)

Figure 2A:
C001 Radon Analytical Results and Gamma Survey Map

Canadian Radium and Uranium Site
Mount. Kisco, New York

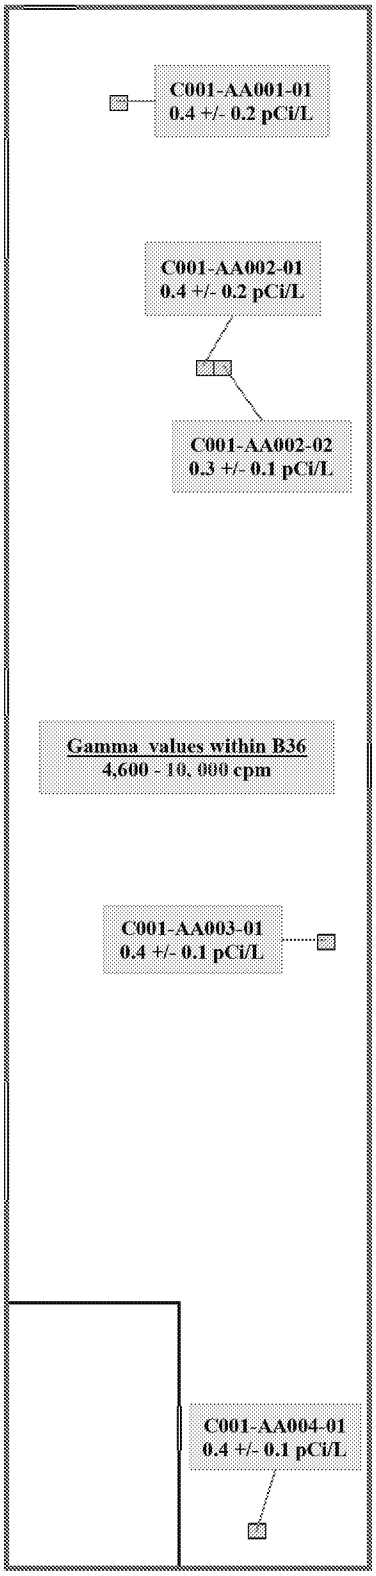
Notes:
Radon sampling was conducted using charcoal canisters
Radon analytical results are reported in pico curies per liter (pCi/L)
Gamma survey was conducted using Ludlum-2241.
Background gamma values = 7,500 - 9,500 counts per minute (cpm).
Values in red exceed Ludlum-2241 background gamma values.
