SITE DETAILS

PROJECT: Canadian Radium & Uranium Corp.

TITLE
Gamma Radiation Screening Results Map
Canadian Radium & Uranium Corp.
103/105 Kisco Avenue
Mount Kisco, NY 10549

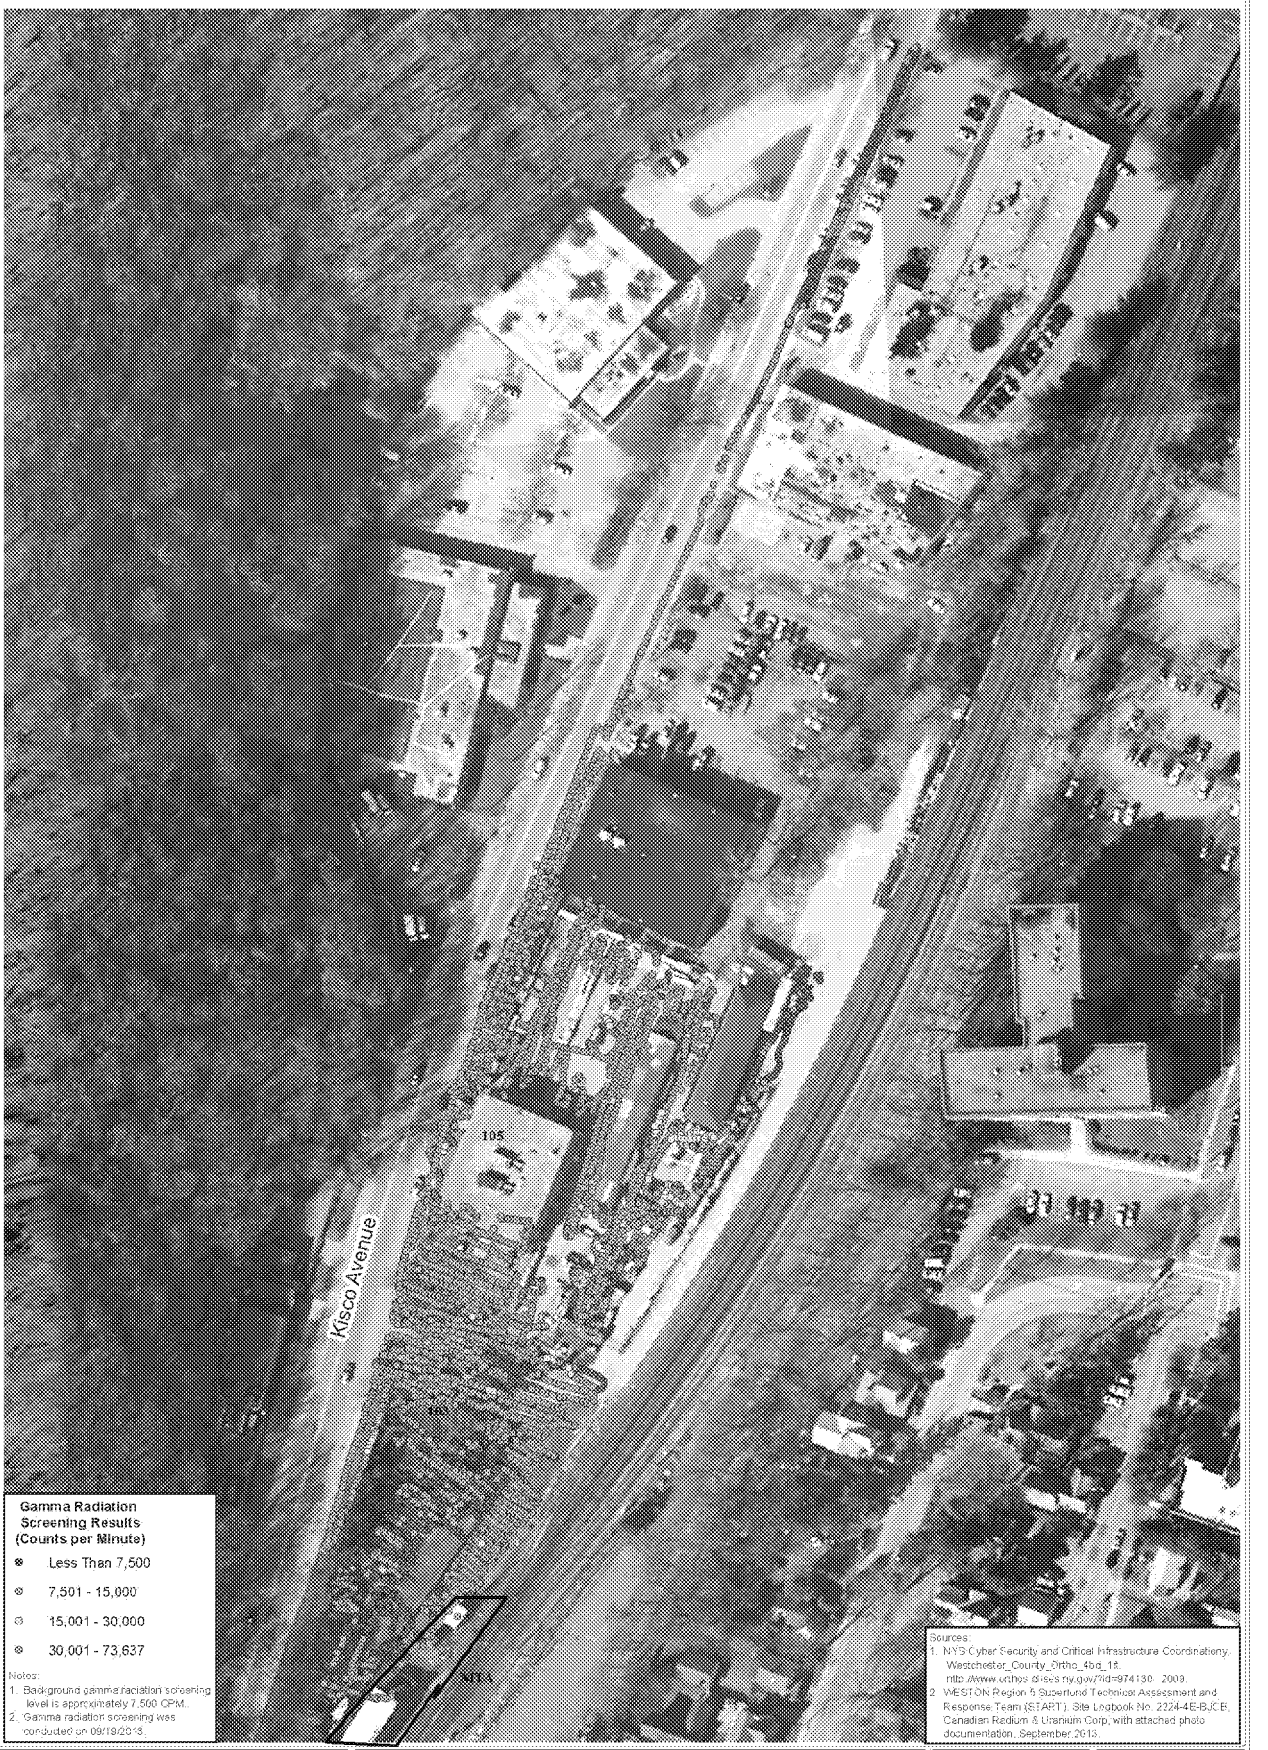
Gamma Radiation Screening Results (Counts per Minute)

- Less Than 7,500
- 7,501 - 15,000
- 15,001 - 30,000
- 30,001 - 73,637

Notes:
1. Background gamma radiation screening level is approximately 7,500 CPM.
2. Gamma radiation screening was conducted on 09/19/2013.
