June 11, 2014

Subject: **Final Site Reassessment Summary Letter Report**
Work Assignment No.: 2222, Canadian Radium & Uranium Corp. site
Contract No.: EP-S5-06-04, TDD No. S05-0013-1307-009

SITE REASSESSMENT SUMMARY LETTER REPORT
CANADIAN RADIUM & URANIUM CORP.
KISCO AVENUE
VILLAGE OF MOUNT KISCO, WESTCHESTER COUNTY, NEW YORK

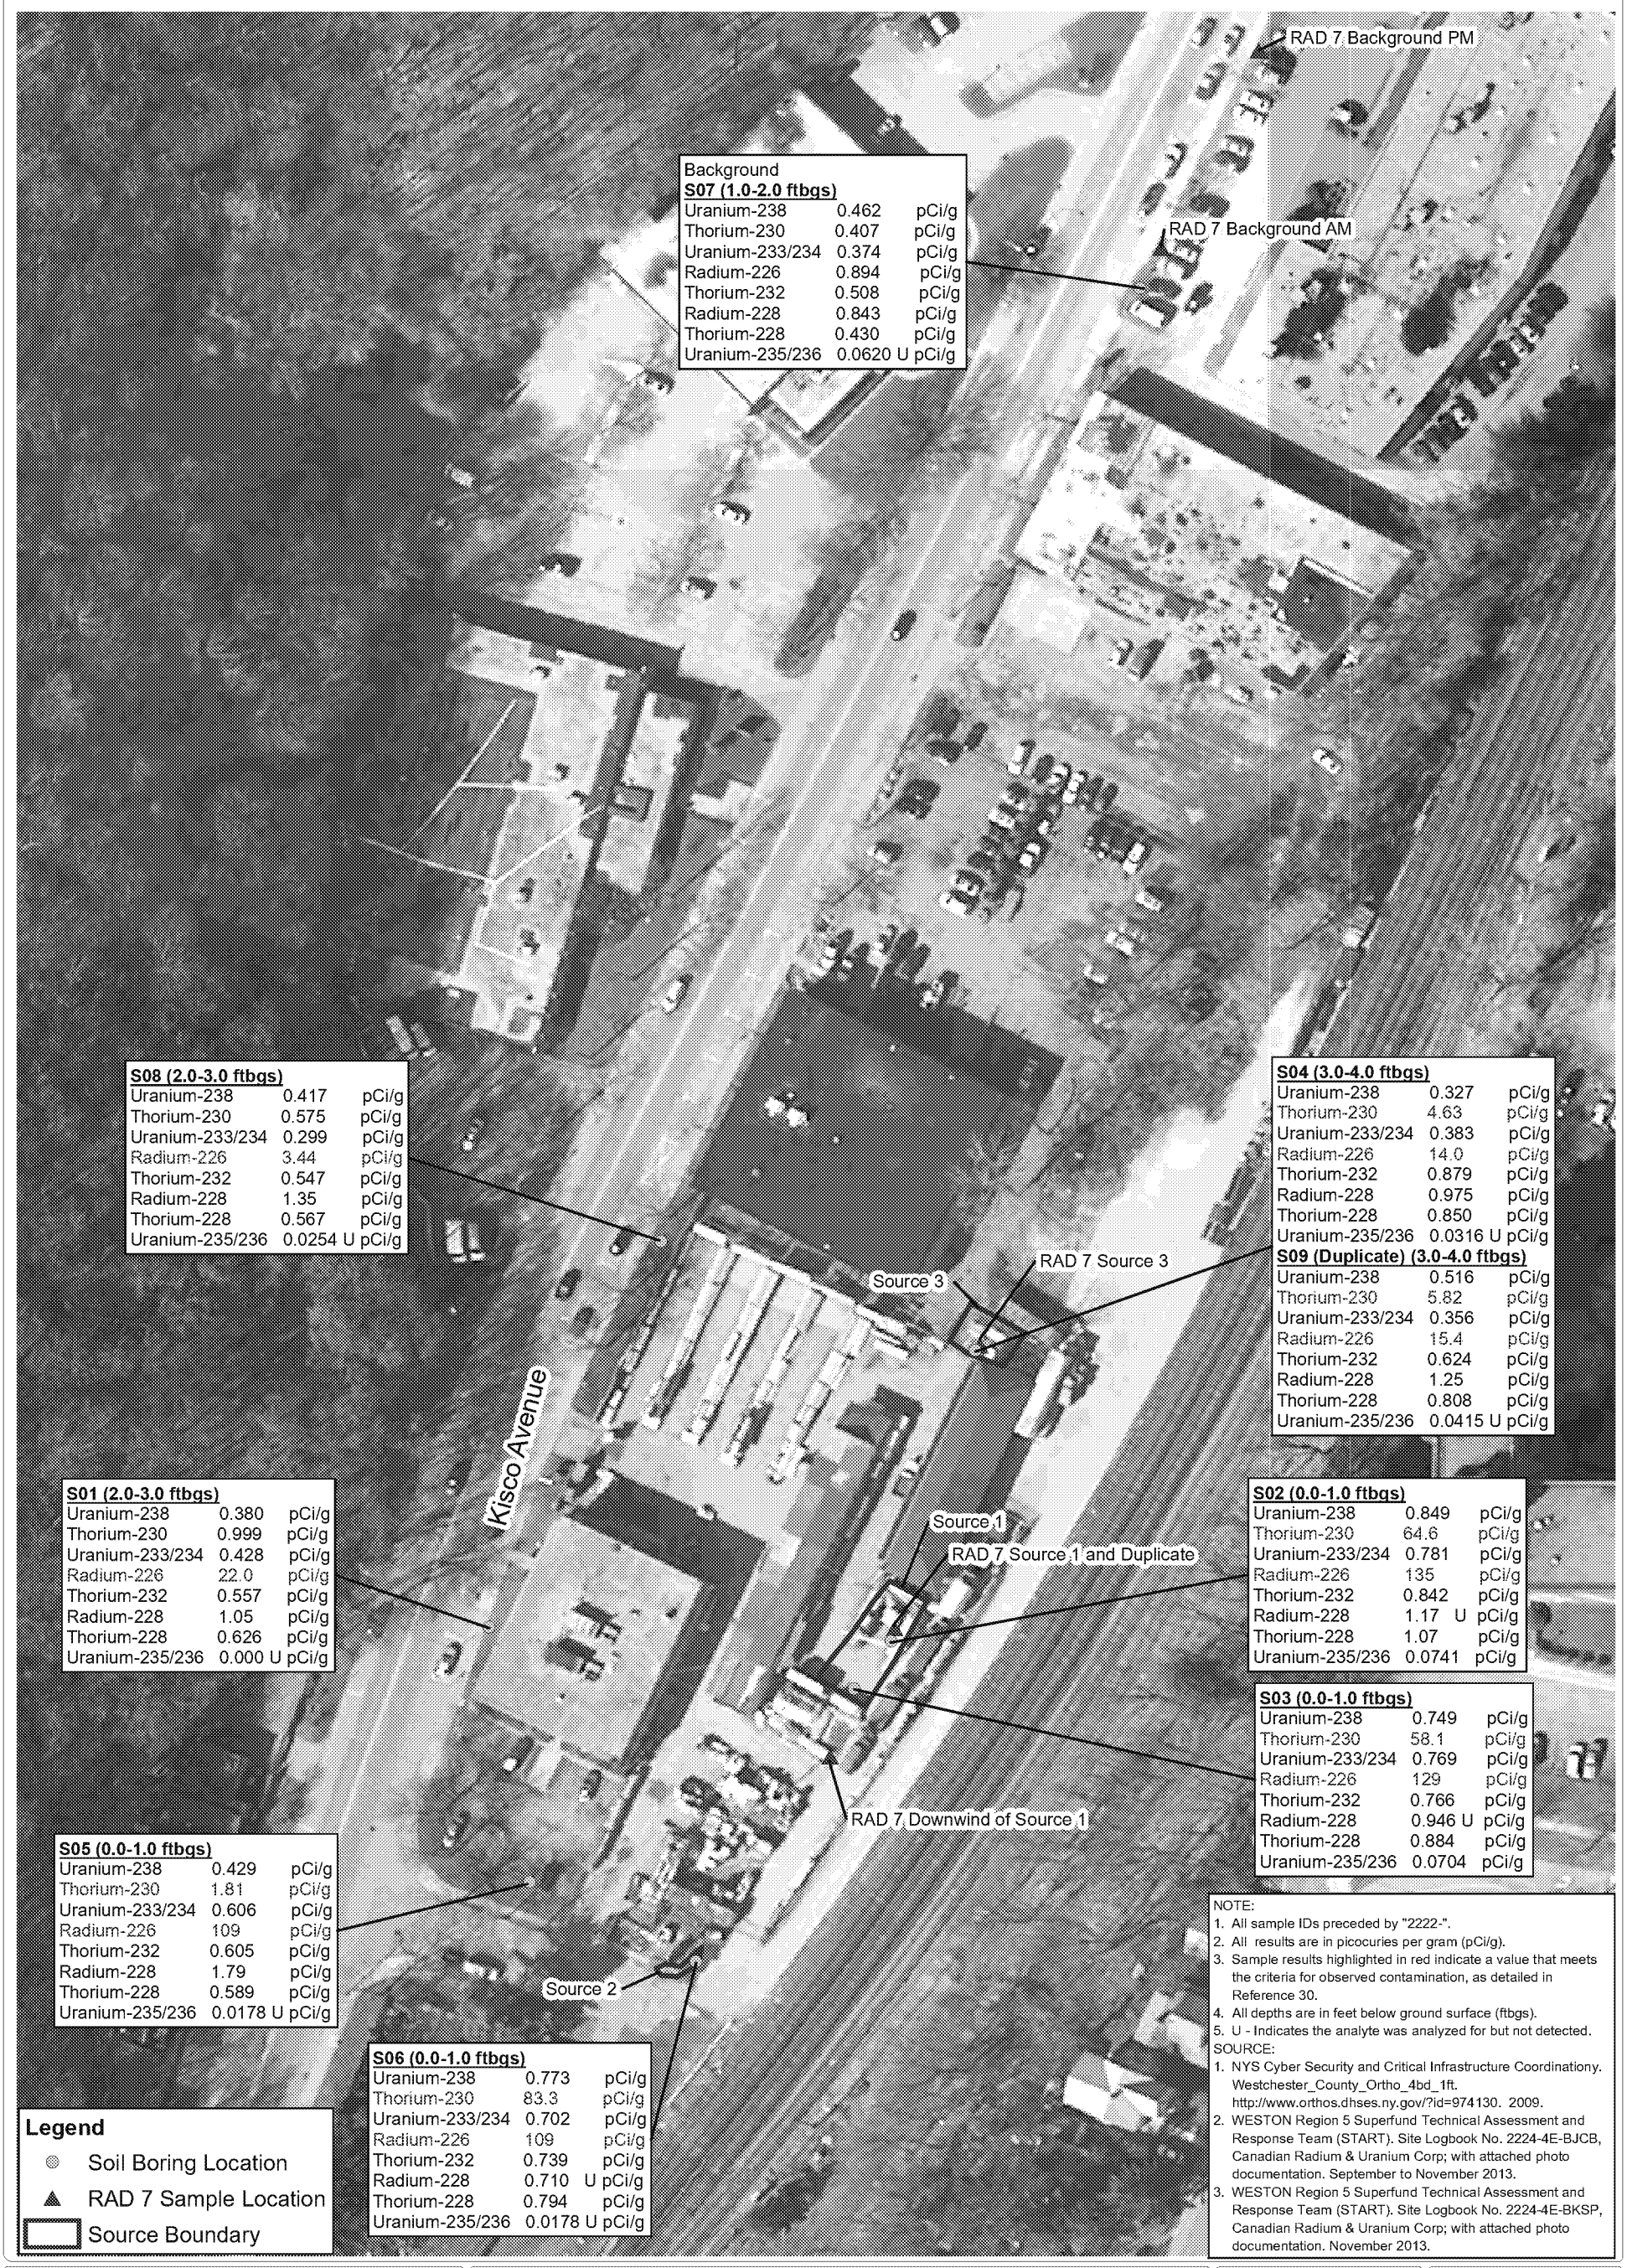
FIGURE #: 4

Ra-226 analytical results in samples 2222-S01, -S02, -S03, -S04, -S05, -S06, and -S09 were all significantly elevated, ranging from 15.4 pCi/g to 135 pCi/g (Ref. 30, pp. 1–2; 34, 19–21). Sample location 2222-S07 was, as expected, at a background level of 0.9 pCi/g (Ref. 30, pp. 1–2; 34, p. 21). Sample 2222-S08, which was collected at an assumed background location near the northeast corner of the subject property, showed a Ra-226 concentration of 3.4 pCi/g, which is slightly elevated above the background level (Ref. 30, pp. 1–2; 34, p. 21). In all instances, when an elevated concentration of Th-230 was detected in a sample, the Ra-226 was also elevated (Ref. 30, pp. 1–2; 34, 19–21). These results are shown in Figure 4 (Ref. 2, Figure 4).

Lead and thallium isotopes are a result of the decay chain of U-238 and Th-232 (Ref. 36, pp. 1–2, 4). There was one sample location that exhibited greater than three times (3x) the highest background level of lead: 2222-S04/-S09 (duplicate) with 1,000 mg/kg and 440 mg/kg, respectively (Ref, 2, Figure 4; 34, pp. 12, 17, 20). It is unknown if this exceedance is linked to the residual radioactive contamination on the CRU site (Ref. 2, Figure 4). There were no detections of thallium at the CRU site (Ref. 34, pp. 9–21). Mercury concentrations greater than 3x the highest background level were also documented at 2222-S01, -S03, and -S04, yet are not known to be linked to the former site operations (Ref. 34, pp. 9, 11, 12, 19–20). These results are shown on Figure 4 (Ref. 2, Figure 4).
