UNITED STATES ENVIRONMENTAL PROTECTION AGENCY
REGION IX – PACIFIC SOUTHWEST REGION
75 Hawthorne Street
San Francisco, CA 94105-3901

Enclosed is the inspection report for EPA's Clean Water Act compliance inspection of BETA's Platform Eureka NPDES General Permit No. CAG280000 conducted on September 24, 2019.

Inspection Date(s):	September 24, 2019		
Time:	**Entry:** 8:40 am	**Exit:** 2:15 pm	
Media:	Water		
Regulatory Program(s)	Clean Water Act NPDES		
Company Name:	BETA Offshore		
Facility or Site Name:	Platform Eureka		
Facility/Site Physical Location:	Platform Eureka, Offshore Long Beach, Pacific Ocean Lease OCS-P-0301		
Geographic Coordinates:	Latitude: 33°33'49.61"N, Longitude: 118° 6'59.38"W		
Mailing address:	111 W. Ocean Blvd. Suite 1240 Long Beach, CA 90802		
Facility/Site Contact:	Diana Lang	**Title:** HSE Manager	
	Phone: 562-628-1529	**Email:** dlang@memorialpp.com	
Facility/Site Identifier:	NPDES Permits CAG280000 and CAF001149		
NAICS:	211111 - Crude petroleum and natural gas extraction		
SIC:	1311		
Facility/Site Personnel Participating in Inspection:			
Name	Affiliation	Title	Email
Diana Lang	BETA offshore	HSE Manager	dlang@memorialpp.com
Alexander Vasquez	BETA offsh

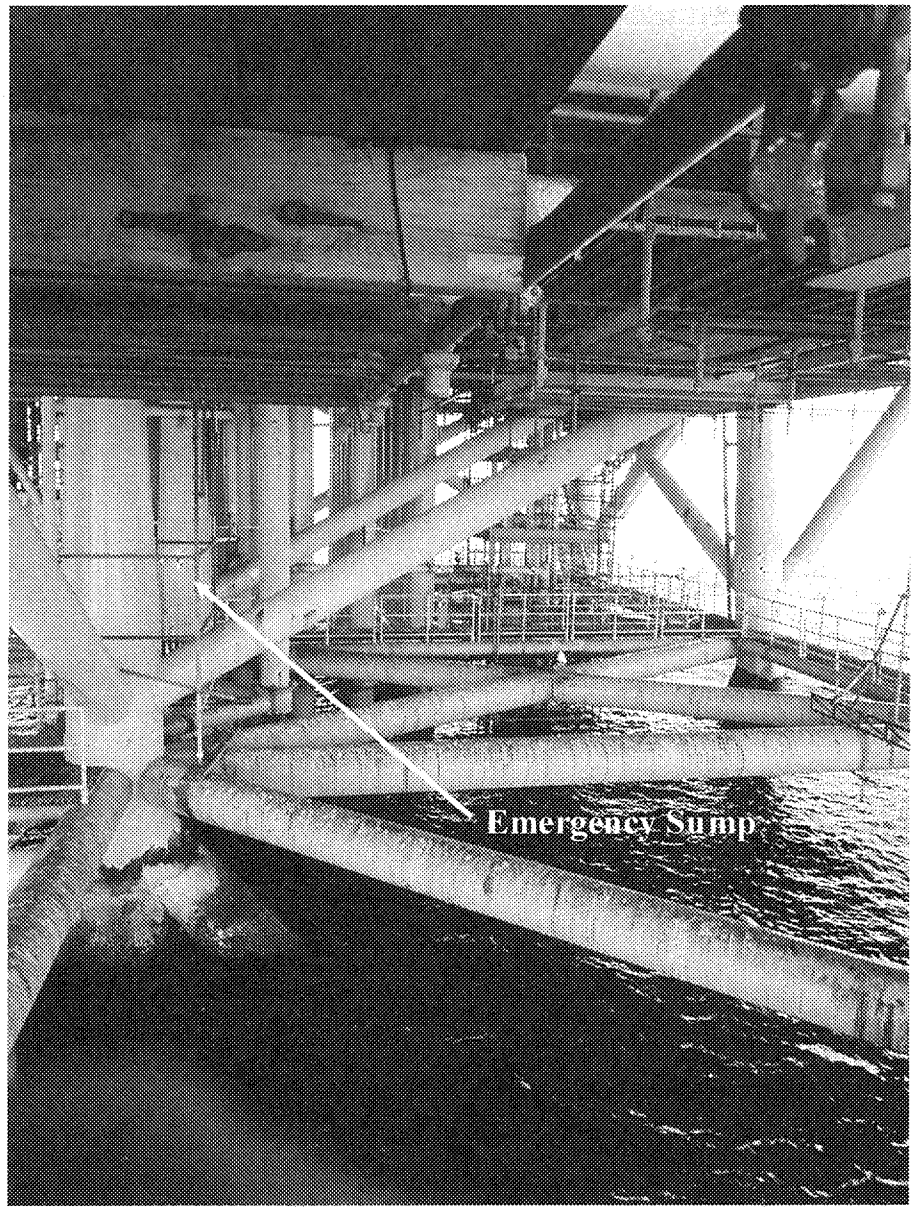
Deck drainage (washdown, rainwater, drip pan and work area drains – Discharge 004) is collected throughout the platform. The top most platform level (Drill Deck) and next level (Production Deck) are enclosed with berms and floor trenches that flow to the sump tank on the Subdeck. Fluid in the sump tank is pumped to a disposal well. If the deck drainage flows ever exceed the capacity of the sump, additional flows can be stored in the emergency sump (Photograph 1). Mr. Vasquez stated that the Facility never has to discharge deck drainage.

Photograph 1: Subdeck structure with emergency sump visible in background..

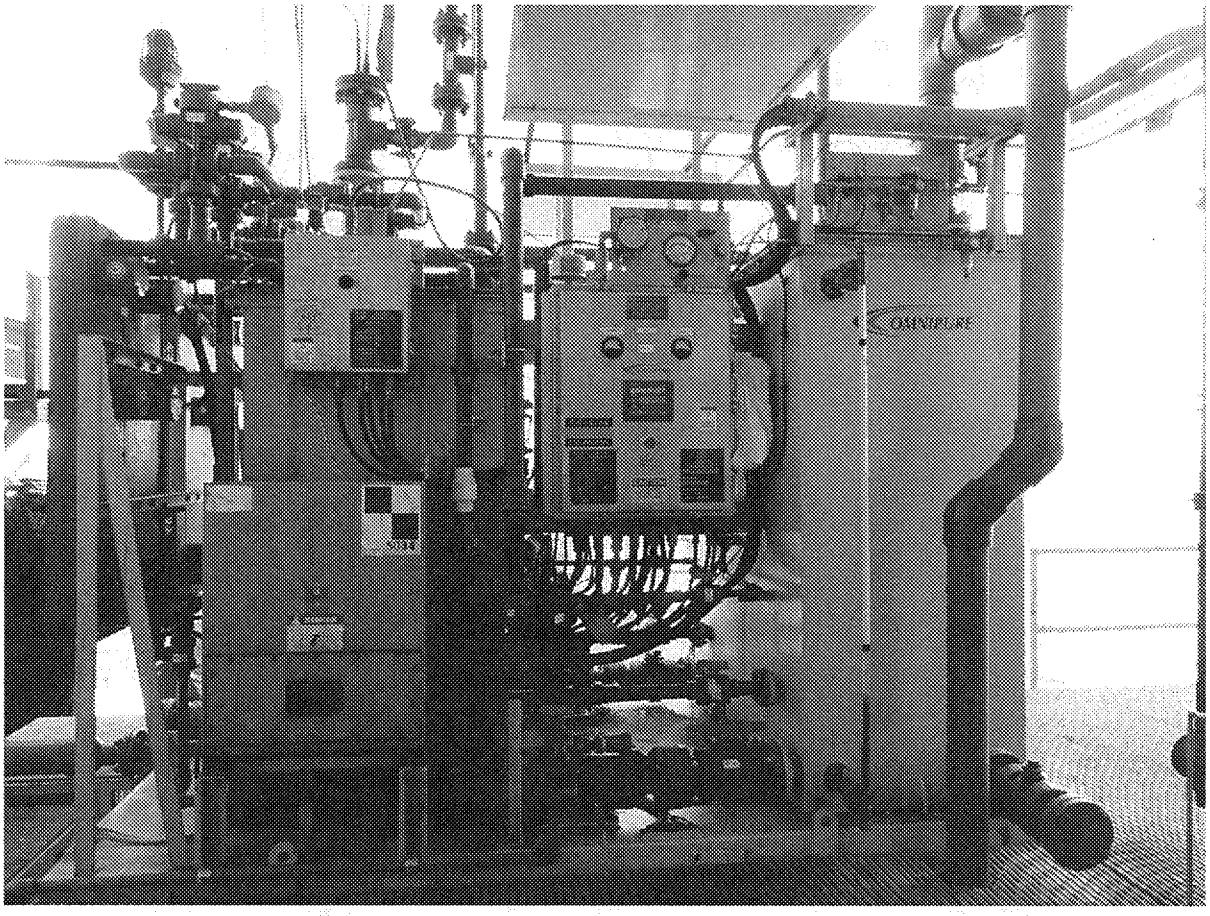
Sanitary Wastewater (Discharge 005) is treated onsite at the Facility with an Omnipure environmental marine sanitation device (MSD) Model No. 12MXMP with serial No. 15-12MXMP-D033301B, which is United States Coast Guard (USCG) approved (Photograph 2). Samples are collected daily from a sample port on the downstream end of the Omnipure (Photograph 3) and tested for residual chlorine. The treated water is pumped to a disposal well. The onsite Facility representatives stated that the daily discharge water flow rate is estimated based on the number of people on the platform and the time spent per person. The MSD unit is sized for a maximum of 7,500 gallons per day (gpd). Domestic wastes (i.e. laundry water) are commingled with deck drainage and sent to a disposal well.

Sanitary wastewater (Discharge 005) is the only wastewater stream to be treated onsite at the Facility. Discharge 005 is treated with an Omnipure MSD (Photograph 2). The self-contained treatment system oxidizes and disinfects sewage by combining it with seawater and electrolyzing the combination in an electrochemical cell which produces hypochlorite for disinfection. Facility personnel stated that the MSD is manually backwashed twice weekly (backwash is sent to deck drainage) and inspected annually by a contractor.

- The Omnipure MSD appeared to be in good working order.

Photograph 2: Omnipure marine sanitation device.

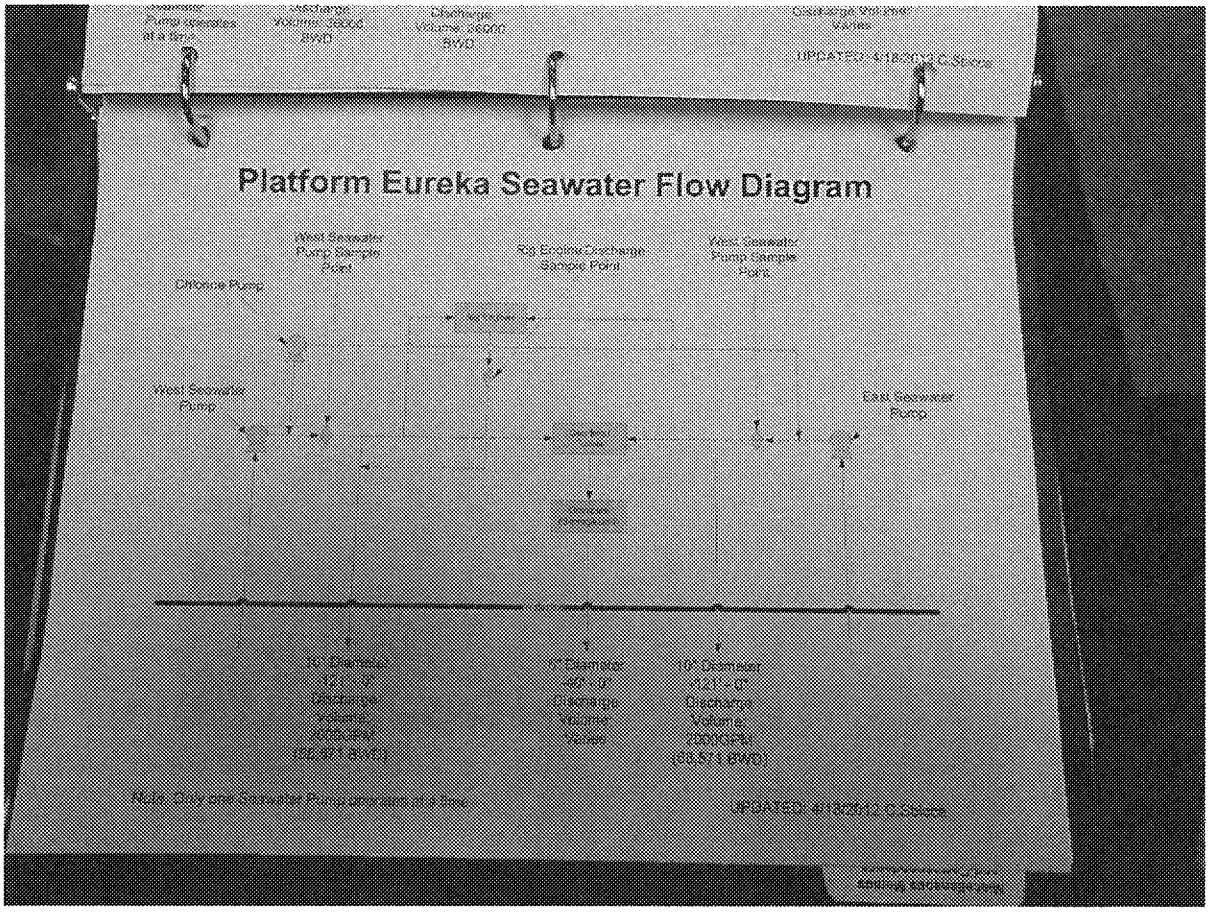
Non-contact Cooling Water (Discharge 009), originates as seawater. Operators inject liquid sodium hypochlorite as a biofilm inhibitor until chlorine concentrations are between 0.2 – 0.5ppm before using it to cool rig engines. The schematic in Photograph 4 shows how seawater is pumped through the Platform and then discharged through 10" diameter pipes at a constant flow rate of 68,571BWD (Barrels of Water per Day). Chlorine residual concentrations are monitored and reported on DMRs.

Photograph 4: Platform Eureka Seawater Flow Diagram.
