Subject/Title: Annual Maintenance Inspection Memo: Sub-Slab Depressurization (SSD) System
Former TRW Microwave Site, 825 Stewart Drive, Sunnyvale, CA

Technical Memorandum

To:	Kurt Batsel, Dextra Group
From:	Tom Wright, GES Project Manager
cc:	Jennifer Clay, GES Holly Holbrook, AECOM
Date:	May 21, 2021
Re:	TRW Microwave Site (Site), Sunnyvale, California: Annual Maintenance Inspection: Sub-Slab Depressurization (SSD) System

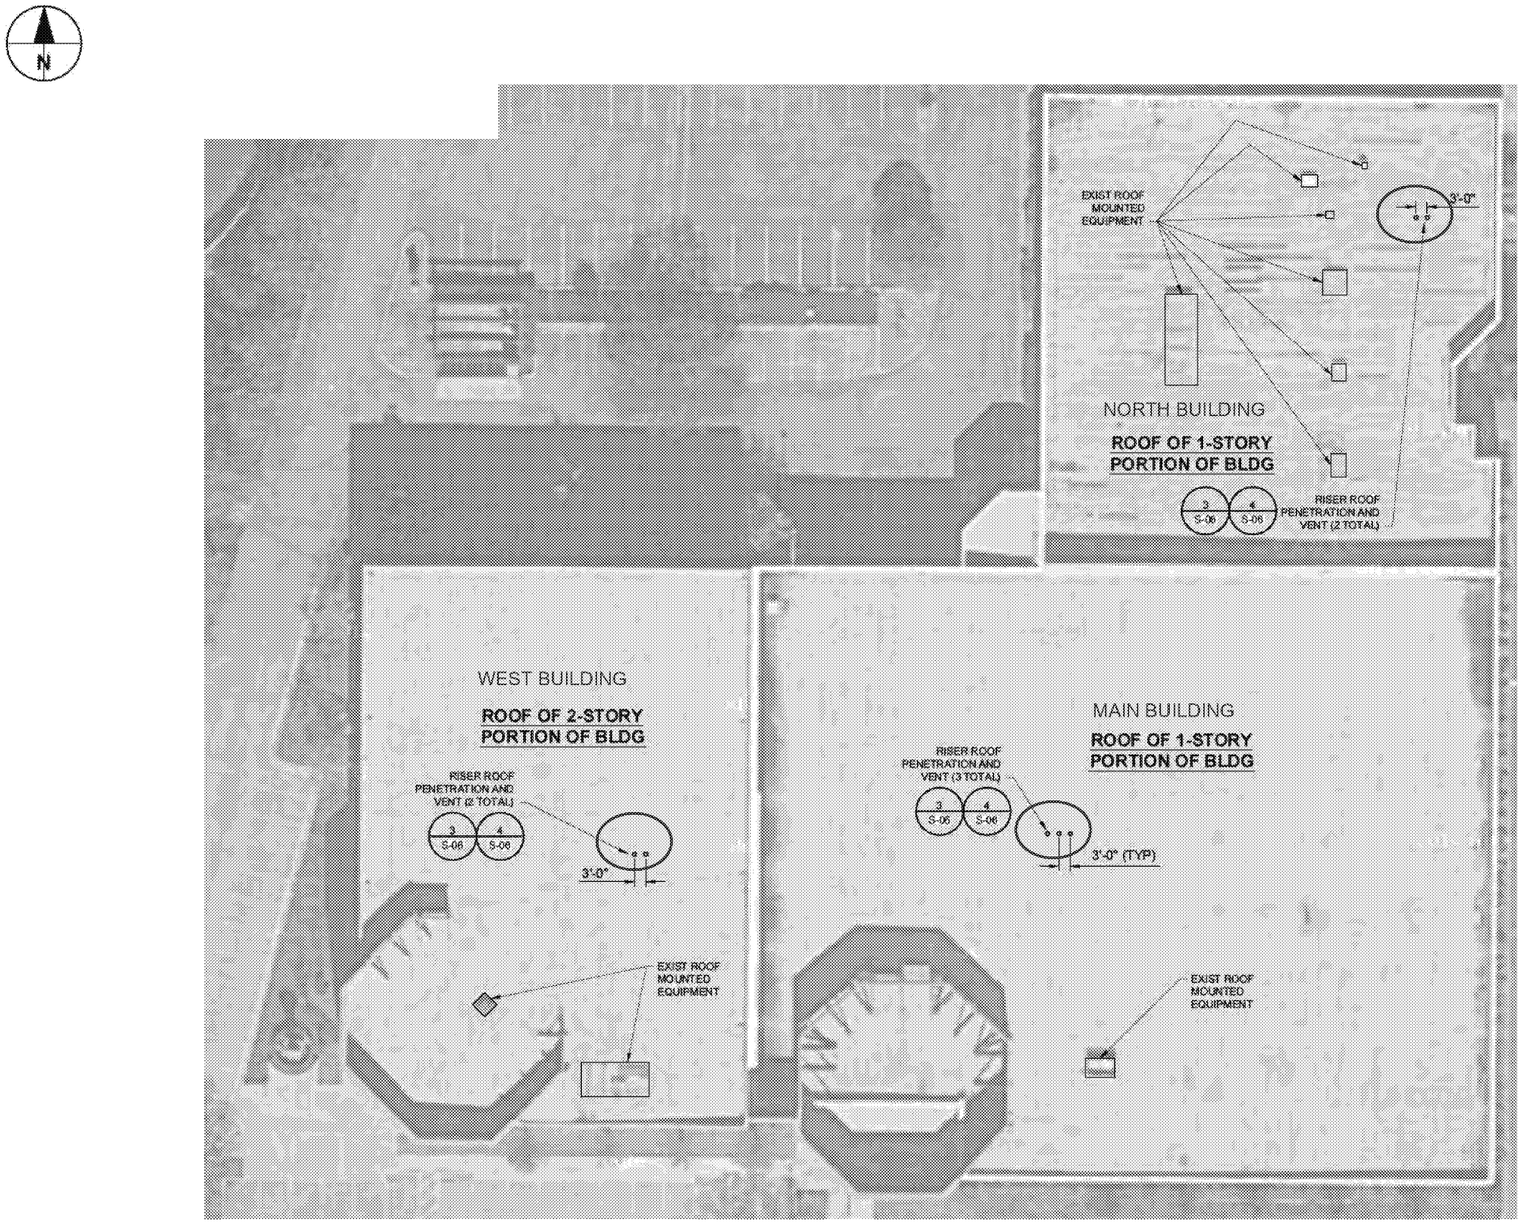
BUILDING ROOF PLAN

- Wind barriers are still in place on all three buildings;
- The vent risers on the main building (**Attachment A**) are currently approximately 1-foot tall, the installed height was approximately 3-feet; and
- All roof turbines spin freely with manual assistance and do not appear to be seized due to corrosion or rust. During the site visit, only the roof turbines on the north building were observed to be spinning due to ambient wind.

RED CIRCLES INDICATE LOCATION OF ROOF RISERS AND VENTS IN 2014

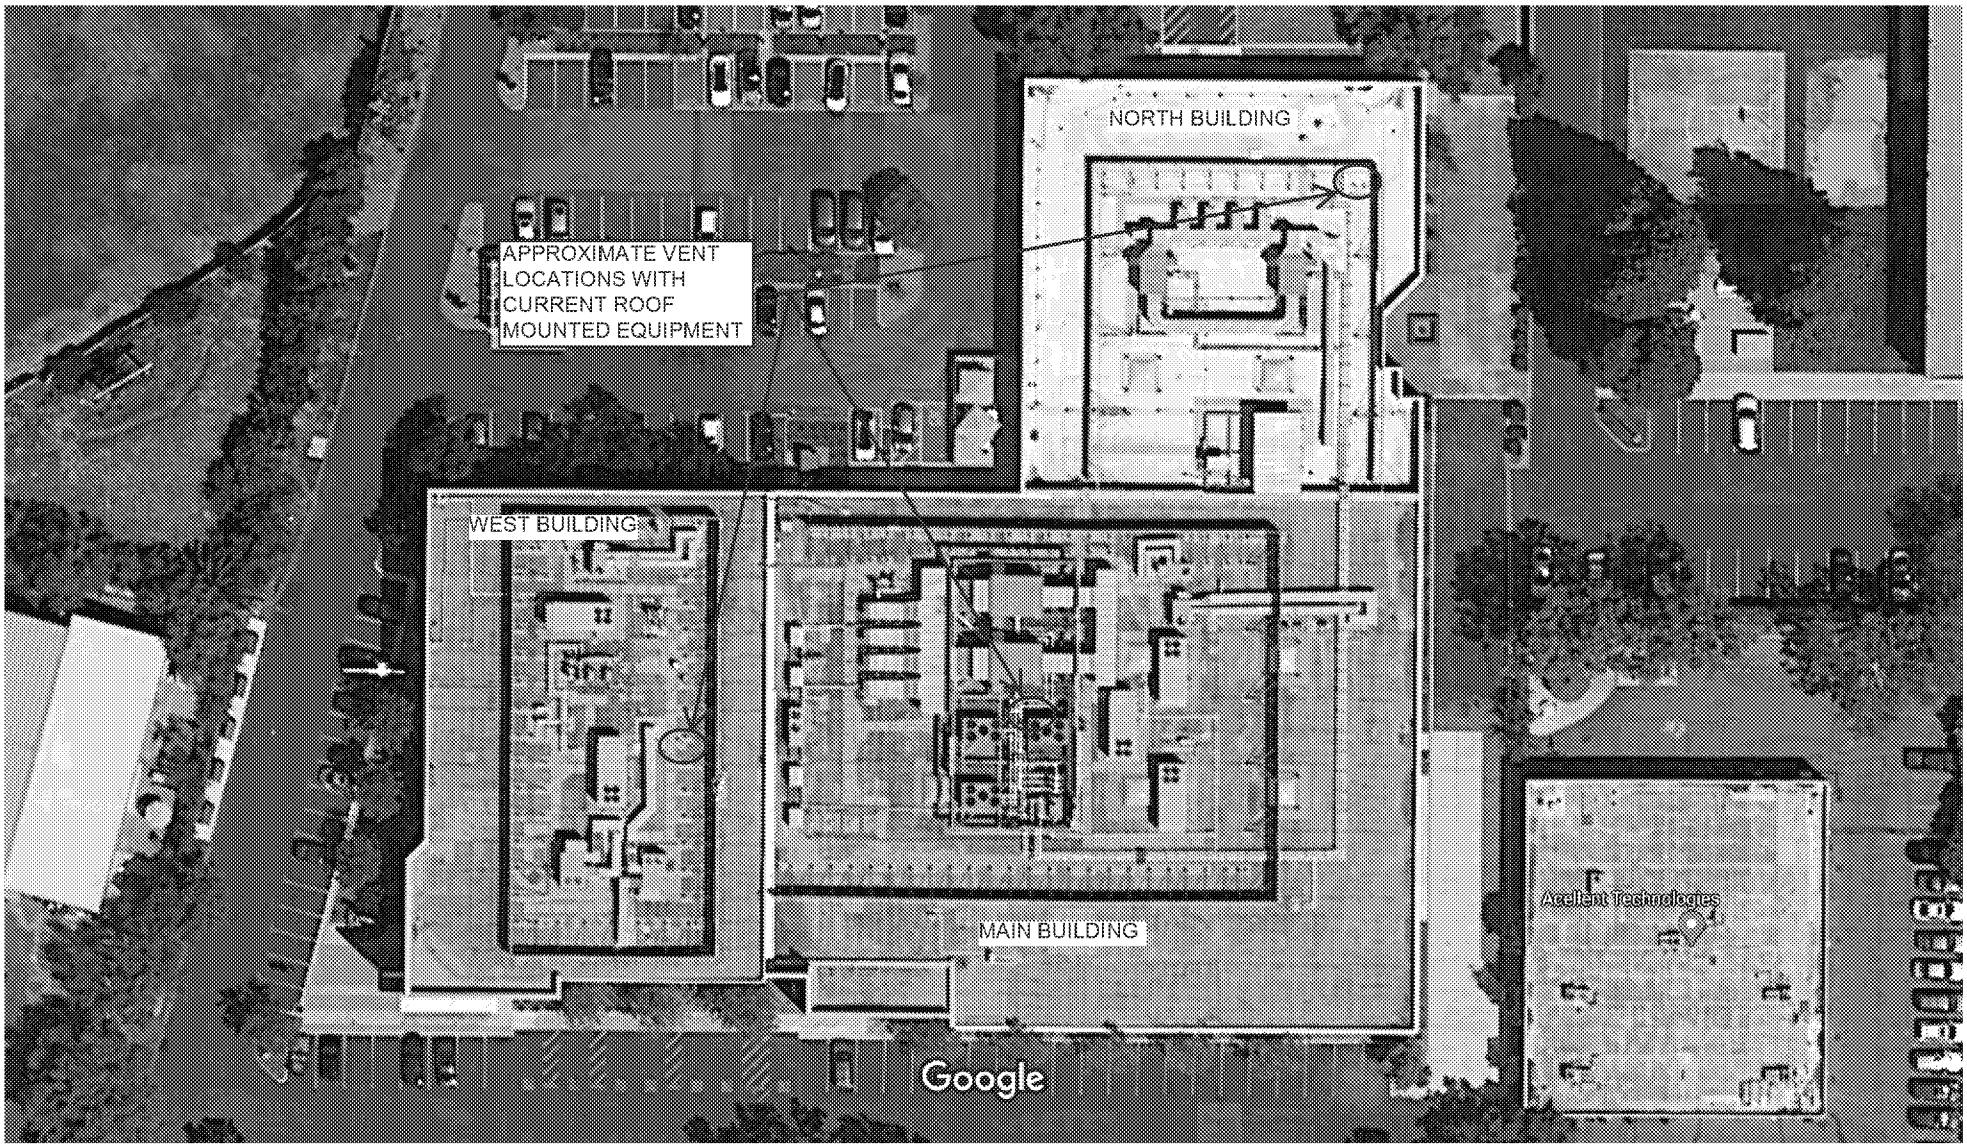
APPROXIMATE CURRENT ROOF MOUNTED EQUIPMENT AS OF 10/12/2020

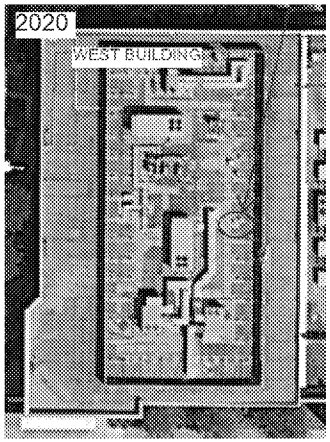
2020

WEST BUILDING VENTS - 10/12/2020 INSPECTION (VIEW SOUTH)

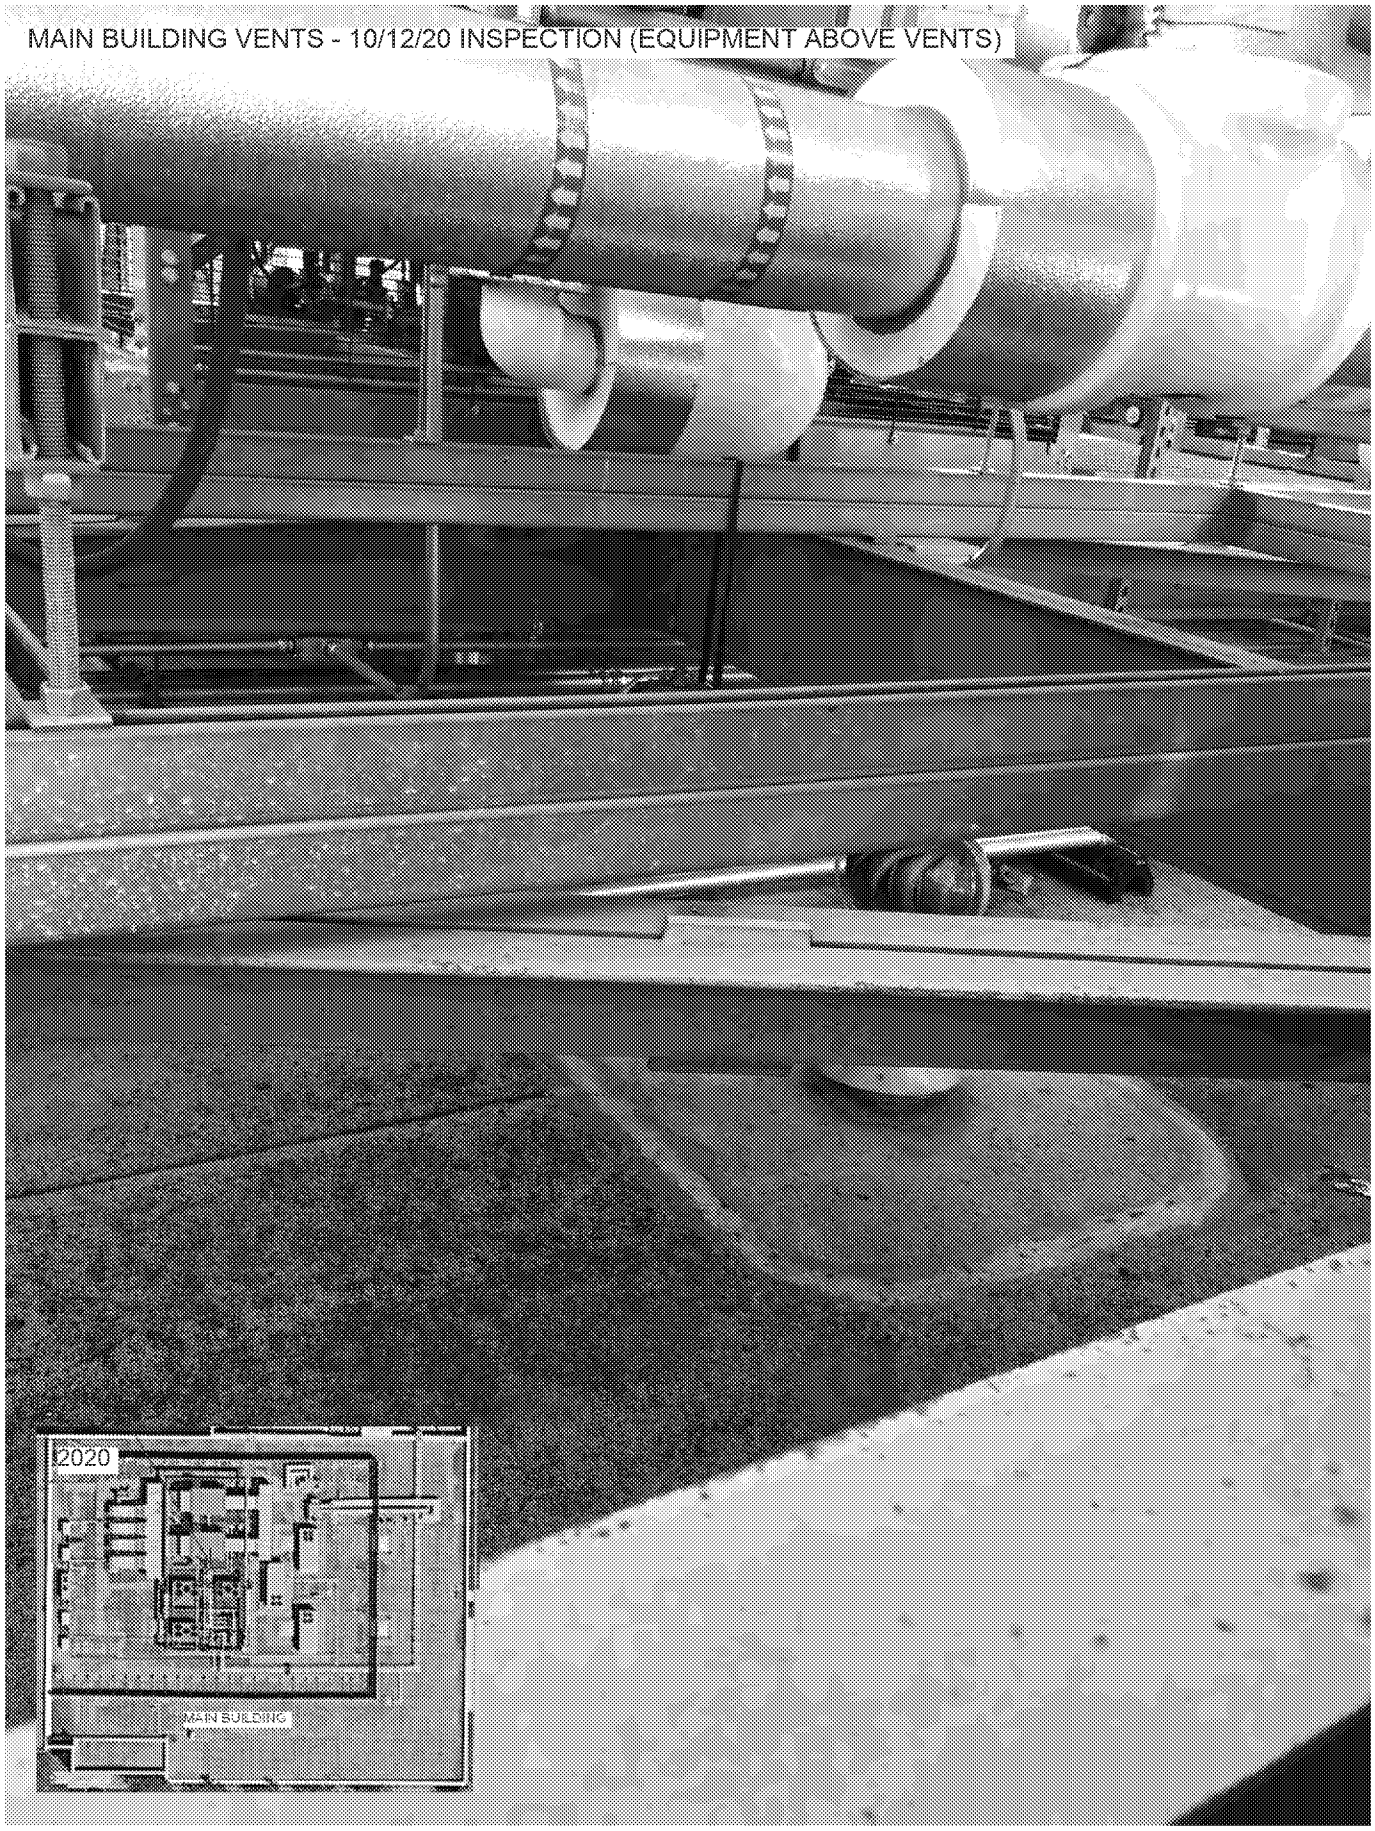
MAIN BUILDING VENTS - 10/12/20 INSPECTION

MAIN BUILDING VENTS - 10/12/20 INSPECTION (EQUIPMENT ABOVE VENTS)

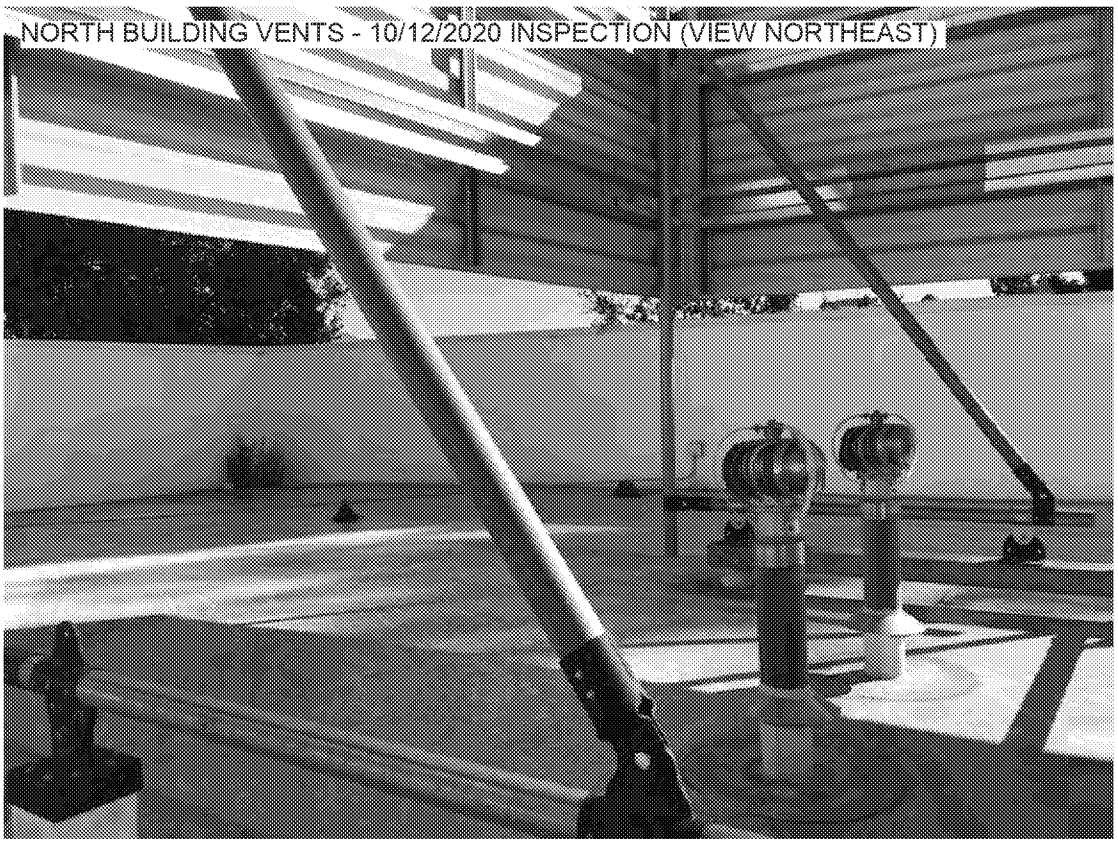
NORTH BUILDING VENTS - 10/12/2020 INSPECTION (VIEW NORTHEAST)

NORTH BUILDING VENTS - 10/12/2020 INSPECTION (VIEW SOUTH)
