Re: ENF-3-1, Clean Water Act Pretreatment Inspection, Pacific Choice Seafoods

The following information addresses the Areas of Concern that were identified during the Pretreatment inspection of the Pacific Choice Seafood operation in Eureka, CA on August 15, 2018.

In response to Section III, Areas of Concern…Pacific Seafood, Eureka, CA August 15, 2018

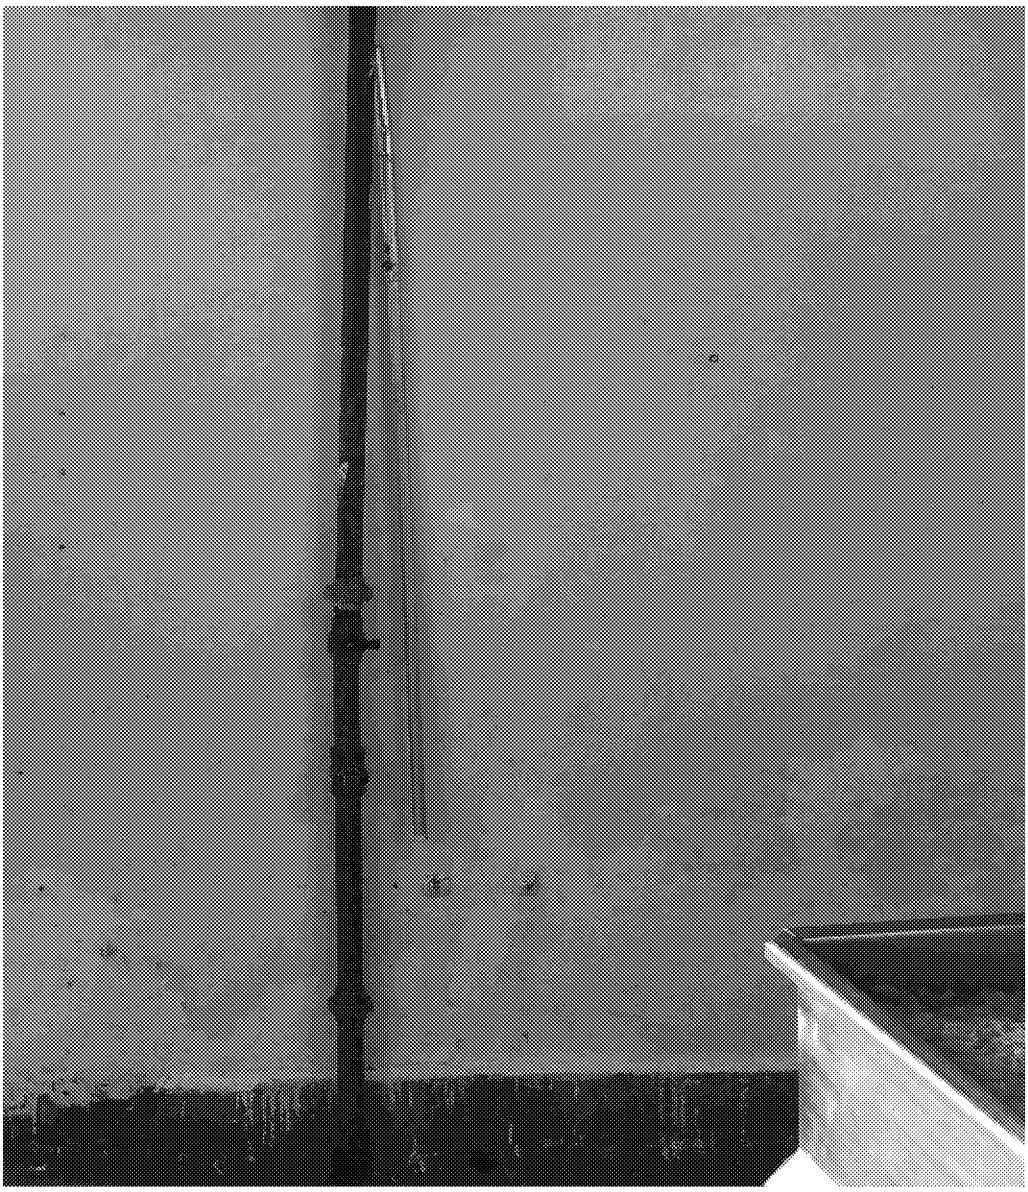
1. Reference Photograph 5, leaking ozone pipe under dock.
   CORRECTIVE ACTION
   - As per inspection report, ozone pipe has been removed, photo e-mailed.
   - Photo enclosed. (Photo 1)

3. Reference Photograph 7, PVC air vent
   CORRECTIVE ACTION
   - PVC pipe has been removed and capped
   - Photo enclosed (Photo 2)

Photo 1…Removed Ozone Pipe

Photo 2…Ventilation Pipe removed and cap.

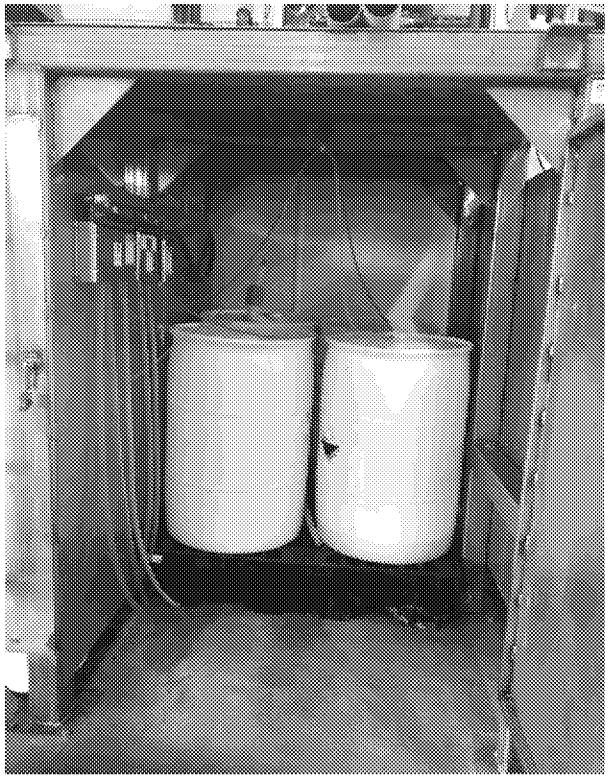
9. Reference Photographs 26 – 28, secondary chemical containment
   CORRECTIVE ACTION
   - Outside secondary containment cabin now only houses unopen plastic barrels.
   - Inside sanitation chemicals all reside on secondary containment receptacles.
   - Photos enclosed (Photos 3, 4, 5 and 6)

Photos 3 and 4 Inside Chemical storage and containment

Photos 5 and 6…Outside chemical storage and containment.
