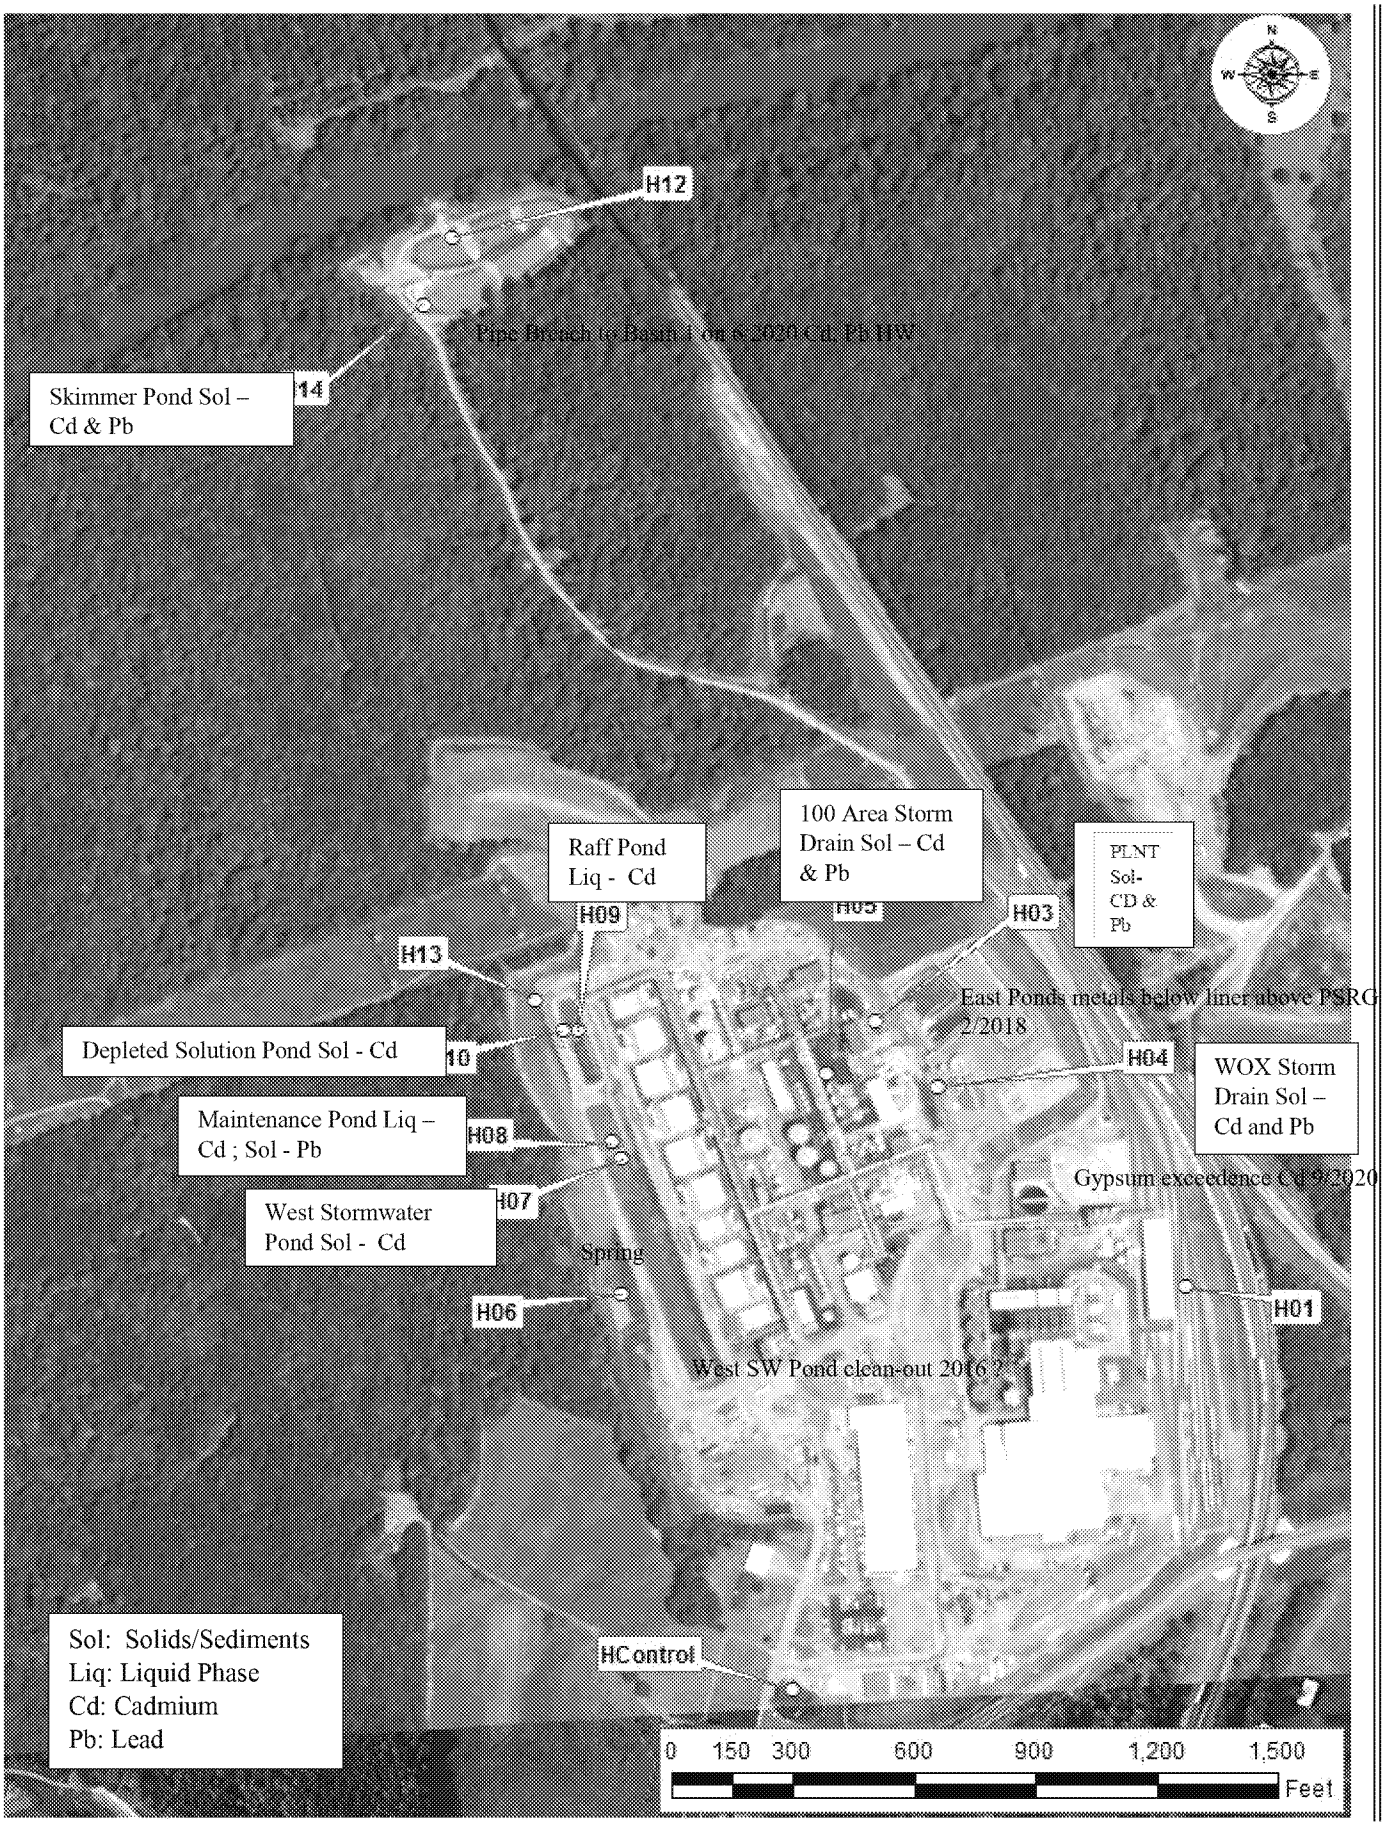
H12
Pipe Breach to Basin 1 on 6/2020 Cd, Pb HW
Skimmer Pond Sol – Cd & Pb
14
Raff Pond Liq - Cd
100 Area Storm Drain Sol – Cd & Pb
PLNT Sol- CD & Pb
H09
H05
H03
H13
East Ponds metals below liner above PSRG 2/2018
Depleted Solution Pond Sol - Cd
10
H04
WOX Storm Drain Sol – Cd and Pb
Maintenance Pond Liq – Cd ; Sol - Pb
H08
Gypsum exceedence Cd 9/2020
H07
West Stormwater Pond Sol - Cd
Spring
H06
H01
West SW Pond clean-out 2016 ?
Sol: Solids/Sediments
Liq: Liquid Phase
Cd: Cadmium
Pb: Lead
HControl
0 150 300 600 900 1,200 1,500
Feet
