Subject: Slauson Tanker Response
Emergency Response Report
Los Angeles, Los Angeles County, California
TDD No.: 0002/1302-T2-R9-17-04-0002
Document Control No.: 0149-08-ACDX

Slauson Tanker Response

PHOTOGRAPH LOG

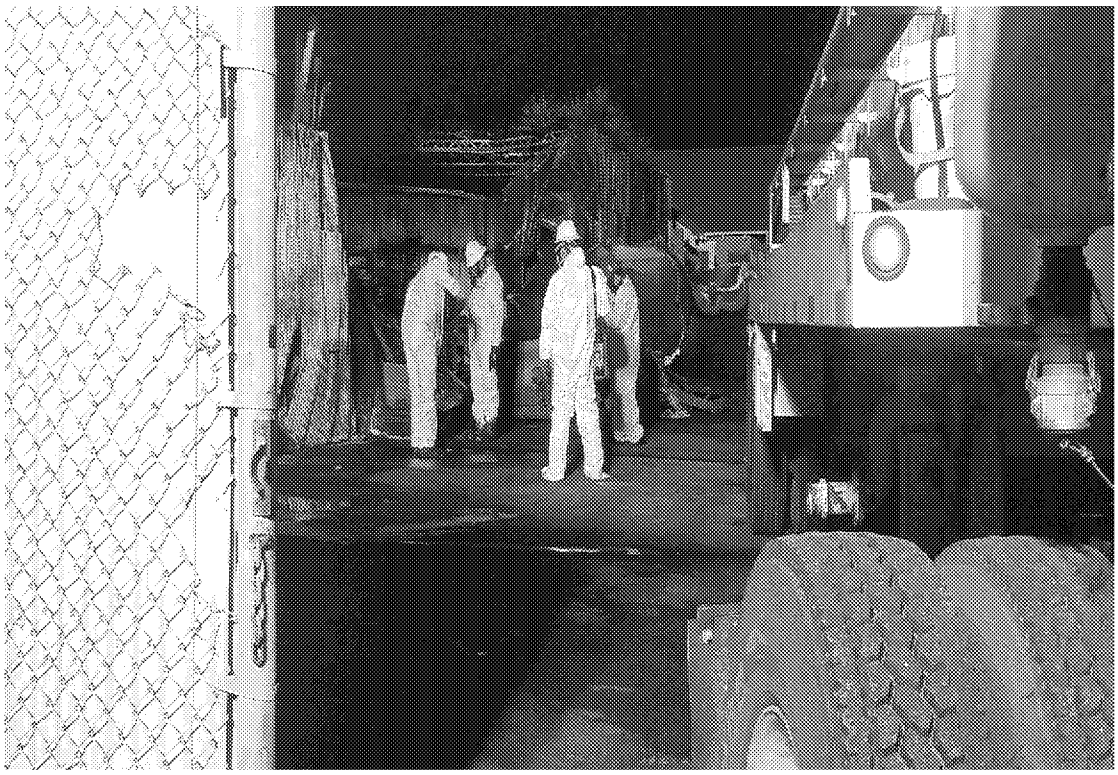
Photo No.	Date:
2	March 17, 2019

Air monitoring during the pumping off of gasoline from Tanker.

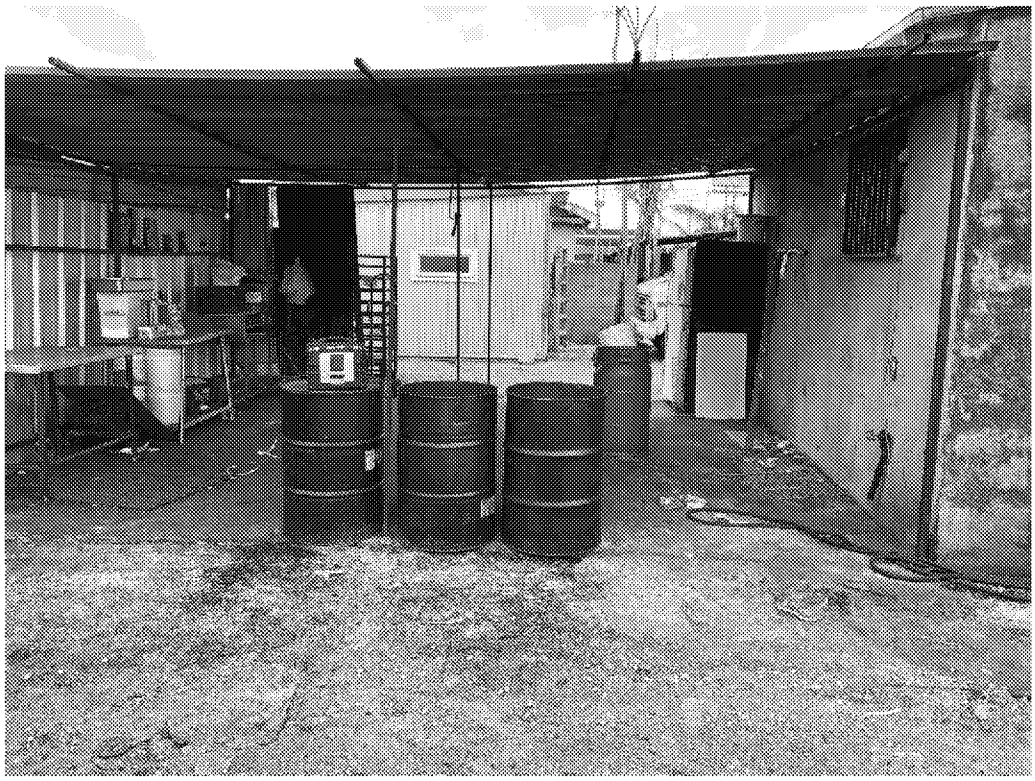
Photo No.	Date:
5	March 17, 2019

Perimeter air monitoring during clean up.
