Confidential Inspection Report

738 Upper Mountain Road
Lewiston, NY 14092

August 11, 2017

Report: CMRD17-255 **Address:** 738 Upper Mountain Road

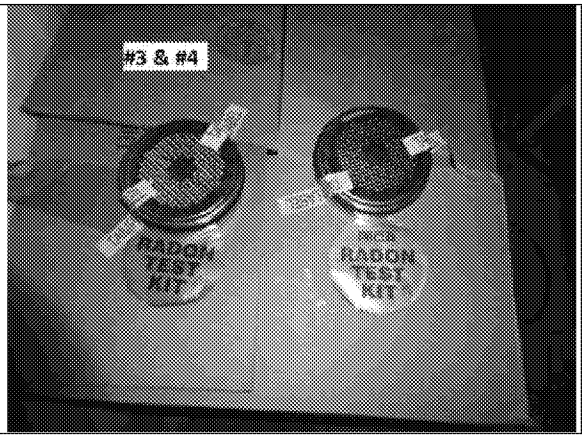
(1) - Duplicate - Test Canister #3 & 4.
