April 25, 2022

SUBJECT: Passive Sub Slab Depressurization (SSD) System Operation and Maintenance Plan (Document Control Number [DCN] FY22SEMD_161) and Evaluation of Passive SSD System, Former TRW Microwave Site, Sunnyvale, California

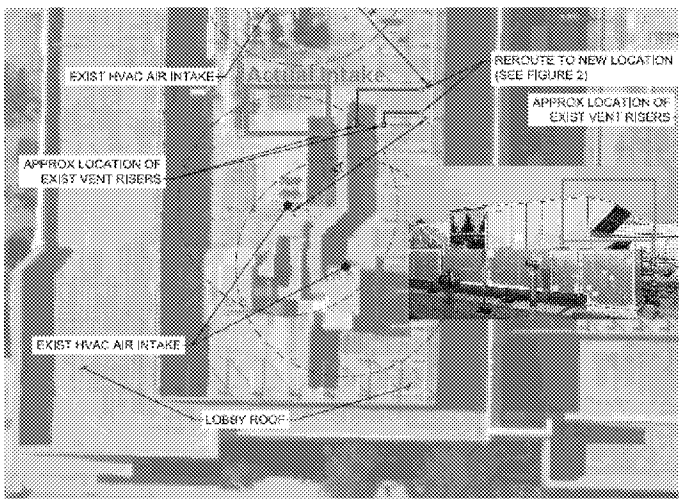
5. [SSD Evaluation; Vent height] The current height proposed does not appear to be sufficient to clear obstructions. Clearing obstructions is important for dispersion of pollutants and to provide sufficient exposure to wind (which provides part of the driving force for proper passive SSD operation).
