Building Specific Work Plan Addendum

811 East Arques Avenue
Sunnyvale, California

Date Published: 17 March 2022

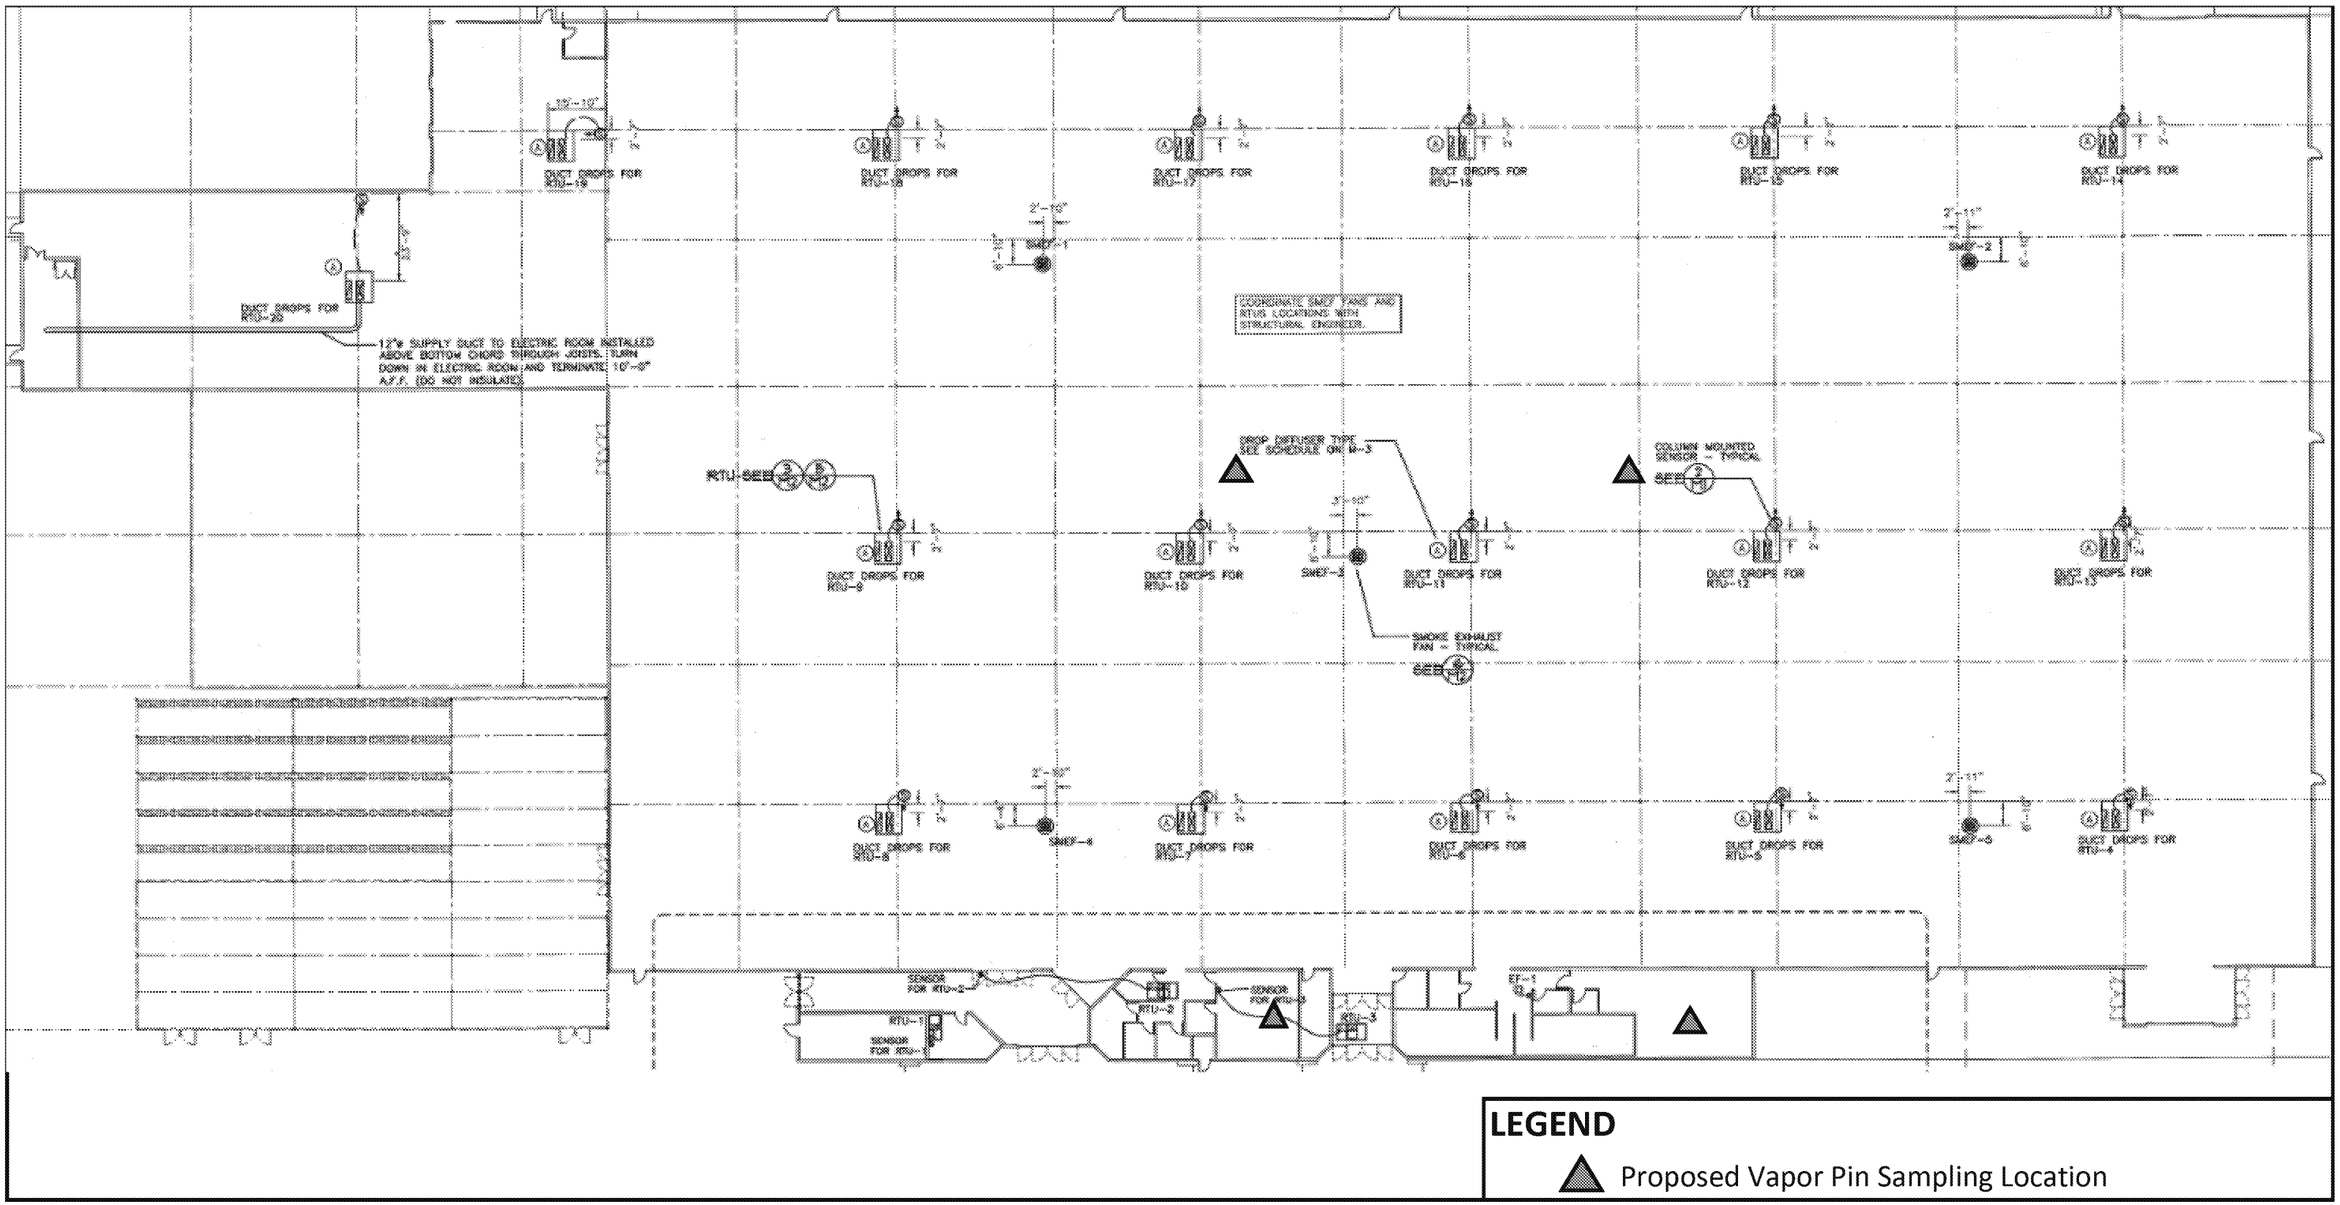
FIGURE 7
BUILDING LAYOUT WITH PROPOSED SAMPLE LOCATIONS
811 EAST ARQUES, SUNNYVALE, CALIFORNIA
SIGNETICS SITE

For this investigation, Summa-passivated canisters will be used to sample the soil gas beneath the building at 811 East Arques from vapor pins to be installed by Locus. At least four vapor pins are recommended to be installed in order to provide a representative sample of the soil gas beneath the slab. Two vapor pins shall be installed in the office and break room areas and two vapor pins shall be installed on the sales floor, near the middle of the building where soil gas concentrations would be most likely to accumulate.
