Re: Reconnaissance Inspections within the Municipality of San Juan December 18 and 20, 2013 Specific Outfalls and Sewers in the Rio Piedras River, Quebrada Mongil and Quebrada Del Ausubo and Los Corozos Lagoon Watersheds.
Municipality of San Juan ("MSJ") Municipal Separate Storm Sewer System ("MS4") Permit (PRR040036)
PRASA Puerto Nuevo Wastewater Treatment Plant Collection System (PR0021555)
Puerto Rico Department of Transportation and Public Works (DTPW) MS4 Permit (PRR040080)
Puerto Rico Department of Natural and Environmental Resources

Reconnaissance Inspection: Department of Natural and Environmental Resources (DNER) Barriada Figueroa (Stop 18 Pump Station) collection system

Inspection Date: December 18 and 20th, 2013

ATTACHMENT 1
Photographs, Municipality of San Juan (Storm Sewers/Sanitary Sewers) Inspection, December 18 and December 20, 2013. Nikon Coolpix P 510

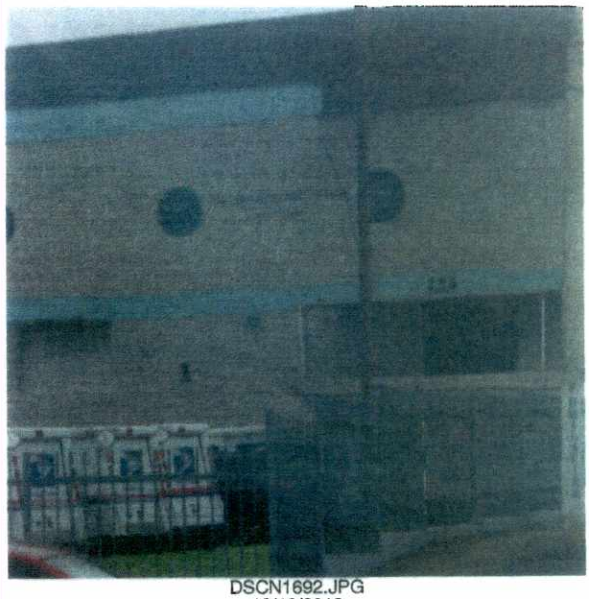
DSCN1691.JPG
12/18/2013

Photo ID No.	Date	Photo Description
DSCN1691	12/18/2014	Manhole on north side of PR-845 (downstream side of bridge) on west side of Calle 1 on bridge over Queb. Del Ausubo that had signs of a sanitary sewer overflow, rags and debris seen outside of manhole.
DSCN1692	12/18/2014	Cupey Post Office on north side of PR-845 and east of Calle 1.
DSCN1693	12/18/2014	Video Manhole on north side of PR-845 (downstream side of bridge) on west side of Calle 1 on bridge over Queb. Del Ausubo that had signs of a sanitary sewer overflow, rags and debris seen outside of manhole.
DSCN1694	12/18/2014	Manhole on north side of PR-845 just west of Queb. Del Ausubo on sidewalk near entrance to gas station. Rags/debris seen outside of manhole sign of Sanitary Sewer Overflow.
DSCN1695	12/18/2014	PR-845 (South Side) on East Side of Queb. Del Ausubo. Pipe and channel leading to Queb. Del Ausubo. Rags/Debris in channel.
DSCN1696	12/18/2014	PR-845 (South Side) on East Side of Queb. Del Ausubo. Pipe and channel leading to Queb. Del Ausubo. Rags/Debris in channel.

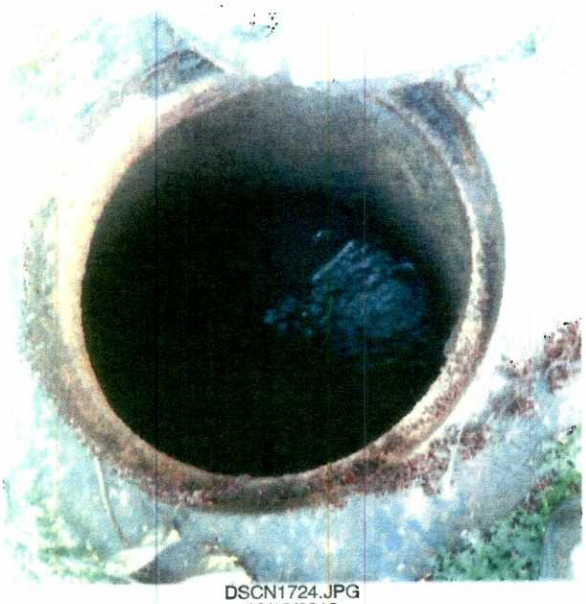
DSCN1720.JPG
12/18/2013

Photo ID No.	Date	Photo Description
DSCN1718	12/18/2014	Sanitary Sewage from Sanitary Sewer Overflow from Calle Rodano/Amazonas flowing downhill towards Calle Támesis and then enters channel flowing to Río Piedras River.
DSCN1719	12/18/2014	
DSCN1720	12/18/2014	Channel with sanitary sewage flow from Calle Rodano/Amazonas entering the Río Piedras River
DSCN1721	12/18/2014	Video of channel with sanitary sewage flow from Calles Rodano/Amazonas entering the Río Piedras River
DSCN1722	12/18/2014	Video of channel with sanitary sewage flow from Calle Rodano/Amazonas entering the Río Piedras River
DSCN1723	12/18/2014	Video of channel with sanitary sewage flow from Calle Rodano/Amazonas entering the Río Piedras River
DSCN1724	12/18/2014	Sanitary sewer at Calle Ural and Calle Wesser, level in sewer/manhole relatively high.
DSCN1725	12/18/2014	Sanitary sewer at Calle Ural and Calle Wesser, level in sewer/manhole relatively high.

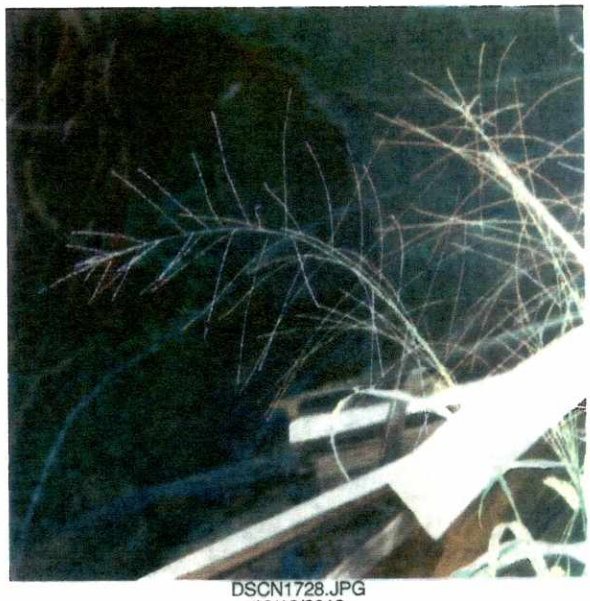
DSCN1727.JPG
12/18/2013

DSCN1726	12/18/2014	Video of sanitary sewer at Calle Ural and Calle Wesser, level in sewer/manhole relatively high.
DSCN1727	12/18/2014	Sampling of the storm sewer at Calle Ural and Calle Wesser.
DSCN1728	12/18/2014	Storm discharge point off of Calle Ural
DSCN1729	12/18/2014	Eroded slope around and under sewer pipe parallel to Calle Ural at or near Calle San Lorenzo.
DSCN1730	12/18/2014	Video of eroded slope around and under sewer pipe parallel to Calle Ural at or near Calle San Lorenzo.

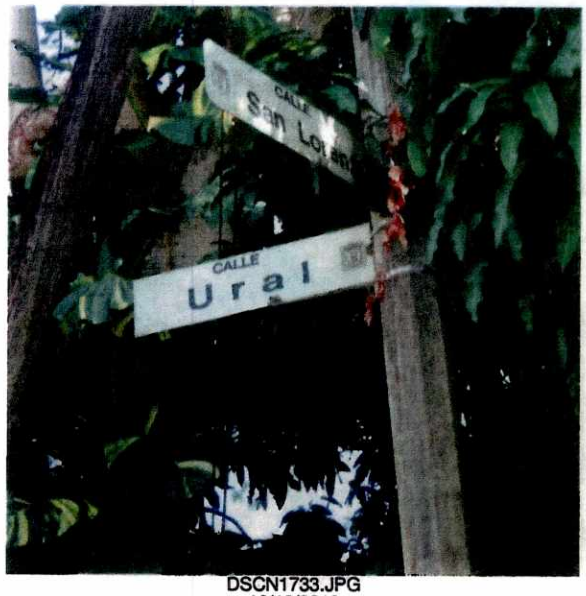
DSCN1732.JPG
12/18/2013

Photo ID No.	Date	Photo Description
DSCN1731	12/18/2014	Gate on Calle Ural that separates Calle Ural near Calle San Lorenzo from the Paraíso community.
DSCN1732	12/18/2014	Eroded slope around and under sewer pipe parallel to Calle Ural at or near Calle San Lorenzo.
DSCN1733	12/18/2014	Street sign at Calle San Lorenzo and Calle Ural
DSCN1734	12/18/2014	Street sign at Calle San Lorenzo and Calle Ural
DSCN1735	12/18/2014	Sanitary sewer at Calle San Lorenzo and Calle Ural. Sanitary sewer is quite shallow relative to the manhole rim.
DSCN1736	12/18/2014	Trench drain at foot of Calle San Lorenzo at the intersection with Calle Ural
DSCN1737	12/18/2014	Video Trench drain at foot of Calle San Lorenzo at the intersection with Calle Ural
DSCN1738	12/18/2014	Flow during dry weather from the box sewer into the Baldorioty de Castro Pump Station
DSCN1739	12/18/2014	Flow during dry weather from the box sewer into the Baldorioty de Castro Pump Station

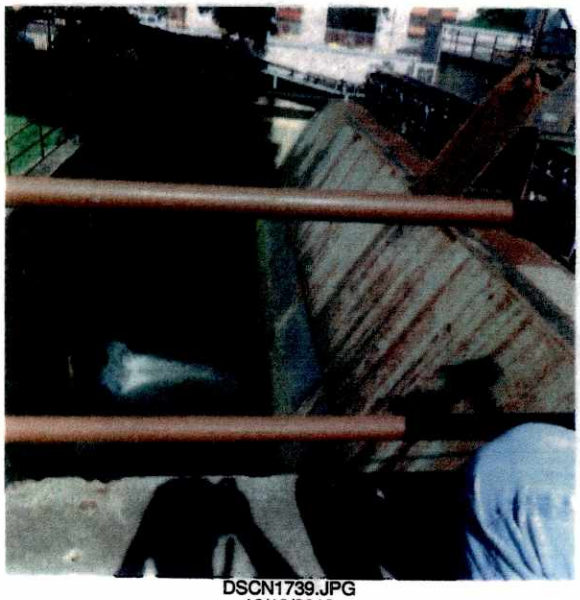
DSCN1738.JPG
12/18/2013

Location	Drainage	Summary	Photo Nos.	Attachment	Status
DNER Baldorioty de Castro PS	Los Corozos Lagoon	EPA visited the DNER Baldorioty de Castro Pump Station. There was dry weather flow from the box sewer shown in photographs 1738, 1739. EPA conducted ammonia test strip samples of the flow from the box sewer and recorded an ammonia concentration of 3 mg/l. EPA also used an ammonia test strip to analyze a sample that was collected by the DNER pump station operator earlier in the morning and that result was also 3 mg/l. The smaller 50,000 gpm pump that is usually run during dry weather was not operational and DNER was instead using the larger pumps. DNER said it was planning on installing two 8,000 gpm pumps to replace the 50,000 gpm pump that is used during dry weather. DNER should explain the operational status of the 50,000 gpm pump that was used during dry weather as well as the two 8,000 gpm pumps it is planning on installing. On December 20, 2013 EPA inspected a storm sewer manhole located upstream of the pump station located within school grounds. Several sewer lines that were flowing were seen entering the storm sewer line tributary to the Baldorioty de Castro PS in this location (See Photos 1832 and 1834)	1738, 1739, 1832 to 1834	1	Potential Non Compliance

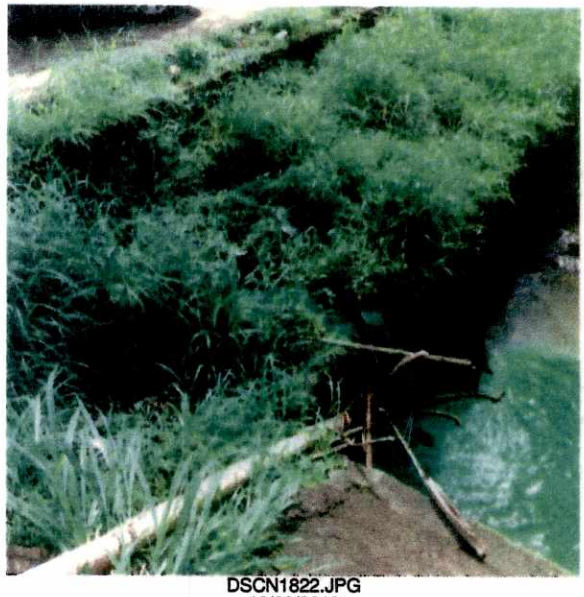
DSCN1821.JPG
12/20/2013

DSCN1821	12/20/2014	Dye testing of a manhole on the upstream side (south side) of PR-845 adjacent to Queb. Del Ausubo near Zee Medical Services building was the source of the sanitary sewer overflow, the dyed sewage is seen flowing into the Quebrada Del Ausubo.
DSCN1822	12/20/2014	Dye testing of a manhole on the upstream side (south side) of PR-845 adjacent to Queb. Del Ausubo near Zee Medical Services building was the source of the sanitary sewer overflow, the dyed sewage is seen flowing into the Quebrada Del Ausubo.

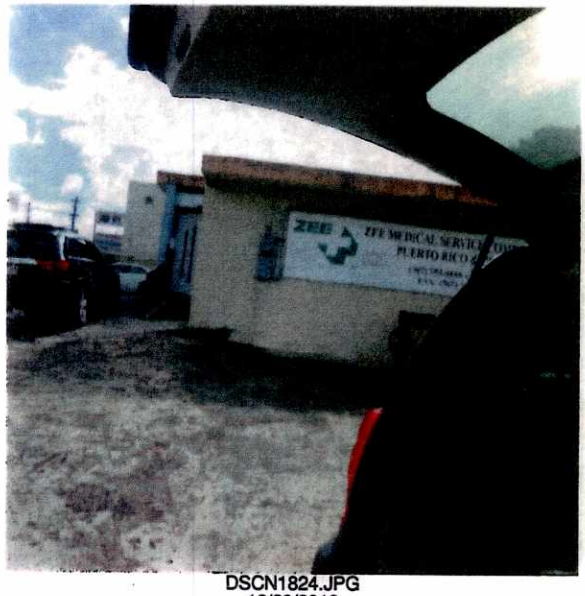
DSCN1823.JPG
12/20/2013

Photo ID No.	Date	Photo Description
DSCN1823	12/20/2014	Dye testing of a manhole on the upstream side (south side) of PR-845 adjacent to Queb. Del Ausubo near Zee Medical Services building was the source of the sanitary sewer overflow, the dyed sewage is seen flowing into the Quebrada Del Ausubo.
DSCN1824	12/20/2014	Dye testing of a manhole on the upstream side (south side) of PR-845 adjacent to Queb. Del Ausubo near Zee Medical Services building was the source of the sanitary sewer overflow, the dyed sewage is seen flowing into the Quebrada Del Ausubo.
DSCN1825	12/20/2014	Dye testing of a manhole on the upstream side (south side) of PR-845 adjacent to Queb. Del Ausubo near Zee Medical Services building was the source of the sanitary sewer overflow, the dyed sewage is seen flowing into the Quebrada Del Ausubo.
DSCN1826	12/20/2014	Dye testing of a manhole on the upstream side (south side) of PR-845 adjacent to Queb. Del Ausubo near Zee Medical Services building was the source of the sanitary sewer overflow, the dyed sewage is seen flowing into the Quebrada Del Ausubo.

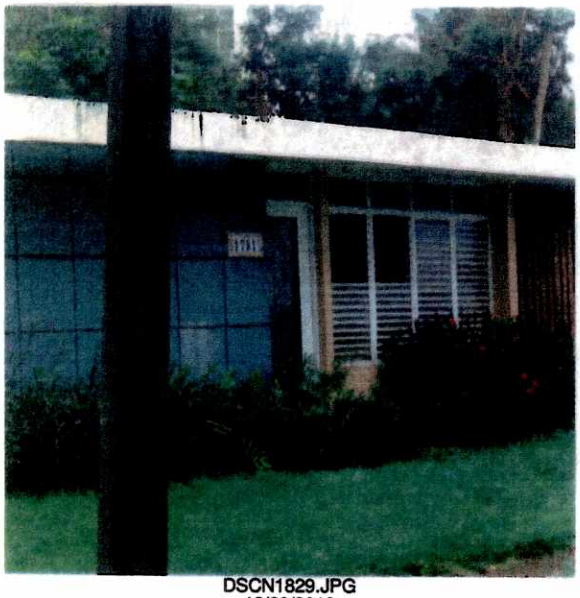
DSCN1828.JPG
12/20/2013

Table 2 EPA Reconnaissance Inspection December 20, 2013, San Juan Puerto Rico					
Location	**Drainage**	**Summary**	**Photo/Video Nos.**	**Attach ments**	**Status**
Crown Hills - Calle Jájome	Rio Piedras River	Based on complaints to EPA about sewage in the storm sewer and a mosquito problem, EPA inspected the storm sewer tributary to the Rio Piedras that runs perpendicular to Calle Jájome at or near 1781 and 1791 Calle Jájome in Crown Hills, San Juan. EPA opened the storm sewer catch basin and observed a flow (Note that it was not raining during the inspection however there was a precipitation event earlier in the morning a few hours prior to the inspection.) EPA grabbed a sample of the flow in the storm sewer and detected a sewage odor and ammonia concentrations using the test strips were 3 to 6 mg/l. There is a sanitary trunk line that runs down Calle Jájome (Photos 1828 and 1830), EPA placed dye in the sanitary trunk sewer manhole just upstream of the point where the sanitary trunk sewer crosses the storm sewer. EPA did not see the dye in the storm sewer after 5 to 10 minutes of observing the storm sewer. Alex Rivera of EPA notified PRASA, MSJ and other parties via email on December 20, 2013. PRASA reported on April 14, 2014 as part of their presentation at EPA- CEPD that the pipe was replaced and the sanitary discharge was eliminated. However, on May 20, 2014 we received an additional complaint alleging that the situation of wastewater odors at the storm sewer persist, occurring this time in front of Jájome Street residence #1800. The situation was referred to PRASA via email on May 20, 2014.	1828 to 1831	1, 6, and 7	Potential Non Compliance
