Expanded Site Inspection of the Pemco Corporation (MD-055)

Prepared by: Maryland Department of the Environment
Waste Management Administration
2500 Broening Highway
Baltimore, MD 21224

Prepared for: U.S. Environmental Protection Agency
Region III
1650 Arch Street
Philadelphia, PA 19103-2029

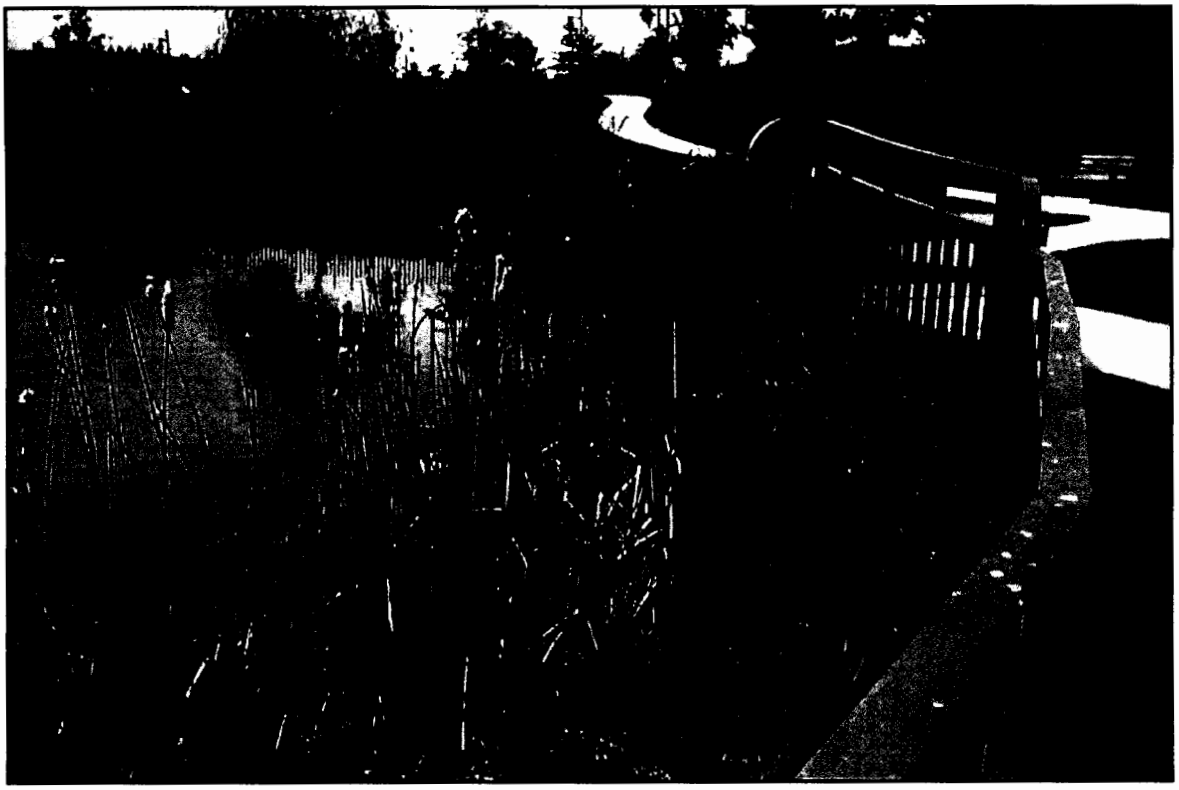
Photograph of GW-2 and S-2 background locations, facing southwest towards the stream.
