Memorandum

To:	Steve Renninger, USEPA Jenny Davison, USEPA Leslie Patterson, USEPA;	Ref. No.:	038443-62-03
From:	Julian Hayward/Valerie Chan/wg/29	Date:	December 2, 2015
cc:	Madelyn Adams, Ohio EPA; Lauren Foster, Tetra-Tech; Brandon Helm; Tetra-Tech; Tom Hut, PHDMC		
Re:	**Summary of July 2015 Vapor Intrusion Analytical Results and Proposed Sub-Slab Depressurization System (SSDS) Modifications**

GHD has prepared this technical memorandum to present proposed sub-slab depressurization system (SSDS) modifications and sampling frequency based on the July 2015 sampling results and system evaluations for the South Dayton Dump and Landfill Site (Site) located in Moraine, Ohio. This memorandum is in response to the meetings with the United States Environmental Protection Agency (USEPA) on June 8, 2015 and September 10, 2015 in Riverside, Ohio where GHD and USEPA discussed the proposed SSDS modifications. GHD is submitting this memorandum on behalf of the Respondents to the Administrative Settlement and Order on Consent (ASAOC) for Removal Action Proceeding Under Sections 104, 106(a), 107, and 122 of the CERCLA, 42 U.S.C §§ 9604, 9606(a), 9607, and 9622 USEPA Docket No. V-W-13-C-010, eff

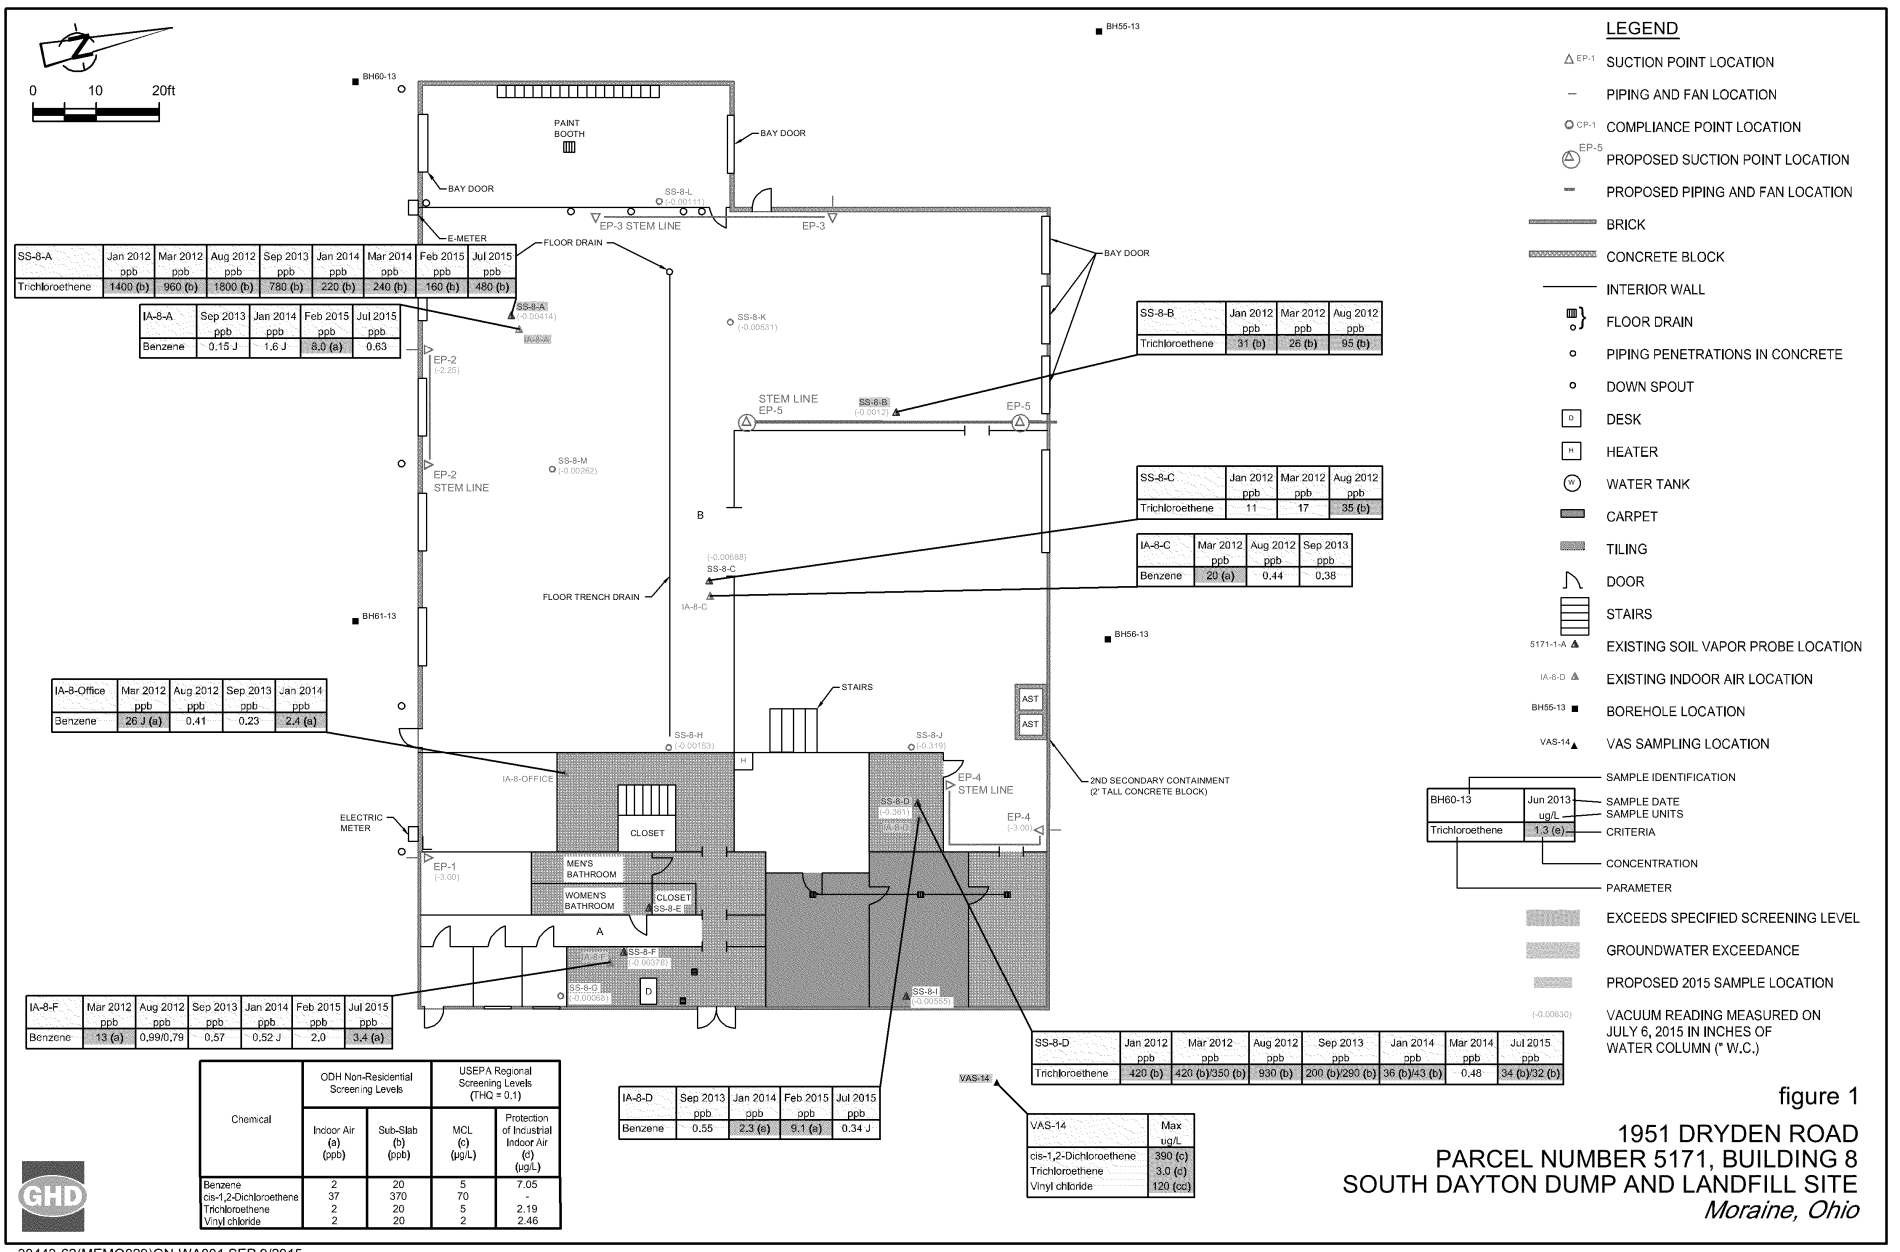
figure 1

The SS concentrations of TCE in Building 8 have decreased since the SSDS was installed in November 2013, as can be seen from the concentrations presented on Figure 1.

The fan at extraction point EP-3 in Building 8 was not operational during the July 2015 sampling and a complete system evaluation cannot be completed at this time.

The SSDS in Building 8 has not attained the ODH SS screening level (AF=33) for TCE at SS-8-A. GHD proposes to install another stemline suction point (EP-3 stemline 2) on the EP-3 header, and another extraction point and stemline suction point, EP-5 and EP-5 stemline, respectively, as presented in Figure 1. These suction points will further encircle the vicinity around SS-8-A, which had the TCE exceedance.

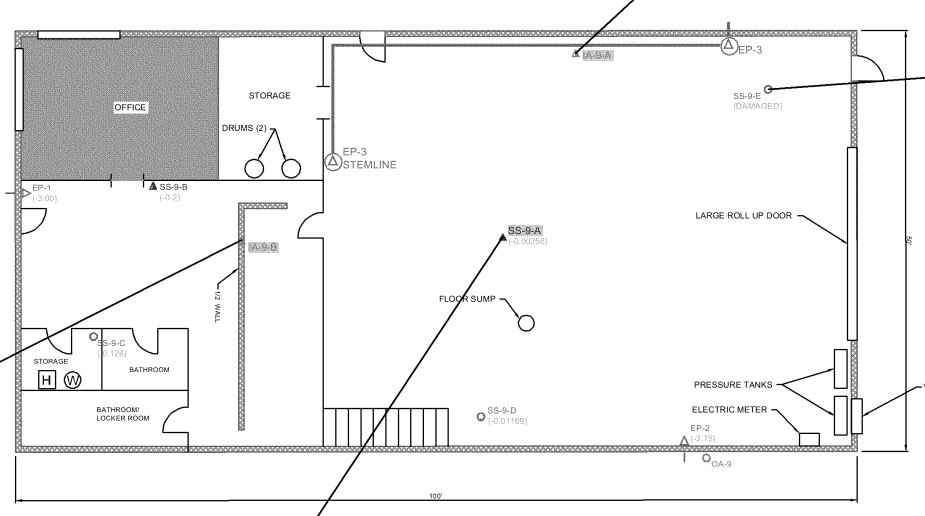
figure 2

SS-9-A had a concentration of TCE of 1,700 ppb, which was greater than the ODH SS screening levels (AF=10 and AF=33). The SS concentrations of TCE at SS-9-A exhibit seasonal fluctuations, with concentrations increasing in the warmer months. The SS concentrations of TCE in Building 9 have decreased since the SSDS was installed in September 2013, as can be seen from the concentrations presented on Figure 2.

The average historic vacuum reading of -0.0097" w.c. at SS-9-A satisfies the required -0.004" w.c. threshold. Historic sub-slab vacuum readings for Building 9 are presented in Table 3.

Concentrations of TCE at SS-9-A in Building 9 remain above the ODH SS screening level (AF=33). GHD proposes to install another stemline suction point (EP-2 stemline), and another extraction point and stemline suction point, EP-3 and EP-3 stemline, respectively, as presented in Figure 2. These suction points will further encircle the vicinity around SS-9-A, which has the TCE exceedance.

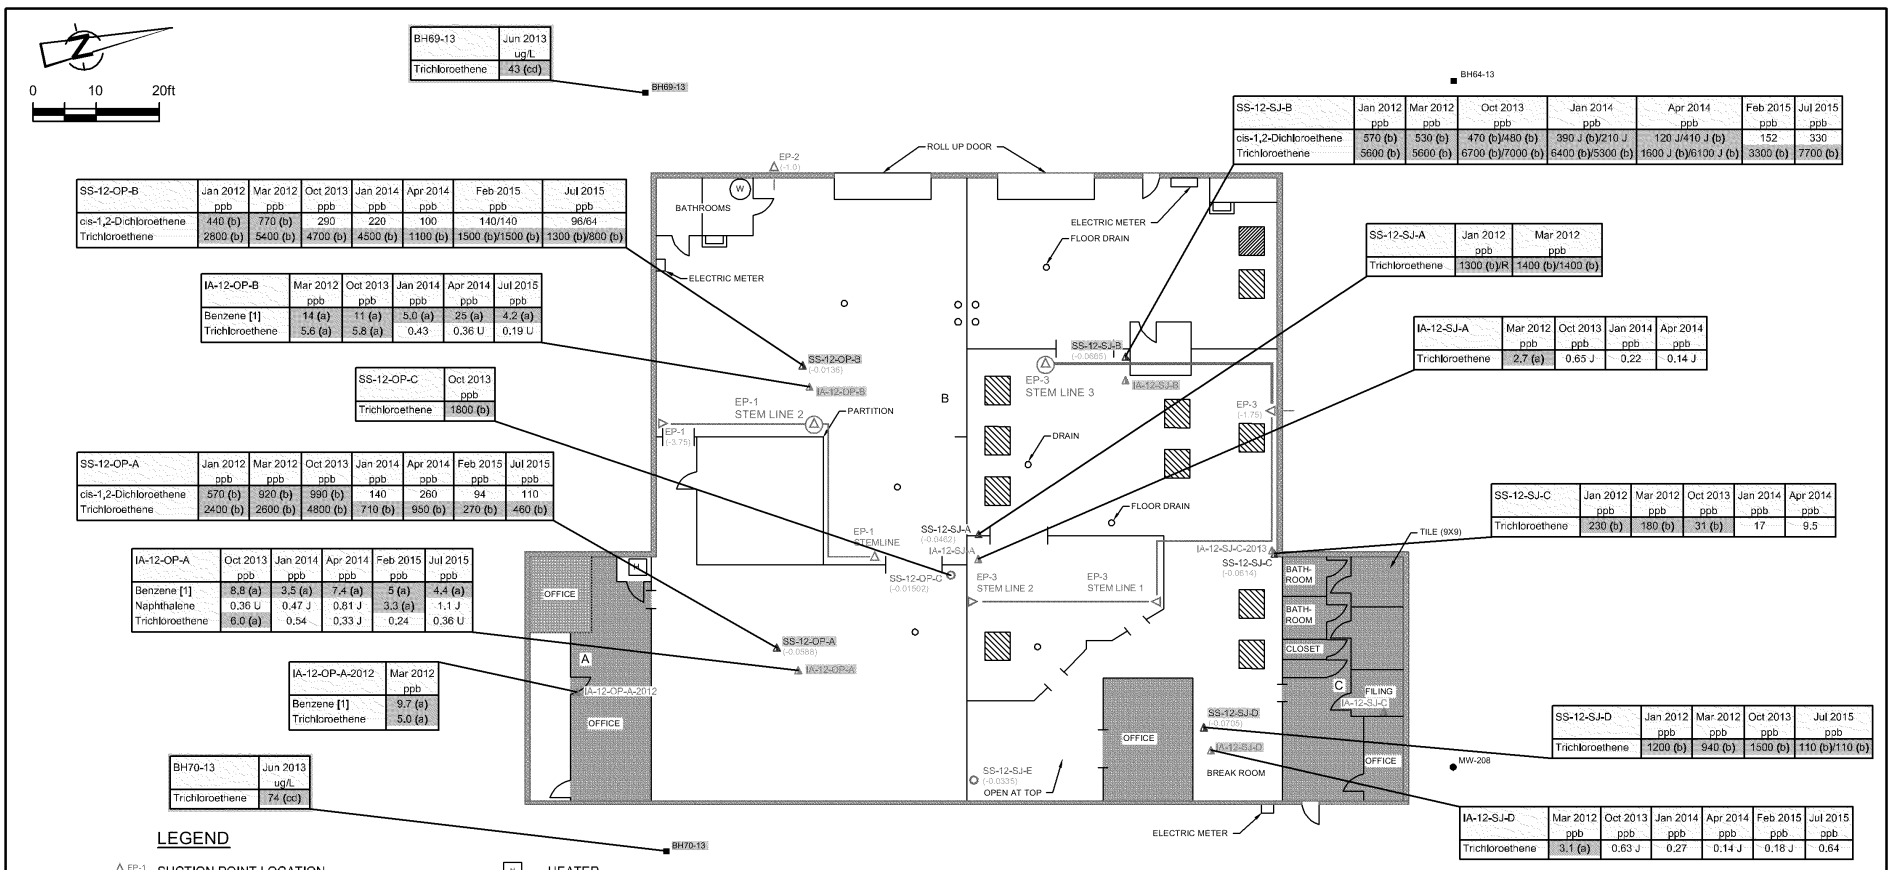
The TCE SS concentrations in Building 12 were greater than the ODH SS Screening Levels (AF=10 and AF=33). The July 2015 TCE concentration at SS-12-SJ-B is the maximum concentration measured to date at that location. GHD notes that Building 12 is located within an area of TCE groundwater impacts (see Figure 3).

The average historic vacuum readings of -0.0369, -0.0714, -0.0461, and -0.0604" w.c., at SS-12-OP-A, SS-12-OP-B, SS-12-SJ-B, and SS-12-SJ-D, respectively, satisfy the required -0.004" w.c. threshold, which means the SSDS is operating properly to mitigate VI in Building 12. Historic sub-slab vacuum readings for Building 12 are presented in Table 6.

TCE at SS-12-OP-A, SS-12-OP-B, SS-12-SJ-B, and SS-12-SJ-D in Building 12 remain above the ODH SS screening level (AF=33). GHD proposes to install three additional stemline suction points: EP-1 stemline 2, EP-3 stemlines 3 and 4 as presented on Figure 3. These suction points will further encircle the vicinity around SS-12-OP-B and SS-12-SJ-B, which had the greatest concentrations of TCE.

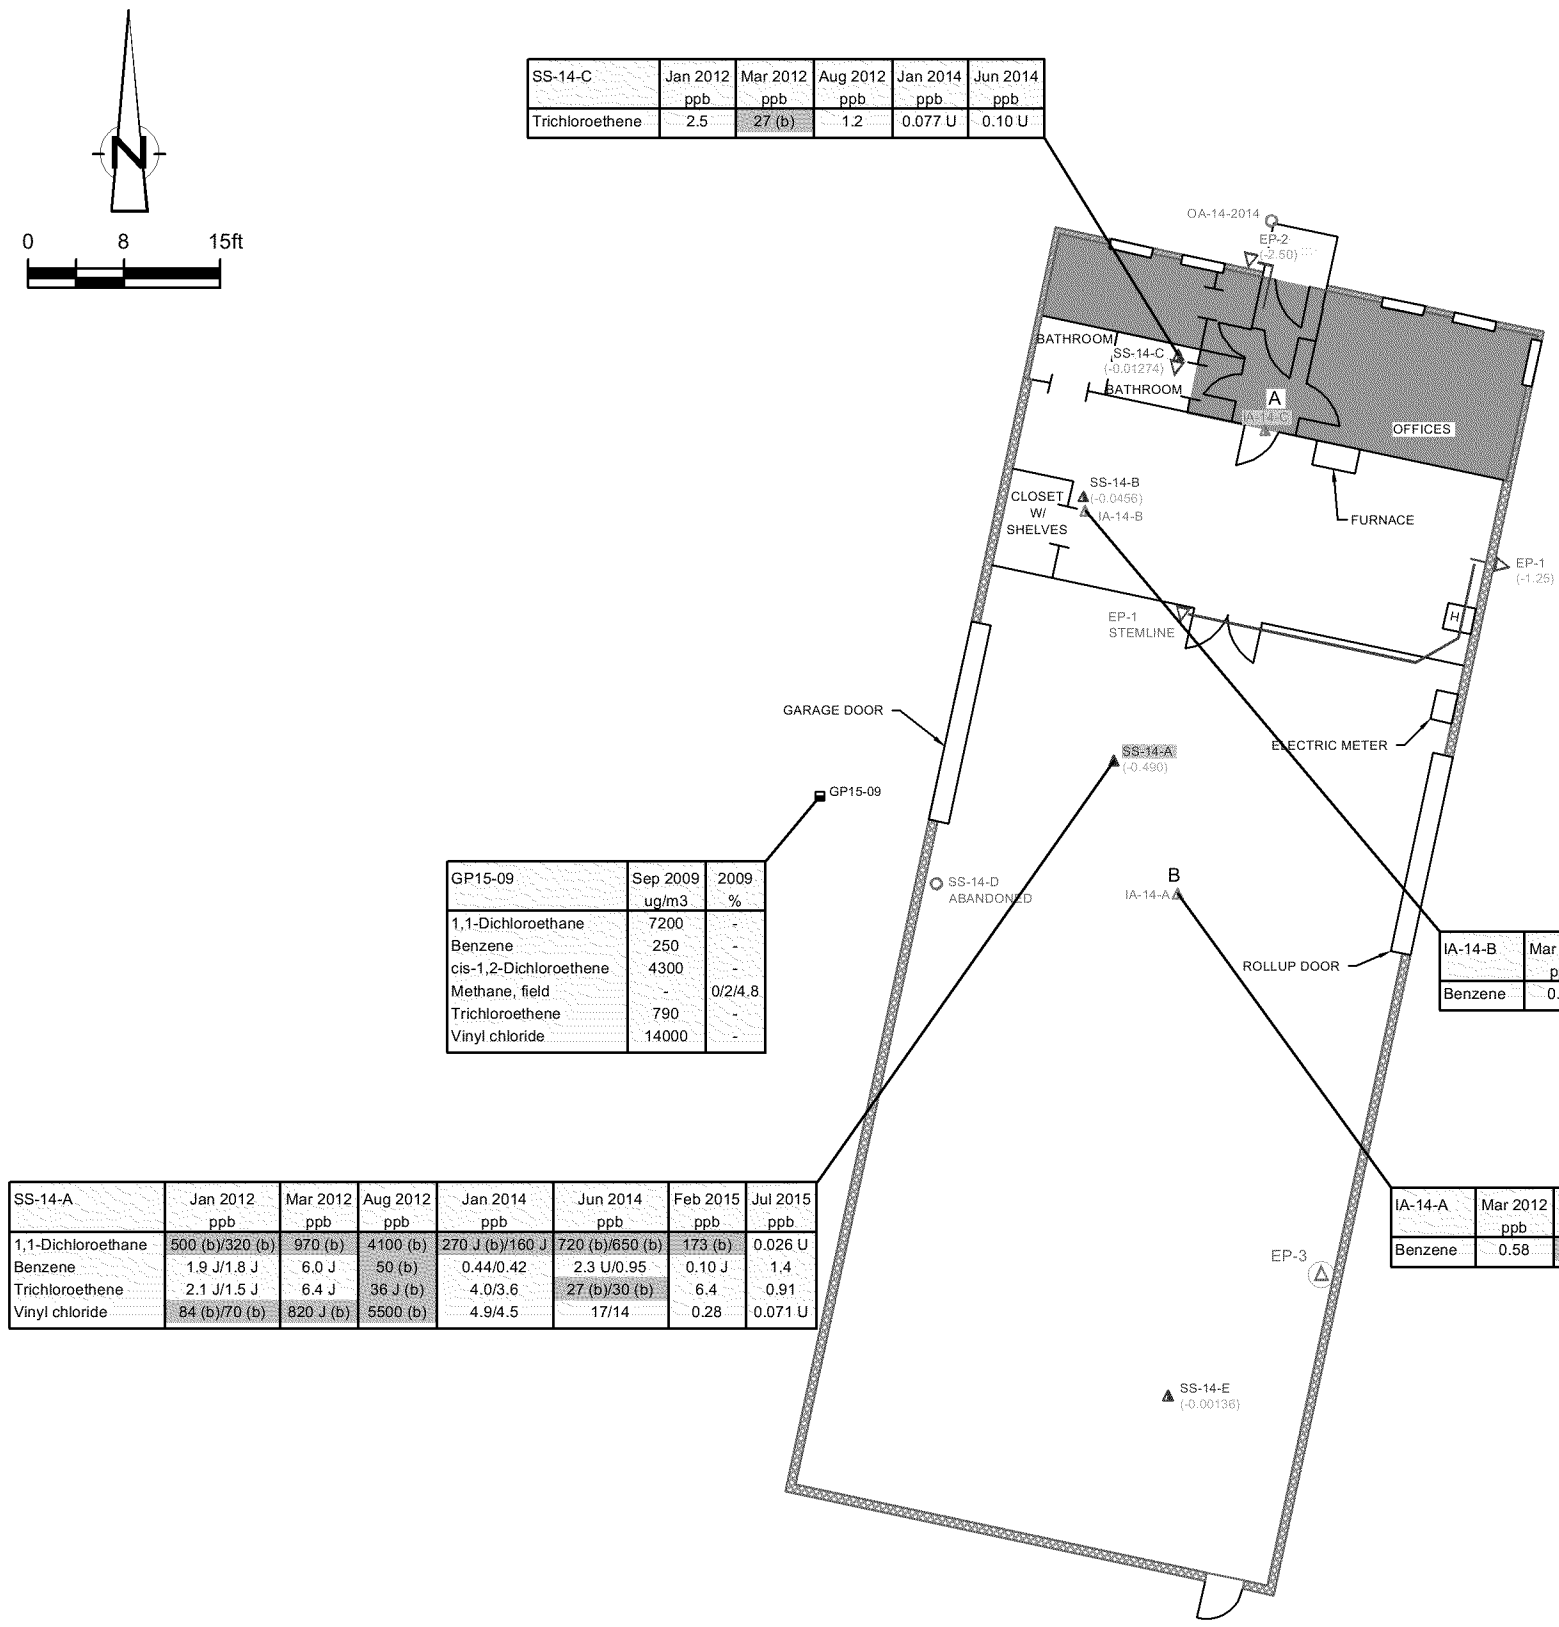
The SS concentrations of COCs in Building 14 have decreased since the SSDS was installed in December 2013, as can be seen from the concentrations presented on Figure 4.

The average historic vacuum readings for SS-14-A, SS-14-B, and SS-14-C satisfy the required -0.004" w.c. threshold. At SS-14-E, the average, historic vacuum reading is -0.0009' w.c., which did not meet the required threshold vacuum of -0.004" w.c. and adequate vacuum was not achieved. Historic sub-slab vacuum readings for Building 14 are presented in Table 8.

Though no July 16, 2015 sample concentrations were greater than ODH SS screening levels (AF=10 or AF=33), GHD proposes an additional extraction point location EP-3 (Figure 4) in order to improve the sub-slab vacuum. GHD amended the proposed location of EP-3 from earlier figures by moving it to the east side of the building from the west side. The entire west outside of Building 14 is covered with a tree/shrub line that would make installation along the west wall problematic. The proposed EP-3 location should also influence the southern section of the building where adequate vacuum has not been achieved.

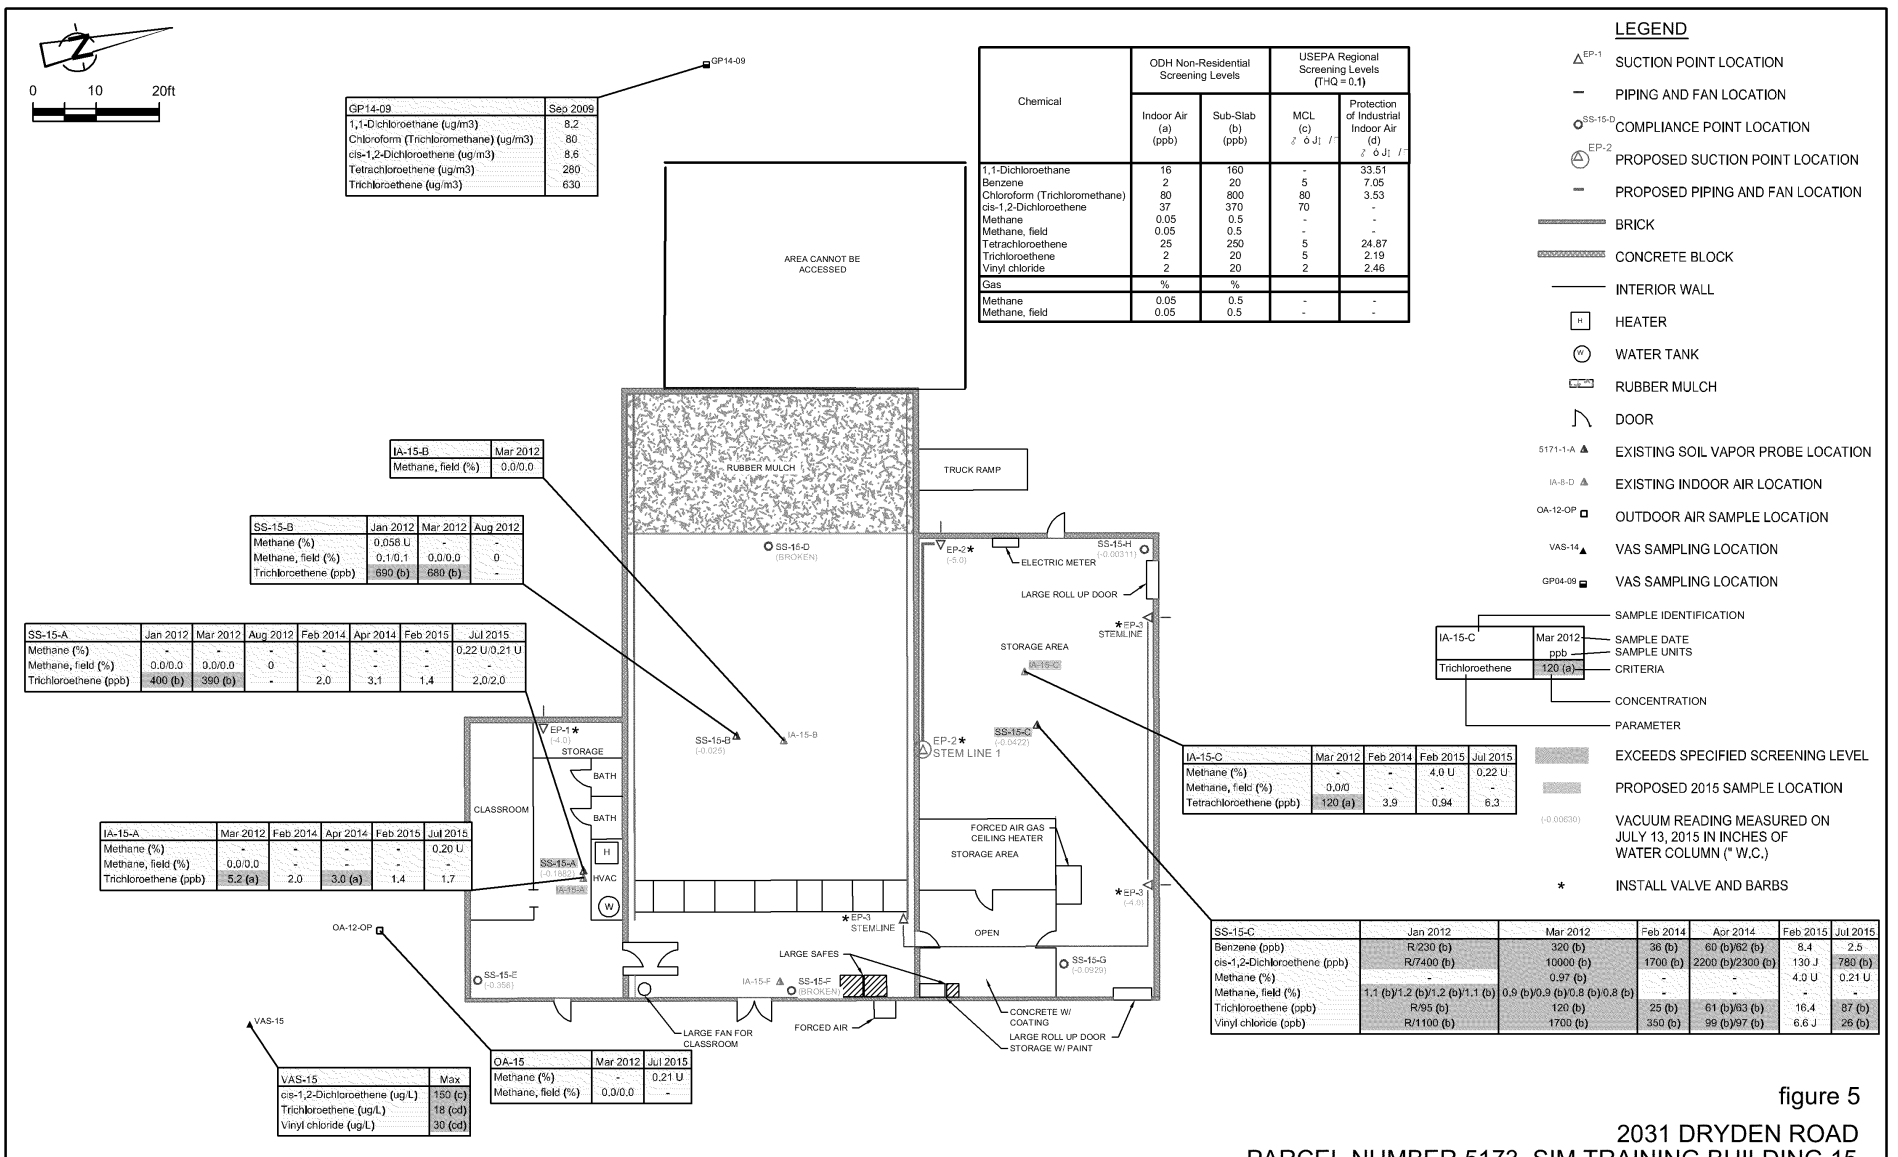
2031 DRYDEN ROAD
PARCEL NUMBER 5173, SIM TRAINING BUILDING 15
SOUTH DAYTON DUMP AND LANDFILL SITE
Moraine, Ohio

SS-15-C had concentrations that were greater than the ODH screening levels (AF=10 and AF=33). Constituent concentrations were below IA screening levels in Building 15. The SS concentrations at SS-15-C exhibit seasonal fluctuations, with concentrations increasing in the warmer months.

The current system is operating as desired with all SS sampling locations having a historic, average, vacuum readings satisfying the -0.004" w.c. requirement across the building slab, with the exception of SS-15-H, which appears to be an anomaly. Historic SS vacuum readings for Building 15 are presented in Table 10.

TCE at SS-15-C in Building 15 was greater than the ODH SS screening level (AF=33) in July 2015. GHD proposes to install one additional stemline suction point, EP-2 stemline 1 as presented on Figure 5. This suction point will further encircle the vicinity around SS-15-C, which had the greatest concentrations of TCE.

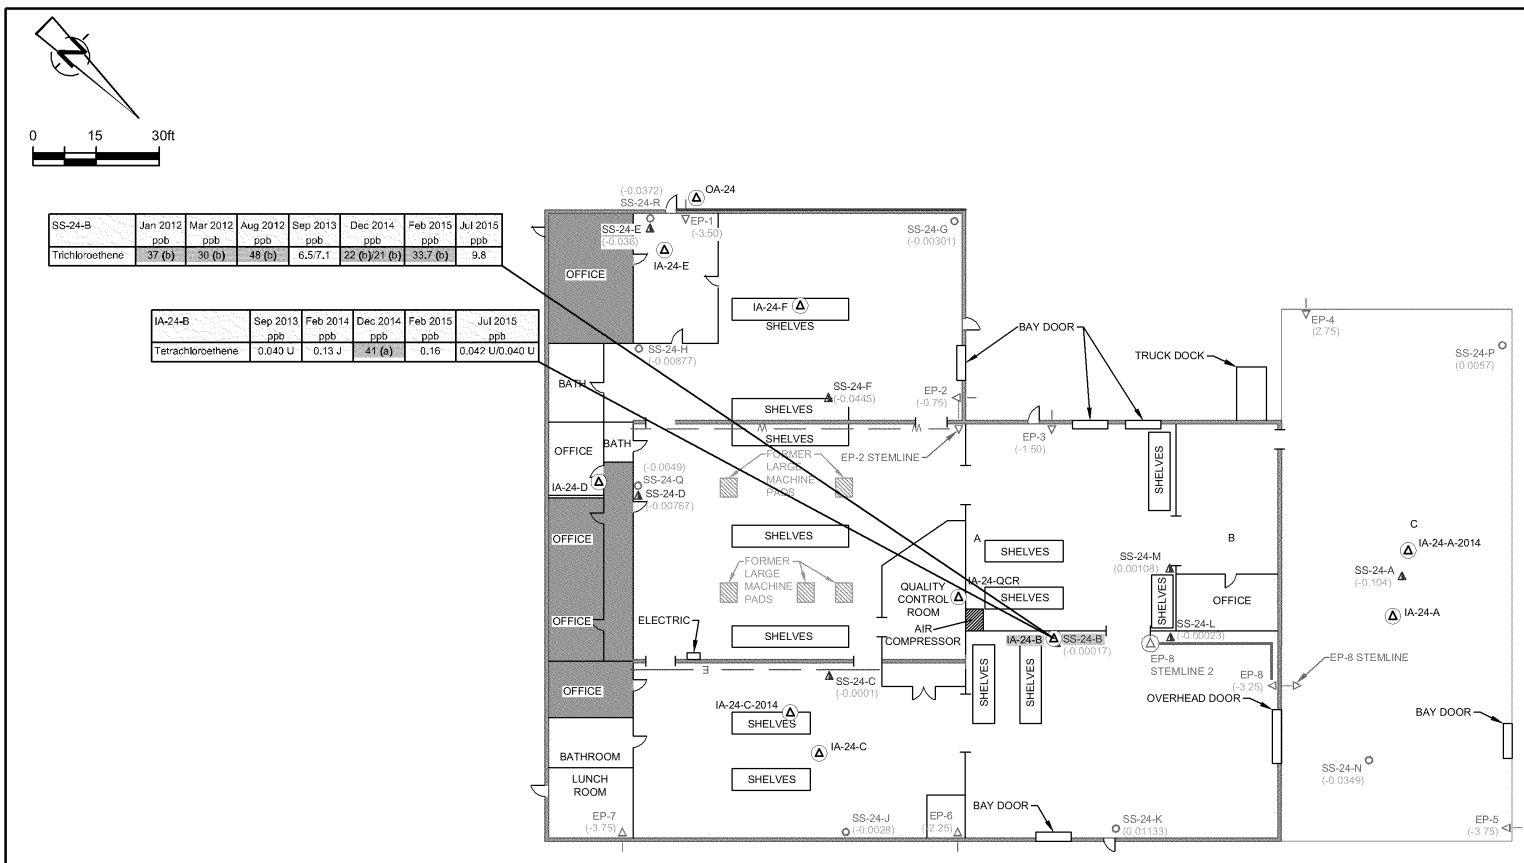
There were no IA or SS soil vapor concentrations greater than the ODH SS screening levels (AF=10 and AF=33). The SSDS in Building 24 is performing effectively.

The average, historical vacuum readings of -0.0002: w.c., were less than the -0.004" w.c. threshold. Historic SS vacuum readings for Building 24 are presented in Table 12.

Based on the above assessment and the 2015 Site walkthrough, GHD proposes to install EP-8 stemline 2 (Figure 6) to increase the SSDS radius of influence (ROI) at SS-24-B where historic exceedances of TCE have been recorded.

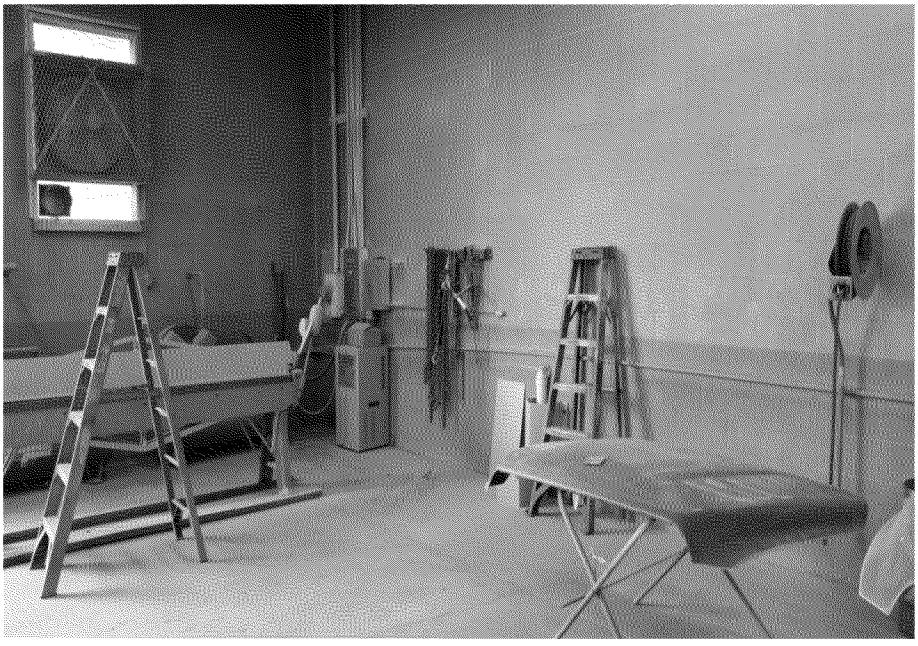
Description: EP-2 location. View-North
Date: 7/15/2015
Photographer: Doug Gatrell

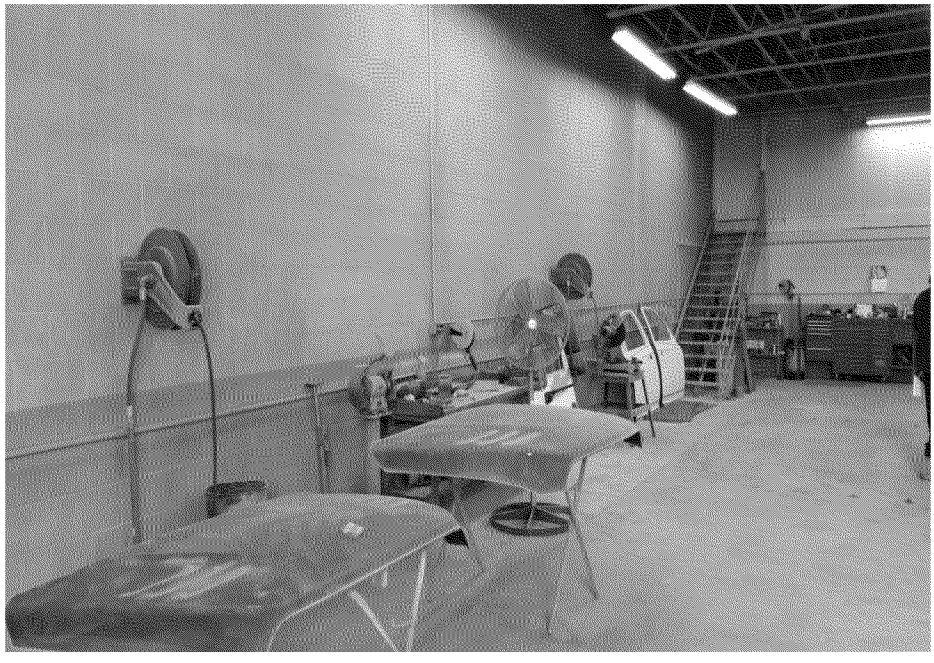
Description: June proposed EP-2 stemline location. View-South
Date: 7/15/2015
Photographer: Doug Gatrell

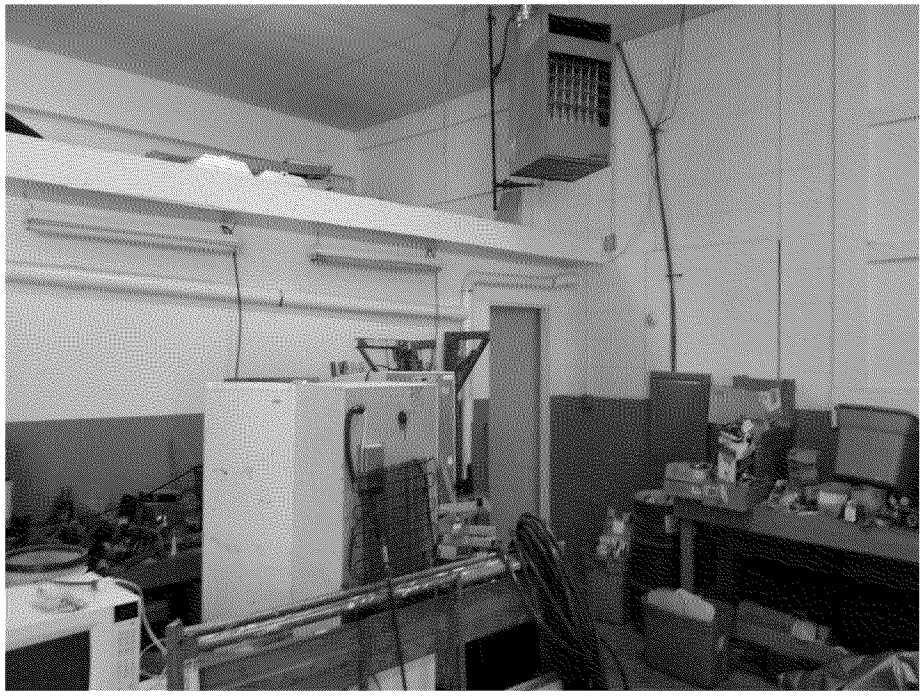
Description: EP-1 suction point and stemline. View-Southeast
Date: 7/15/2015
Photographer: Doug Gatrell

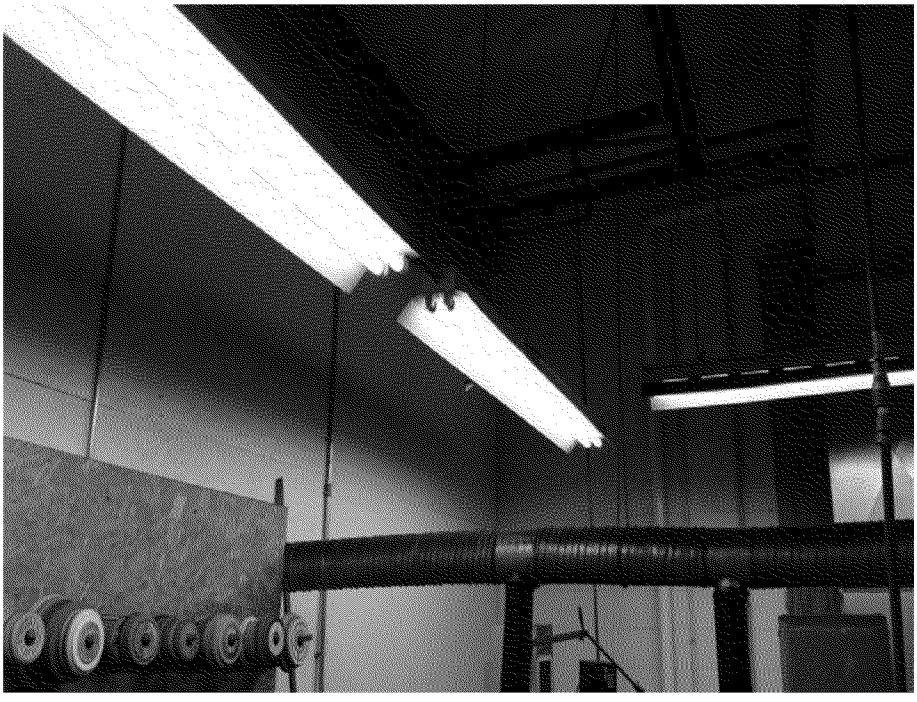
Description: EP-3 suction point. View-North
Date: 7/15/2015
Photographer: Doug Gatrell

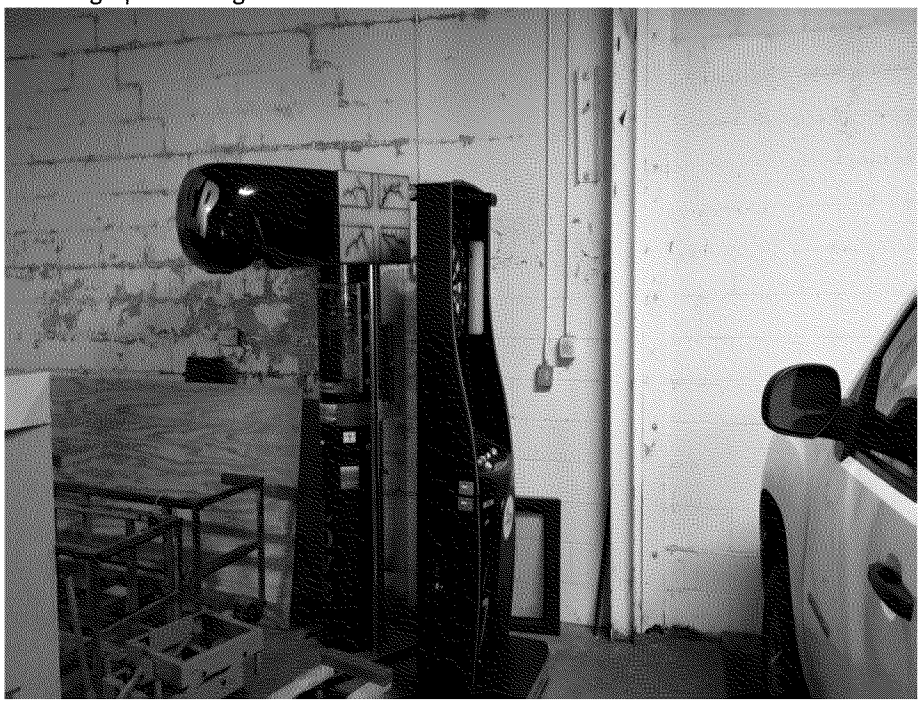
Description: June proposed EP-3 stemline suction point on west wall. View-West
Date: 7/15/2015
Photographer: Doug Gatrell

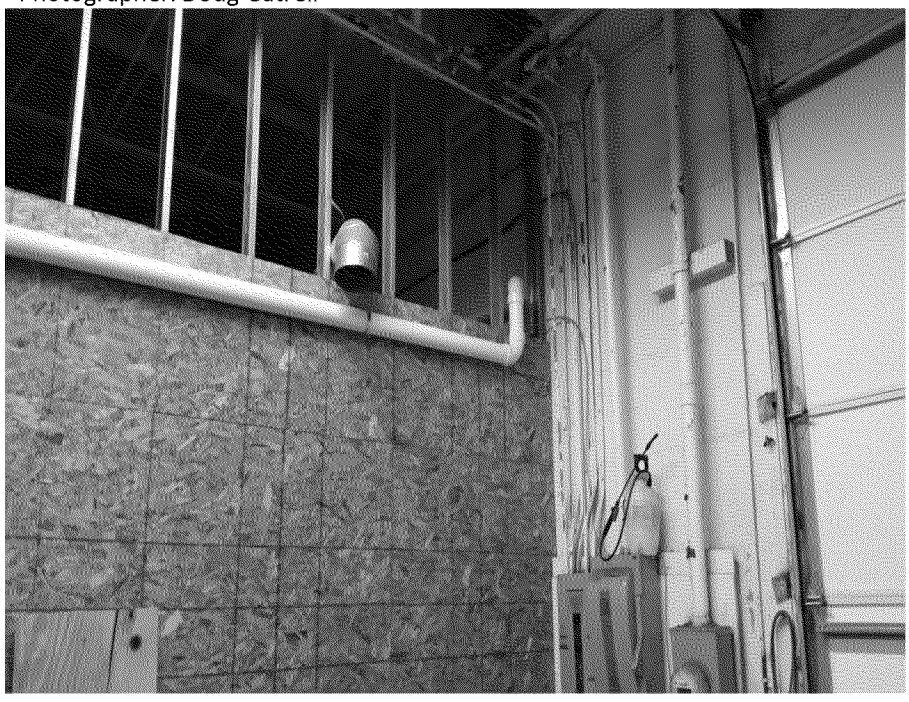
Description: EP-1 stemline. View-Northeast
Date: 7/15/2015
Photographer: Doug Gatrell
