Memorandum

To:	Steve Renninger, USEPA Jenny Davison, USEPA Leslie Patterson, USEPA;	Ref. No.:	038443-62-03
From:	Julian Hayward/Valerie Chan/cb/29	Date:	September 9, 2015
cc:	Madelyn Adams, Ohio EPA; Lauren Foster, Tetra-Tech; Brandon Helm; Tetra-Tech; Tom Hut, PHDMC		
Re:	**Summary of July 2015 Vapor Intrusion Analytical Results and Proposed Sub-Slab Depressurization System (SSDS) Modifications**

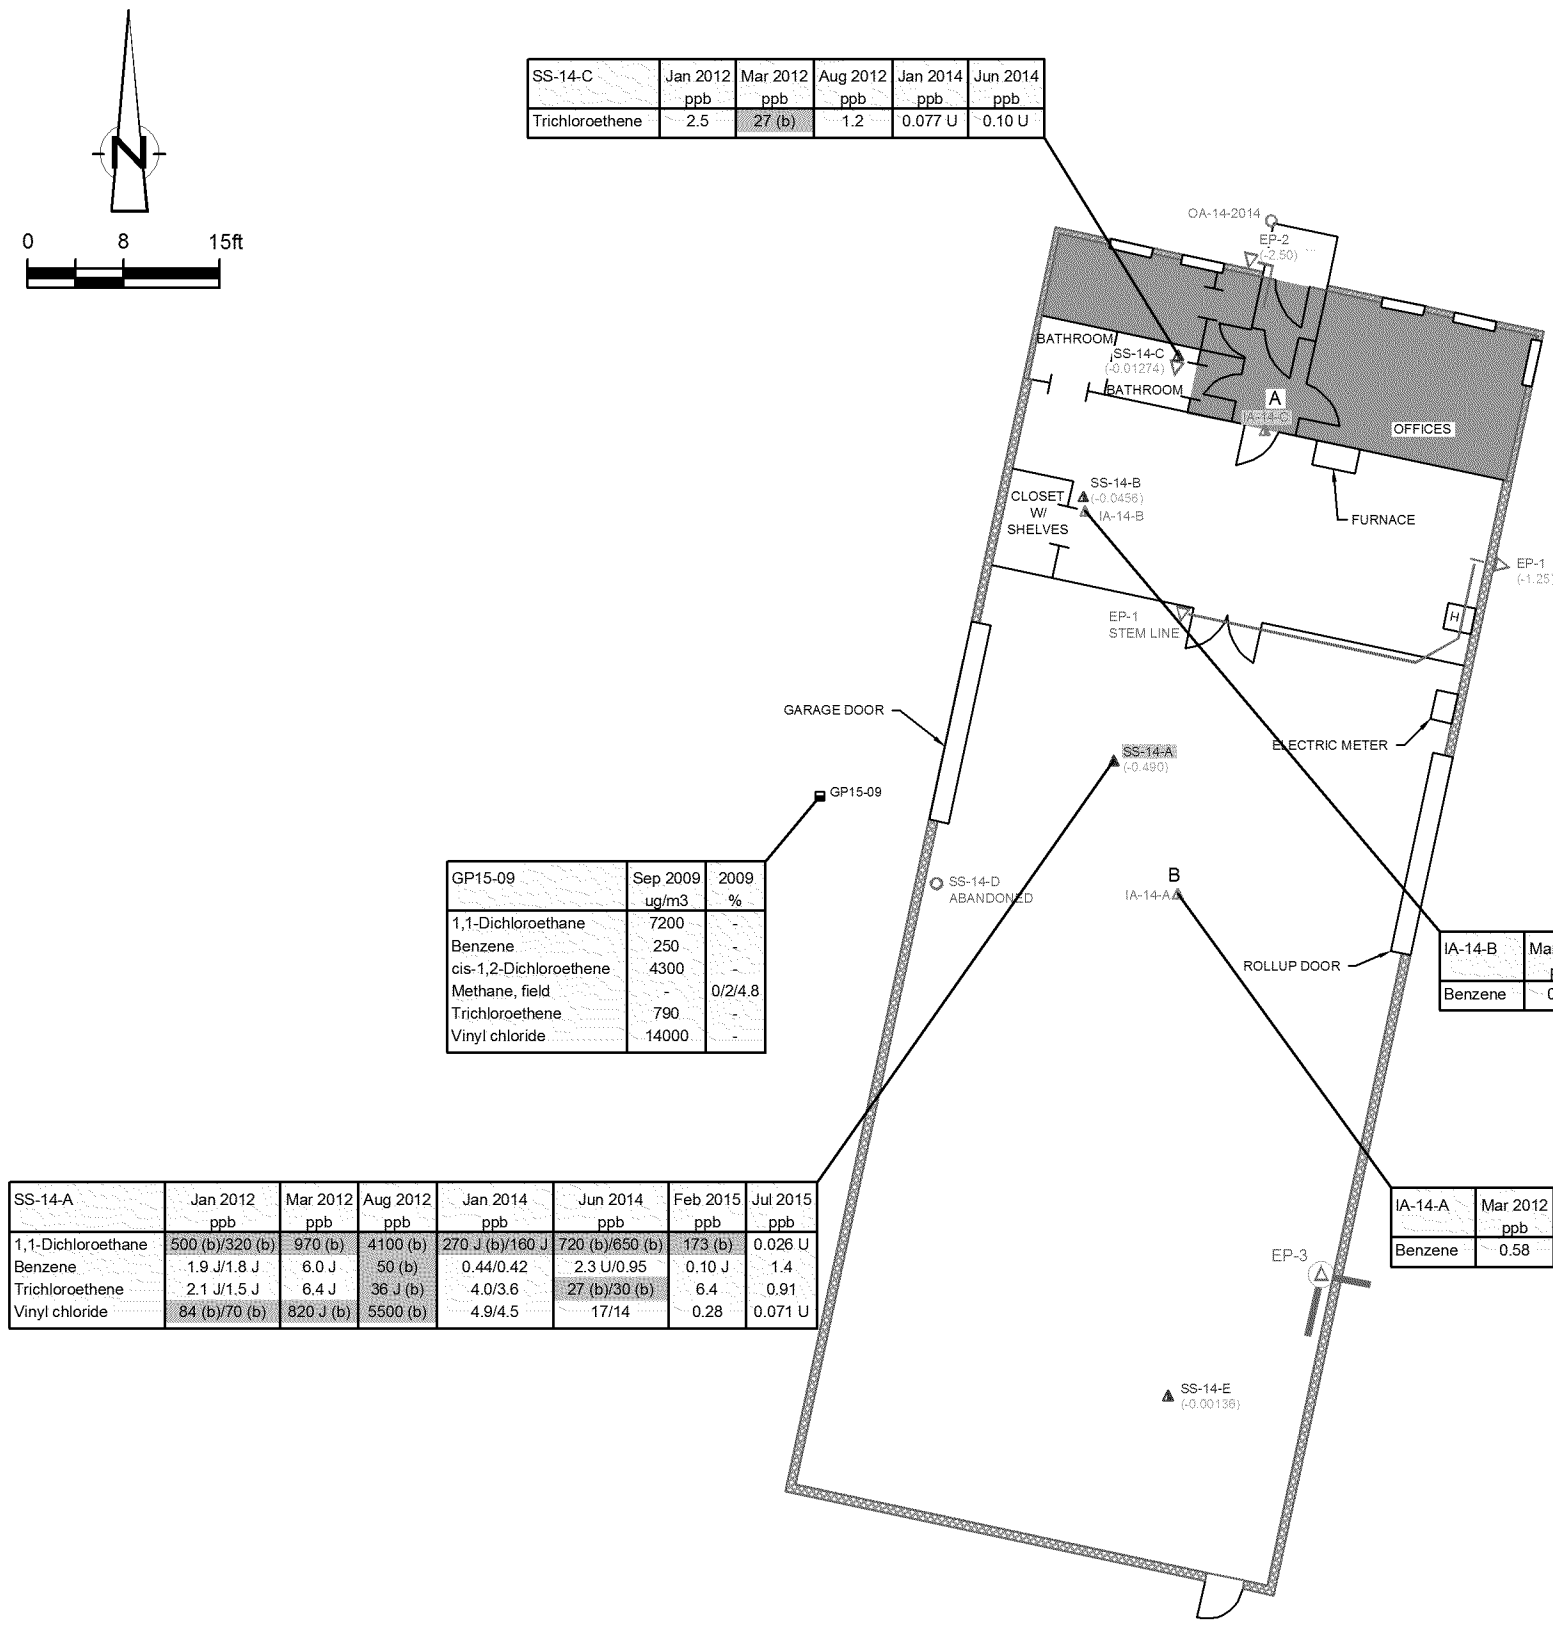
The SS concentrations of COCs in Building 14 have decreased since the SSDS was installed in December 2013, as can be seen from the concentrations presented on Figure 4.

The average historic vacuum readings for SS-14-A, SS-14-B, and SS-14-C satisfy the required -0.004" w.c. threshold. At SS-14-E, the average, historic vacuum reading is -0.0009' w.c., which did not meet the required threshold vacuum of -0.004" w.c. and adequate vacuum was not achieved. Historic sub-slab vacuum readings for Building 14 are presented in Table 8.

Based on the above assessment and the July 15, 2015 Site walkthrough, GHD proposes an additional extraction point location EP-3 (Figure 4). GHD amended the proposed location of EP-3 from earlier figures by moving it to the east side of the building from the west side. The entire west outside of Building 14 is covered with a tree/shrub line that would make installation along the west wall problematic. The proposed EP-3 location should also influence the southern section of the building where adequate vacuum has not been achieved.

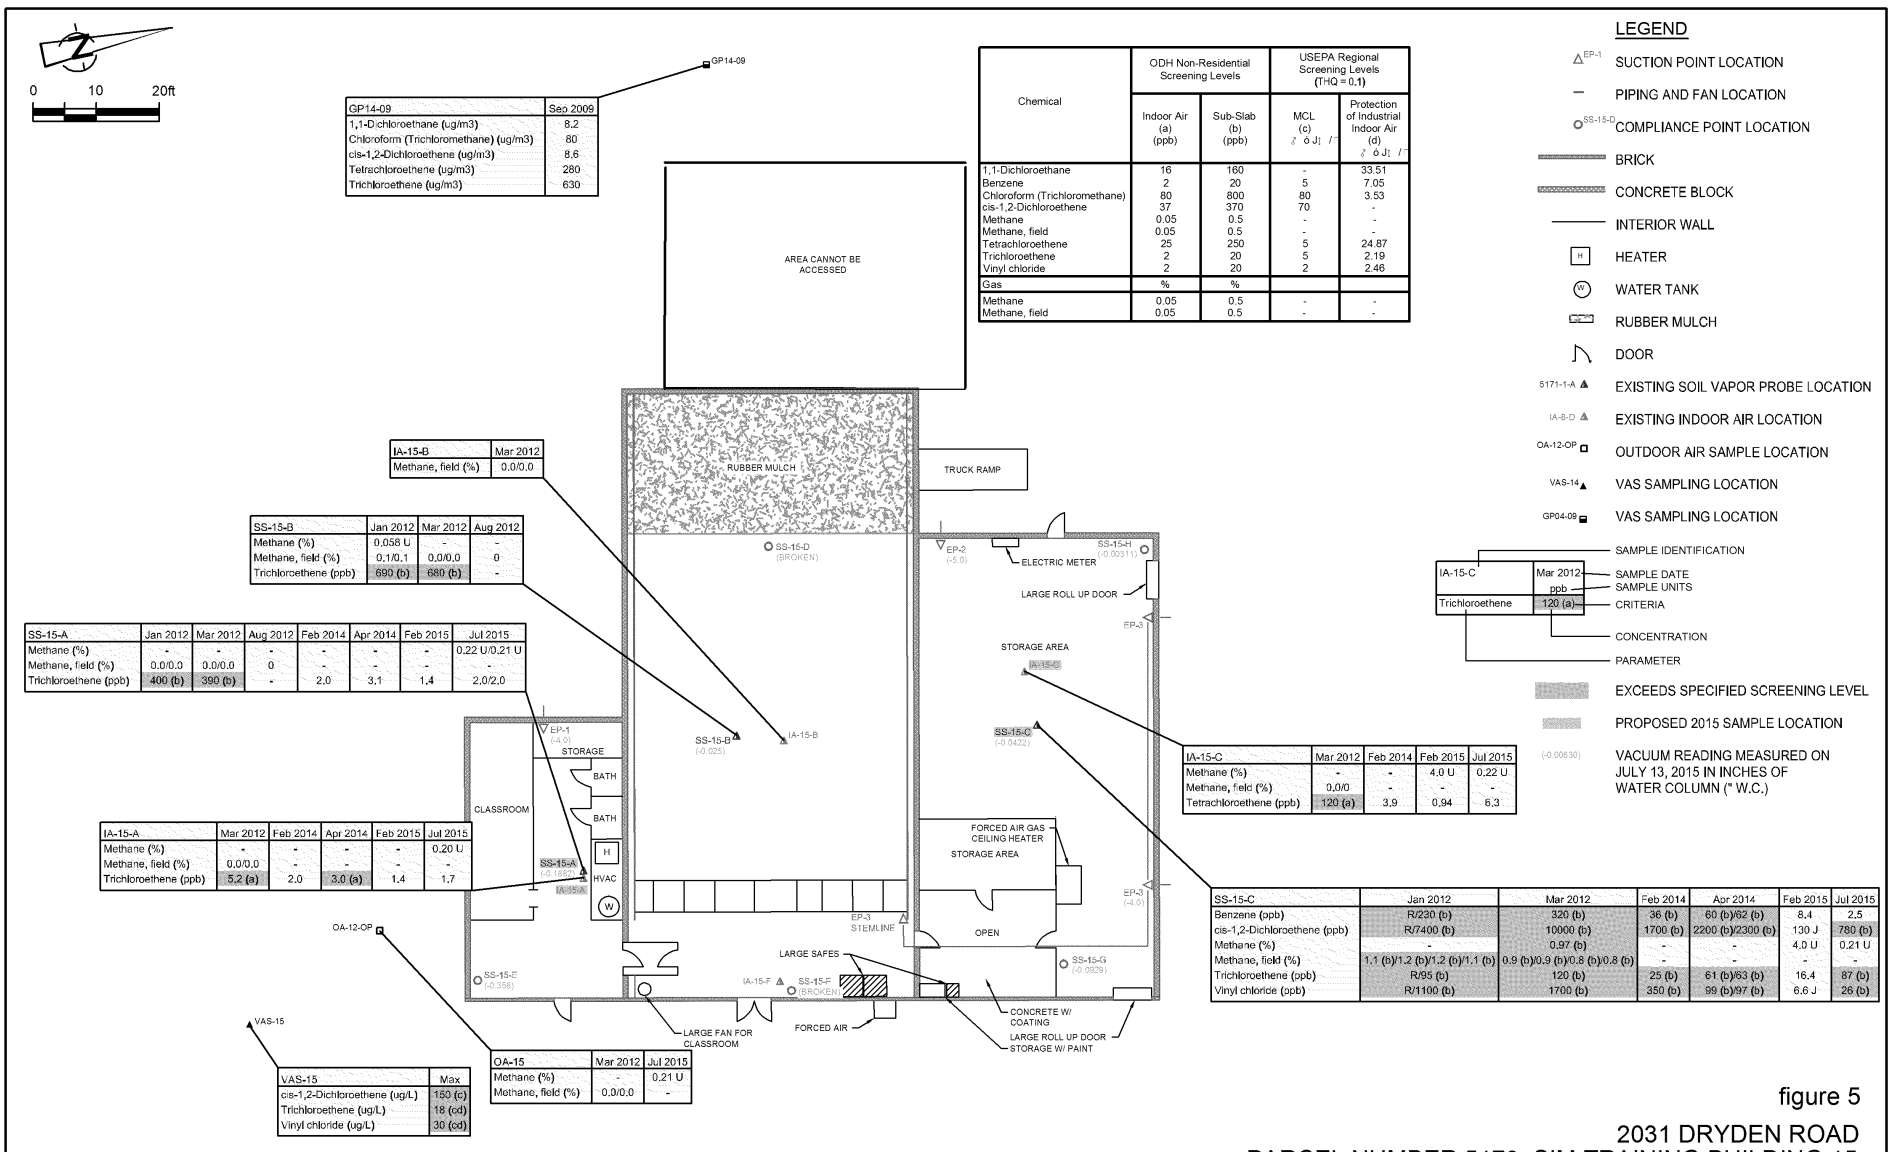
The SS concentrations at SS-15-C exhibit seasonal fluctuations, with concentrations increasing in the warmer months. The SS concentrations of COCs in Building 15 have decreased since the SSDS was installed in January 2014, as can be seen from the concentrations presented on Figure 5.

Based on the above assessment and July 15, 2015 Site walkthrough, GHD does not propose any SSDS modifications.

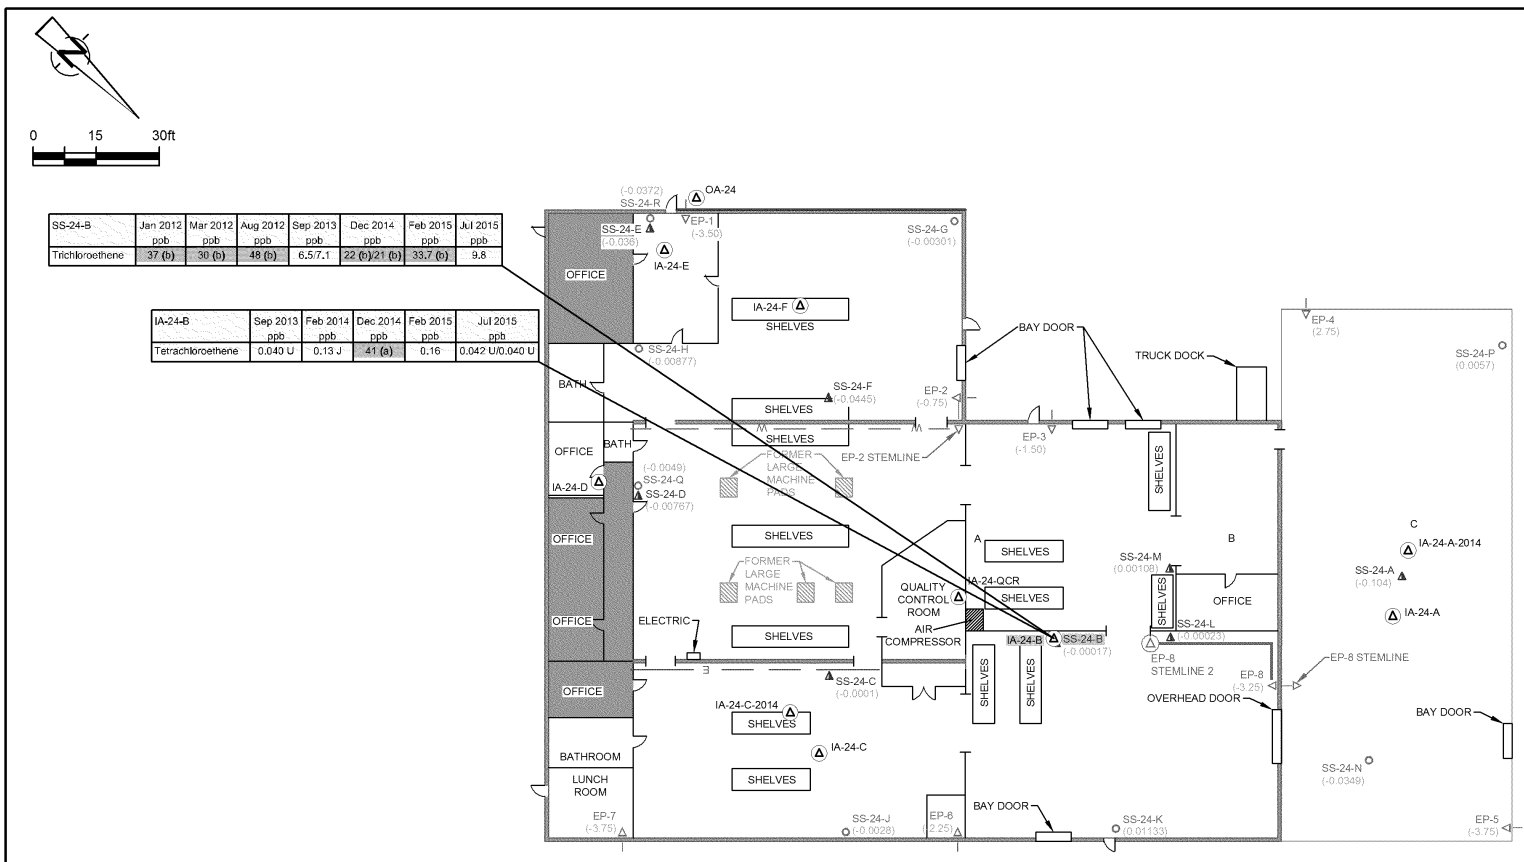
The SS concentrations of COCs in Building 24 have decreased since the SSDS was installed in August 2013, as can be seen from the concentrations presented on Figure 6.

The average, historical vacuum readings of -0.0002: w.c., were not within the required -0.004" w.c. threshold. Historic SS vacuum readings for Building 24 are presented in Table 12. GHD notes that SS vacuum readings may be influenced by the presence of a vapor barrier underneath Building 24.

Based on the above assessment and July 15, the 2015 Site walkthrough, GHD proposes to install EP-8 stemline 2 (Figure 6) to increase the SSDS ROI at SS-24-B where historic exceedances of TCE have been recorded (see comment above regarding vapor barrier).

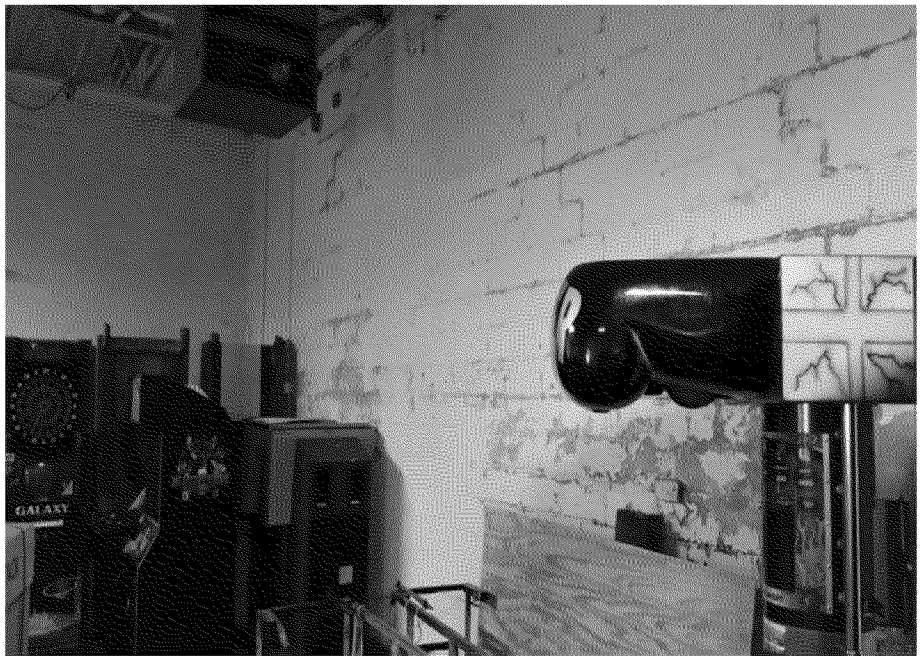
Description: June proposed EP-3 stemline location. View-Southwest
Date: 7/15/2015
Photographer: Doug Gatrell
