figure 1

2015/2019 DRYDEN ROAD
PARCEL NUMBER 5172, BUILDING 12
SOUTH DAYTON DUMP AND LANDFILL SITE
Moraine, Ohio

38443-62(PRES028)GN-WA001 NOV 20/2013

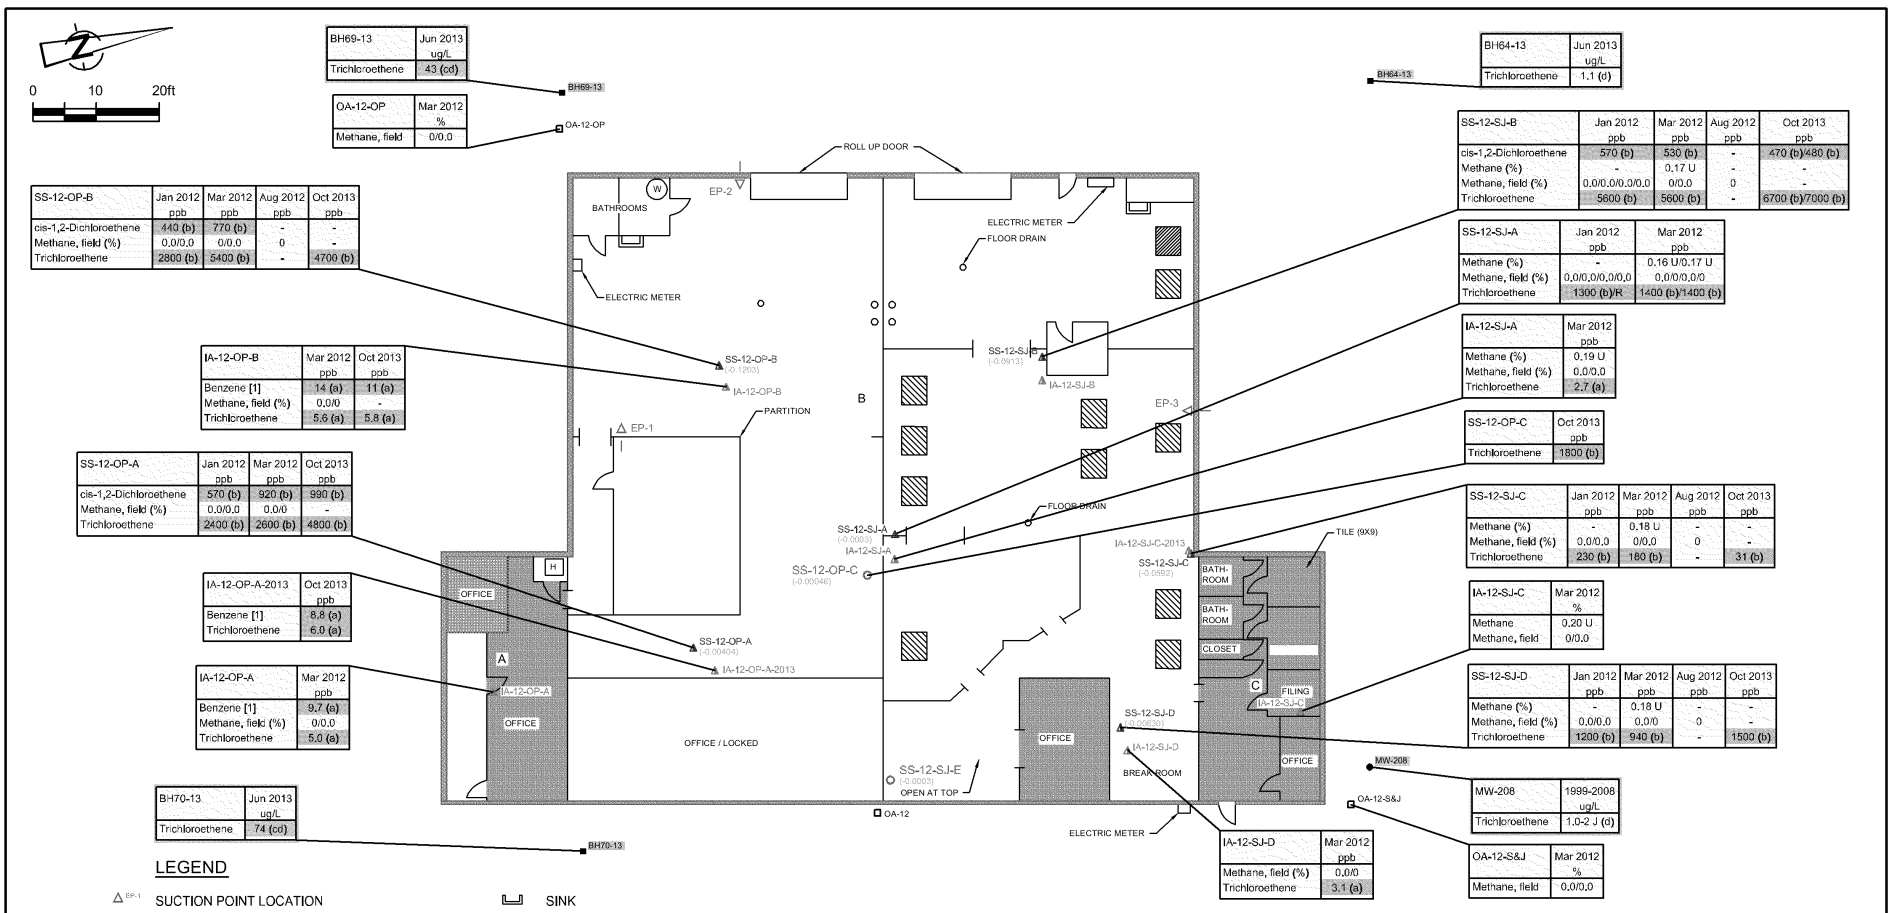
BH69-13	Jun 2013 ug/L
Trichloroethene	43 (cd)

BH64-13	Jun 2013 ug/L
Trichloroethene	1.1 (d)

SS-12-SJ-B	Jan 2012 ppb	Mar 2012 ppb	Aug 2012 ppb	Oct 2013 ppb
cis-1,2-Dichloroethene	570 (b)	530 (b)	-	470 (b)/480 (b)
Methane (%)	-	0.17 U	-	-
Methane, field (%)	0.0/0.0/0.0/0.0	0/0.0	0	-
Trichloroethene	5600 (b)	5600 (b)	-	6700 (b)/7000 (b)

SS-12-OP-B	Jan 2012 ppb	Mar 2012 ppb	Aug 2012 ppb	Oct 2013 ppb
cis-1,2-Dichloroethene	440 (b)	770 (b)	-	-
Methane, field (%)	0.0/0.0	0/0.0	0	-
Trichloroethene	2800 (b)	5400 (b)	-	4700 (b)

SS-12-SJ-A	Jan 2012 ppb	Mar 2012 ppb
Methane (%)	-	0.16 U/0.17 U
Methane, field (%)	0.0/0.0/0.0/0.0	0.0/0/0.0/0
Trichloroethene	1300 (b)/R	1400 (b)/1400 (b)

IA-12-SJ-A	Mar 2012 ppb
Methane (%)	0.19 U
Methane, field (%)	0.0/0.0
Trichloroethene	2.7 (a)

IA-12-OP-B	Mar 2012 ppb	Oct 2013 ppb
Benzene [1]	14 (a)	11 (a)
Methane, field (%)	0.0/0	-
Trichloroethene	5.6 (a)	5.8 (a)

SS-12-OP-C	Oct 2013 ppb
Trichloroethene	1800 (b)

SS-12-OP-A	Jan 2012 ppb	Mar 2012 ppb	Oct 2013 ppb
cis-1,2-Dichloroethene	570 (b)	920 (b)	990 (b)
Methane, field (%)	0.0/0.0	0.0/0	-
Trichloroethene	2400 (b)	2600 (b)	4800 (b)

SS-12-SJ-C	Jan 2012 ppb	Mar 2012 ppb	Aug 2012 ppb	Oct 2013 ppb
Methane (%)	-	0.18 U	-	-
Methane, field (%)	0.0/0.0	0/0.0	0	-
Trichloroethene	230 (b)	180 (b)	-	31 (b)

IA-12-OP-A-2013	Oct 2013 ppb
Benzene [1]	8.8 (a)
Trichloroethene	6.0 (a)

IA-12-OP-A	Mar 2012 ppb
Benzene [1]	9.7 (a)
Methane, field (%)	0/0.0
Trichloroethene	5.0 (a)

SS-12-SJ-D	Jan 2012 ppb	Mar 2012 ppb	Aug 2012 ppb	Oct 2013 ppb
Methane (%)	-	0.18 U	-	-
Methane, field (%)	0.0/0.0	0.0/0	0	-
Trichloroethene	1200 (b)	940 (b)	-	1500 (b)

BH70-13	Jun 2013 ug/L
Trichloroethene	74 (cd)

IA-12-SJ-D	Mar 2012 ppb
Methane, field (%)	0.0/0
Trichloroethene	3.1 (a)

IA-12-OP-B-2013	Oct 2013 ppb
Benzene	11 (a)
Trichloroethene	5.8 (a)
