LAC DU FLAMBEAU BAND
OF LAKE SUPERIOR
CHIPPEWA INDIANS

TRIBAL NATURAL RESOURCE DEPARTMENT

Re: TNR Site # 4-2015
14267 W State Highway 70, Lac du Flambeau
September 2015 Field Work Results

TOWER STANDARD
14267 HIGHWAY 70 WEST
LAC DU FLAMBEAU, WISCONSIN

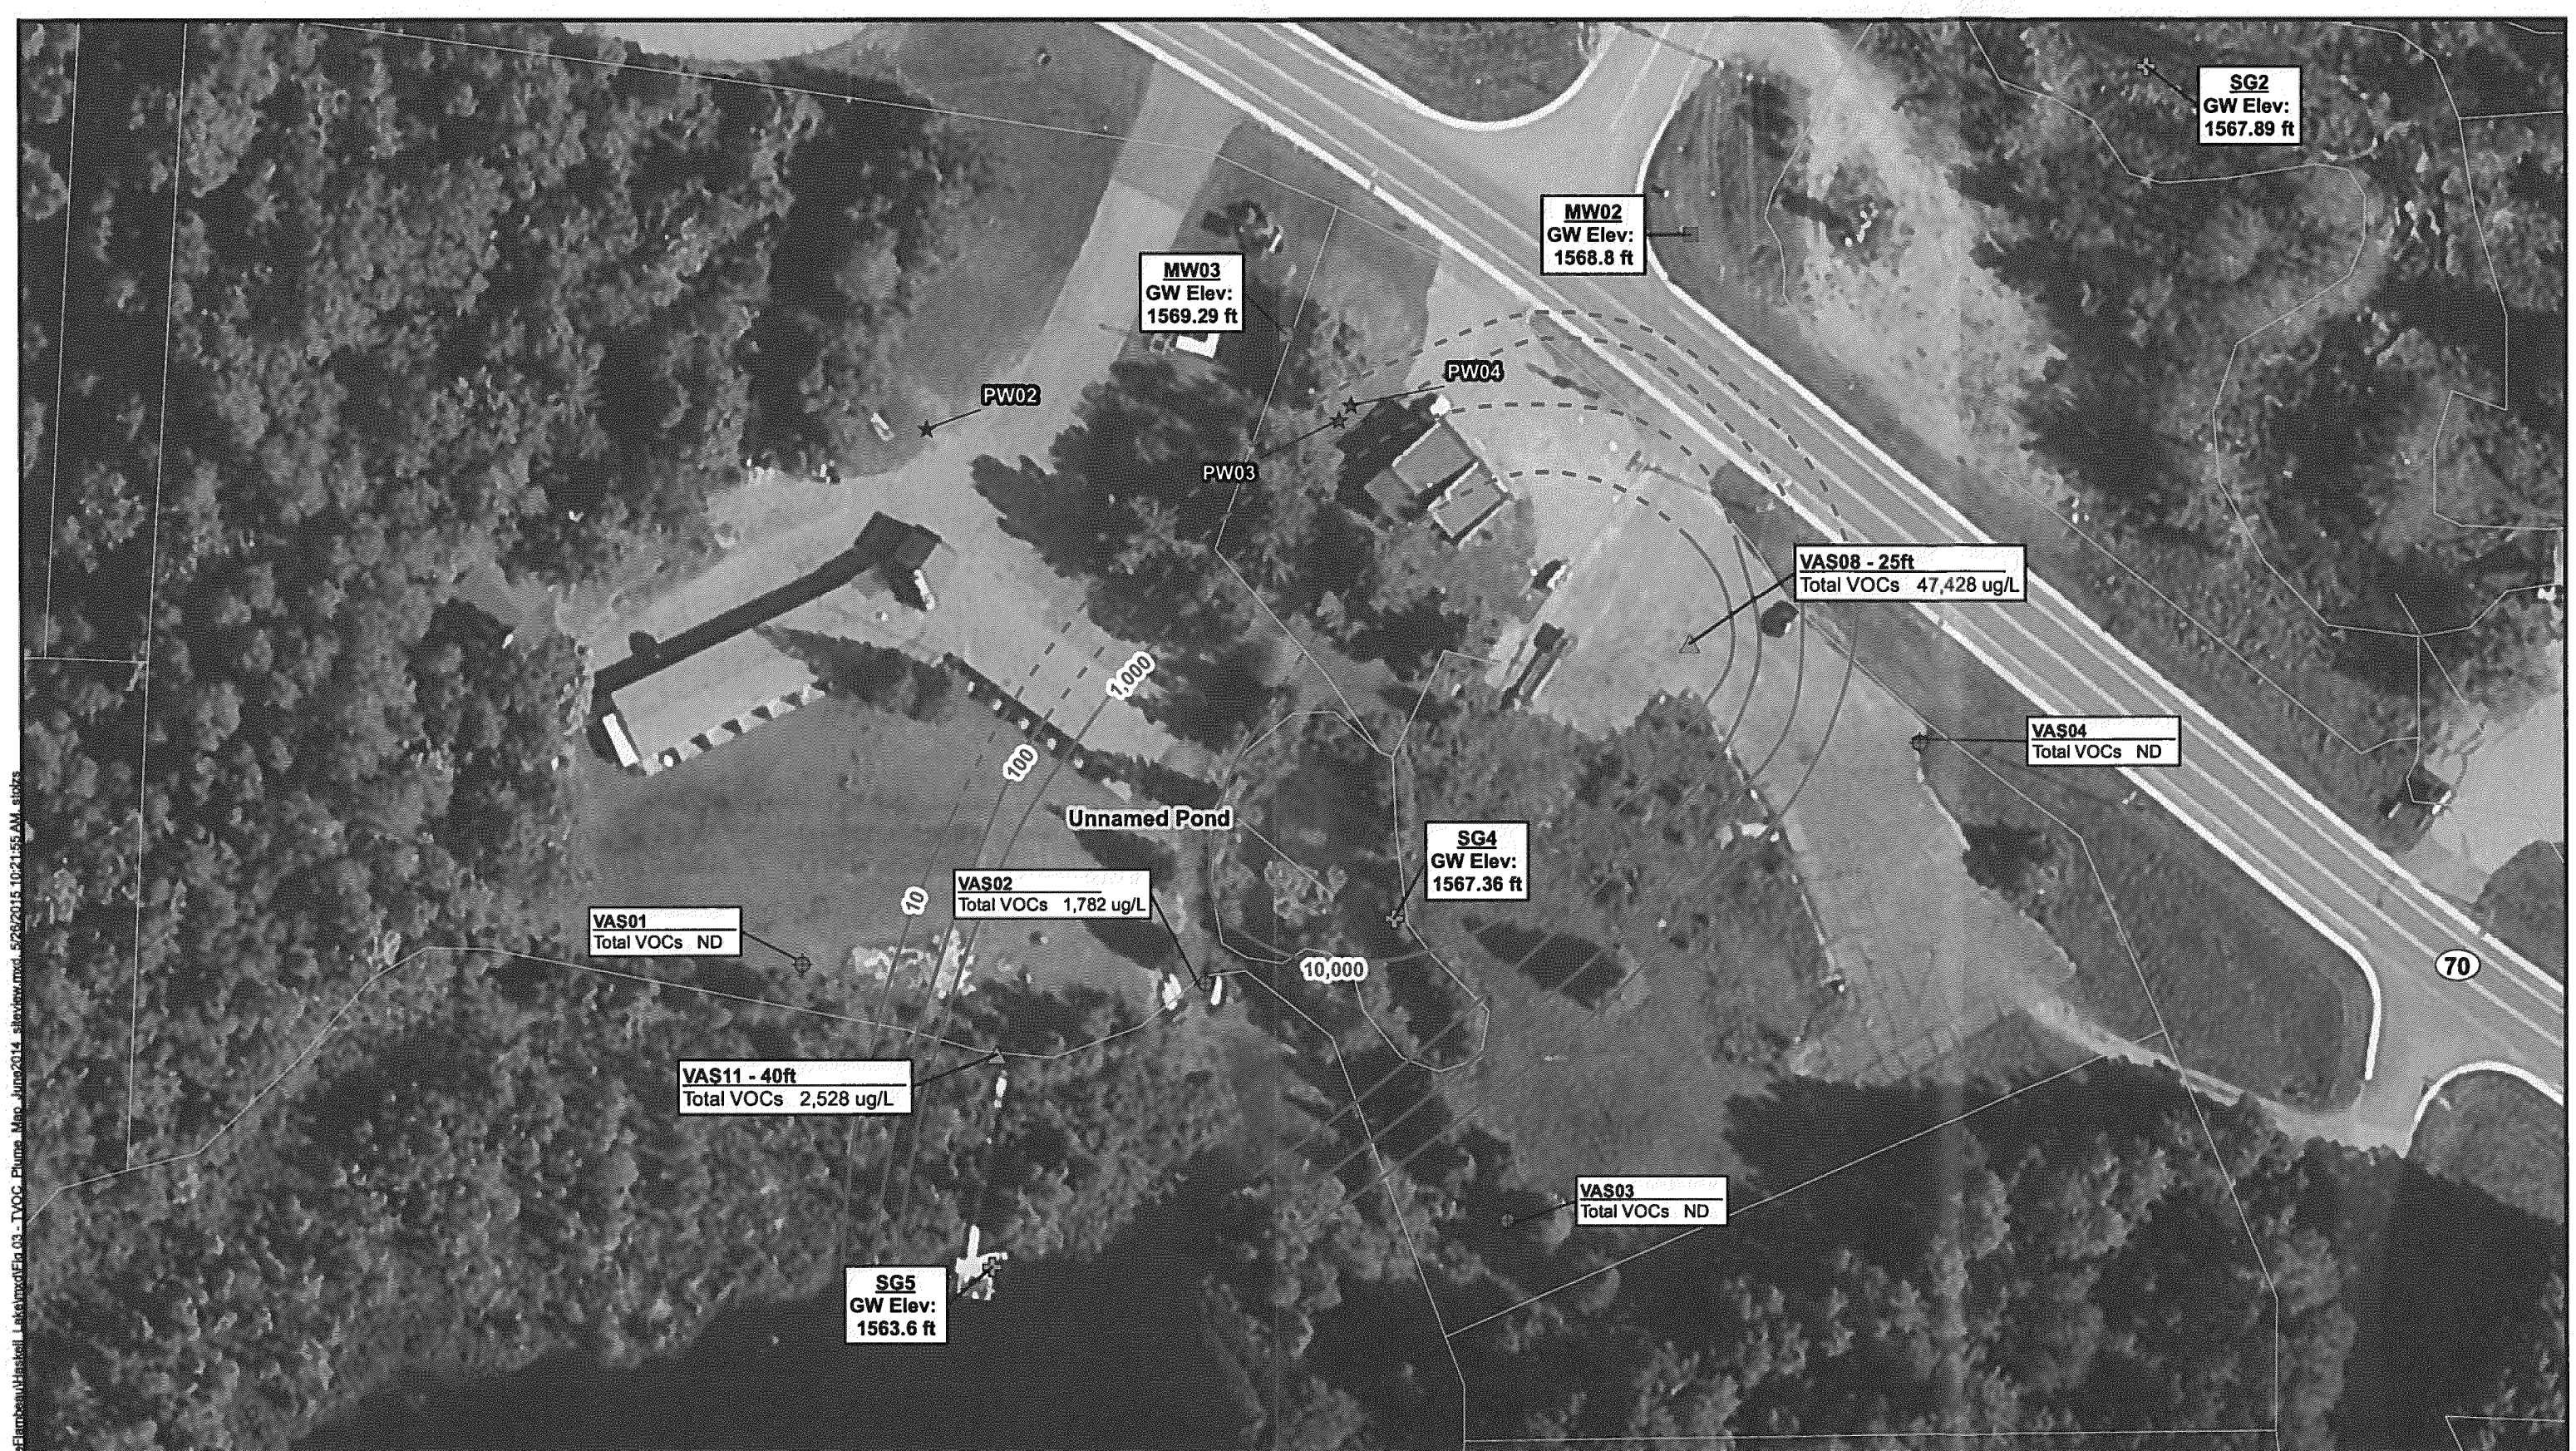
Figure 3
Total VOC Plume Map
Haskell Lake Area
Lac du Flambeau, Vilas County, Wisconsin

These concentrations confirm the plume is closer to your private well than originally thought. We understand you declined USEPA offer to sample your private well this September. We encourage you to sample your well through the PECFA resources available to you. We strongly recommend your private well be sampled.

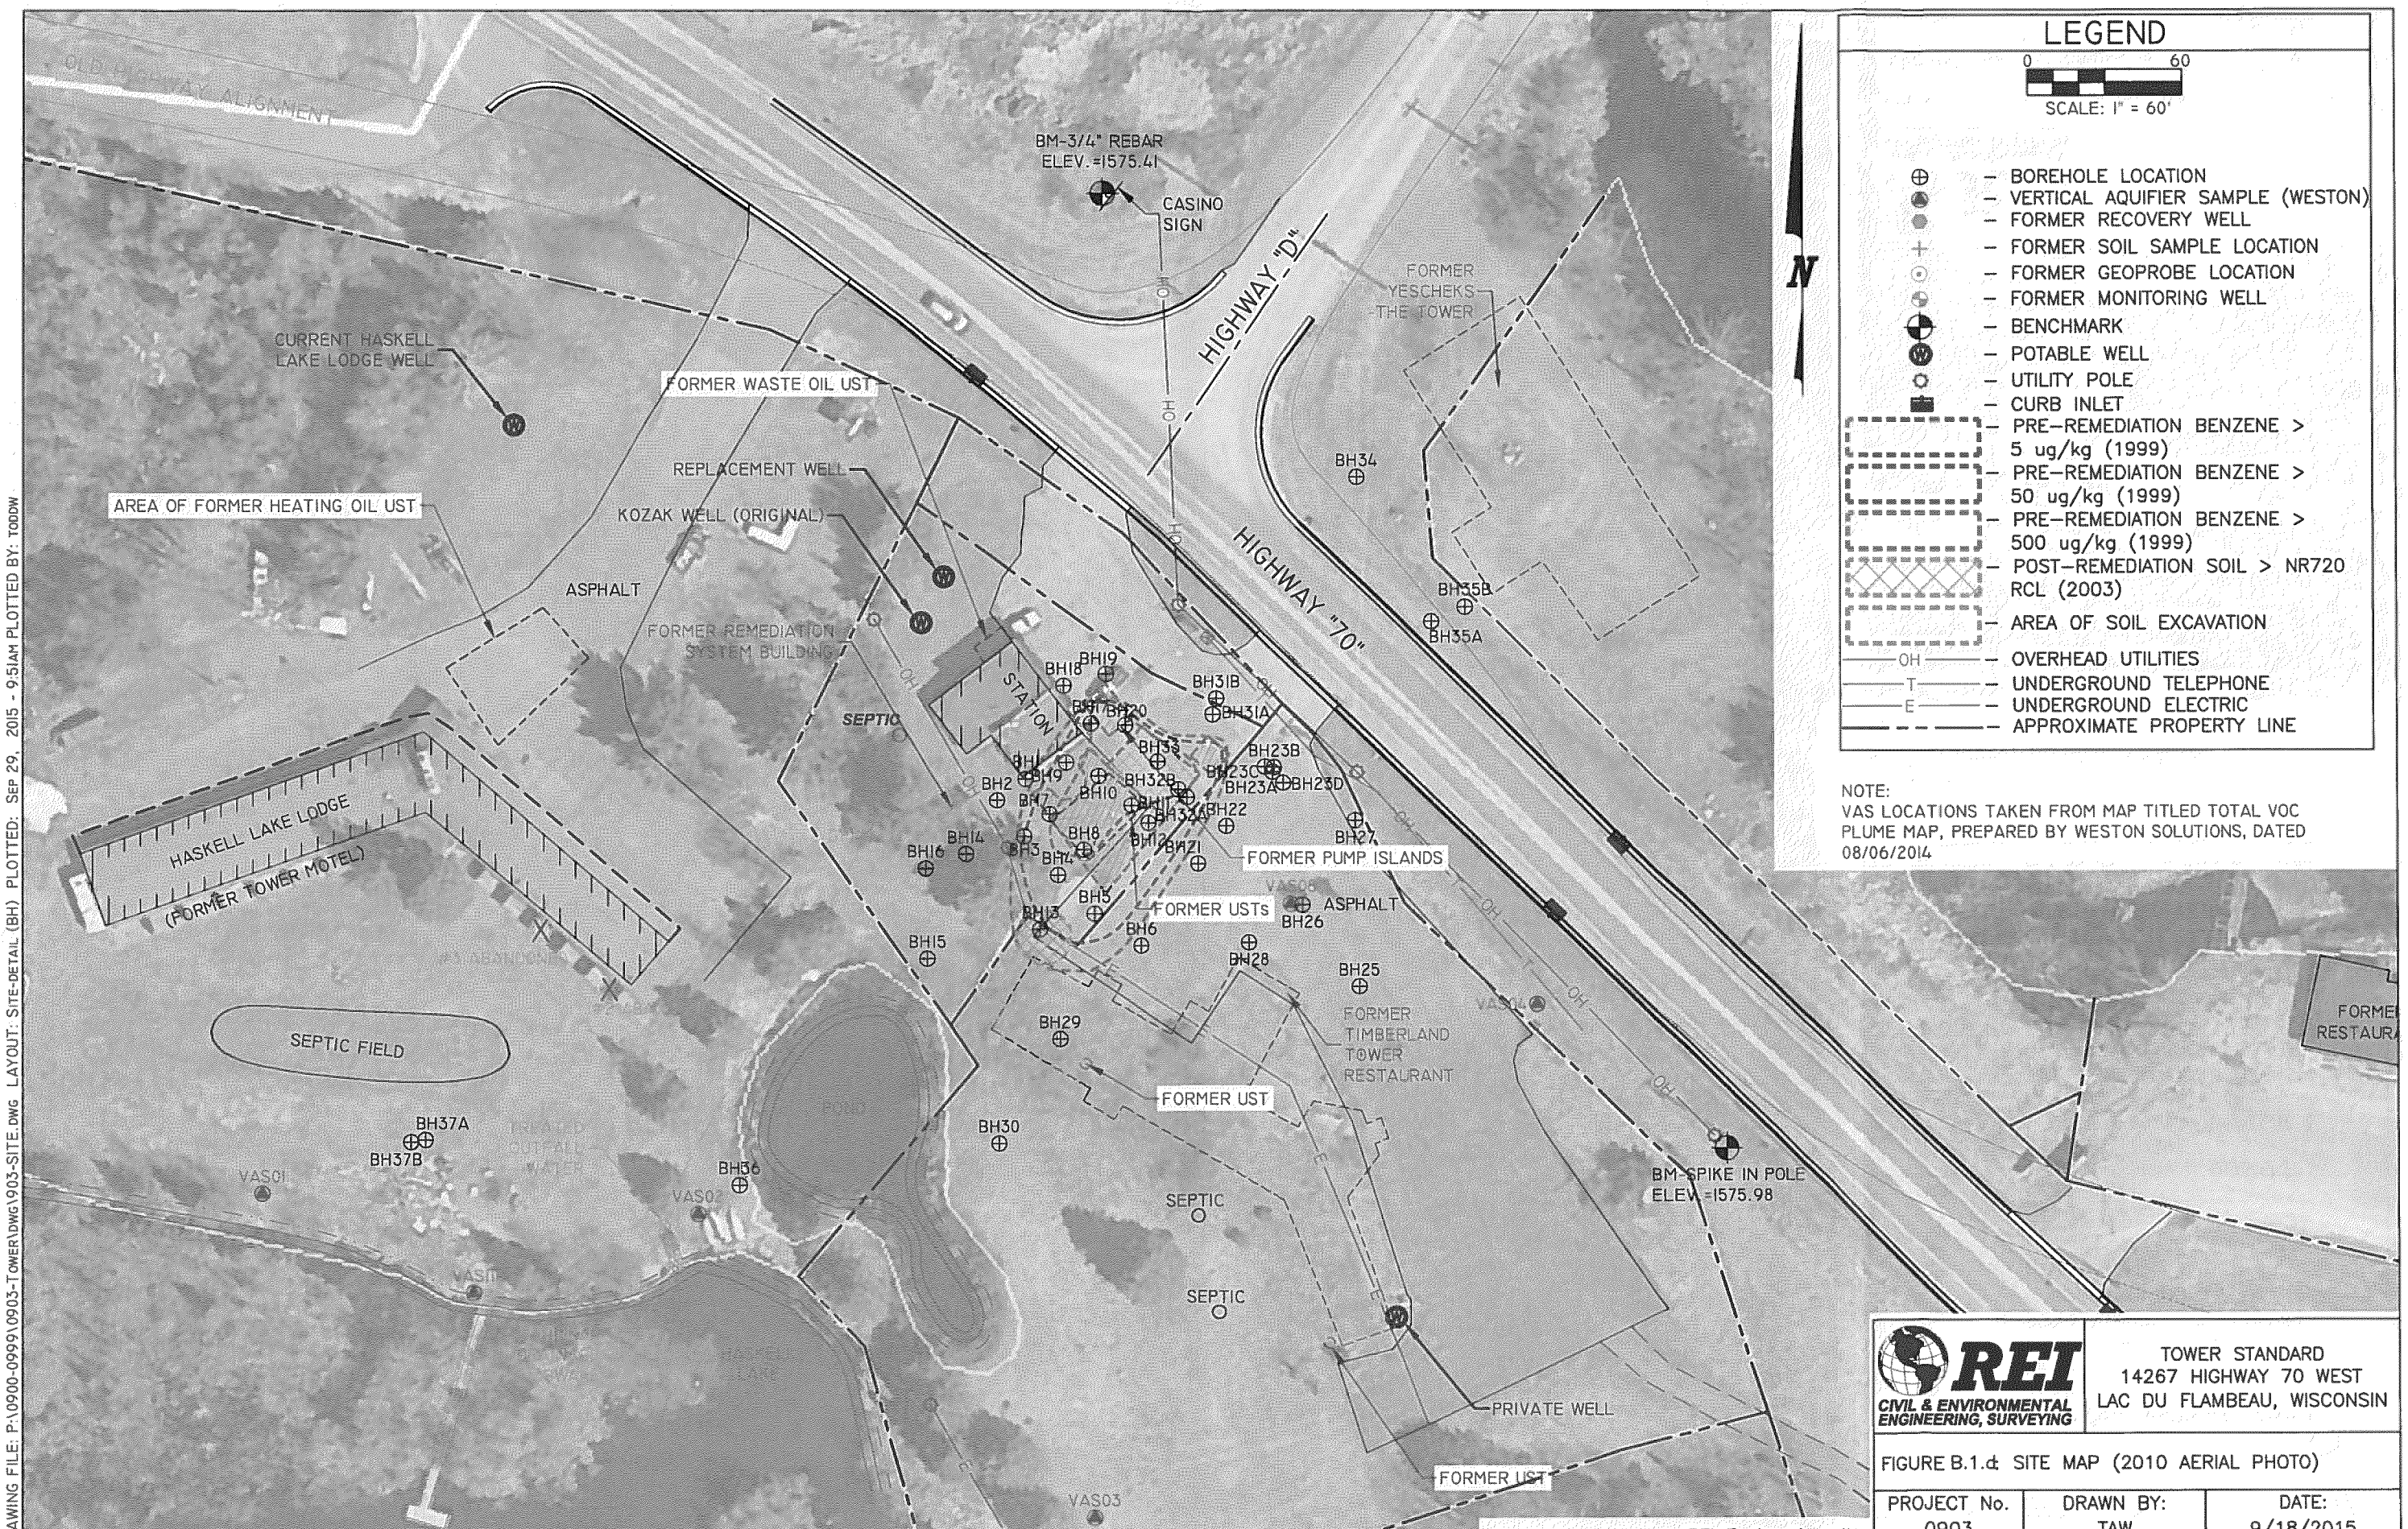
FIGURE B.1.d: SITE MAP (2010 AERIAL PHOTO)

Groundwater Results/ Vapor Intrusion Concern
Groundwater was collected adjacent to your building at BH17 (map attached). The analytical results show concentrations of Volatile Organic Compounds including benzene, toluene, ethylbenzene, xylenes, trimethyl benzenes, and naphthalene (table attached). All of these detections are well above cleanup standards and quite high. There is a possibility the contamination is migrating into your building through vapor.
