Current Conditions Report

Tower Standard
14267 State Highway 70 West
Lac du Flambeau, WI

BRRTS #03-64-127899
PECFA #54538-9517-67
REI Project #903

CURRENT CONDITIONS REPORT

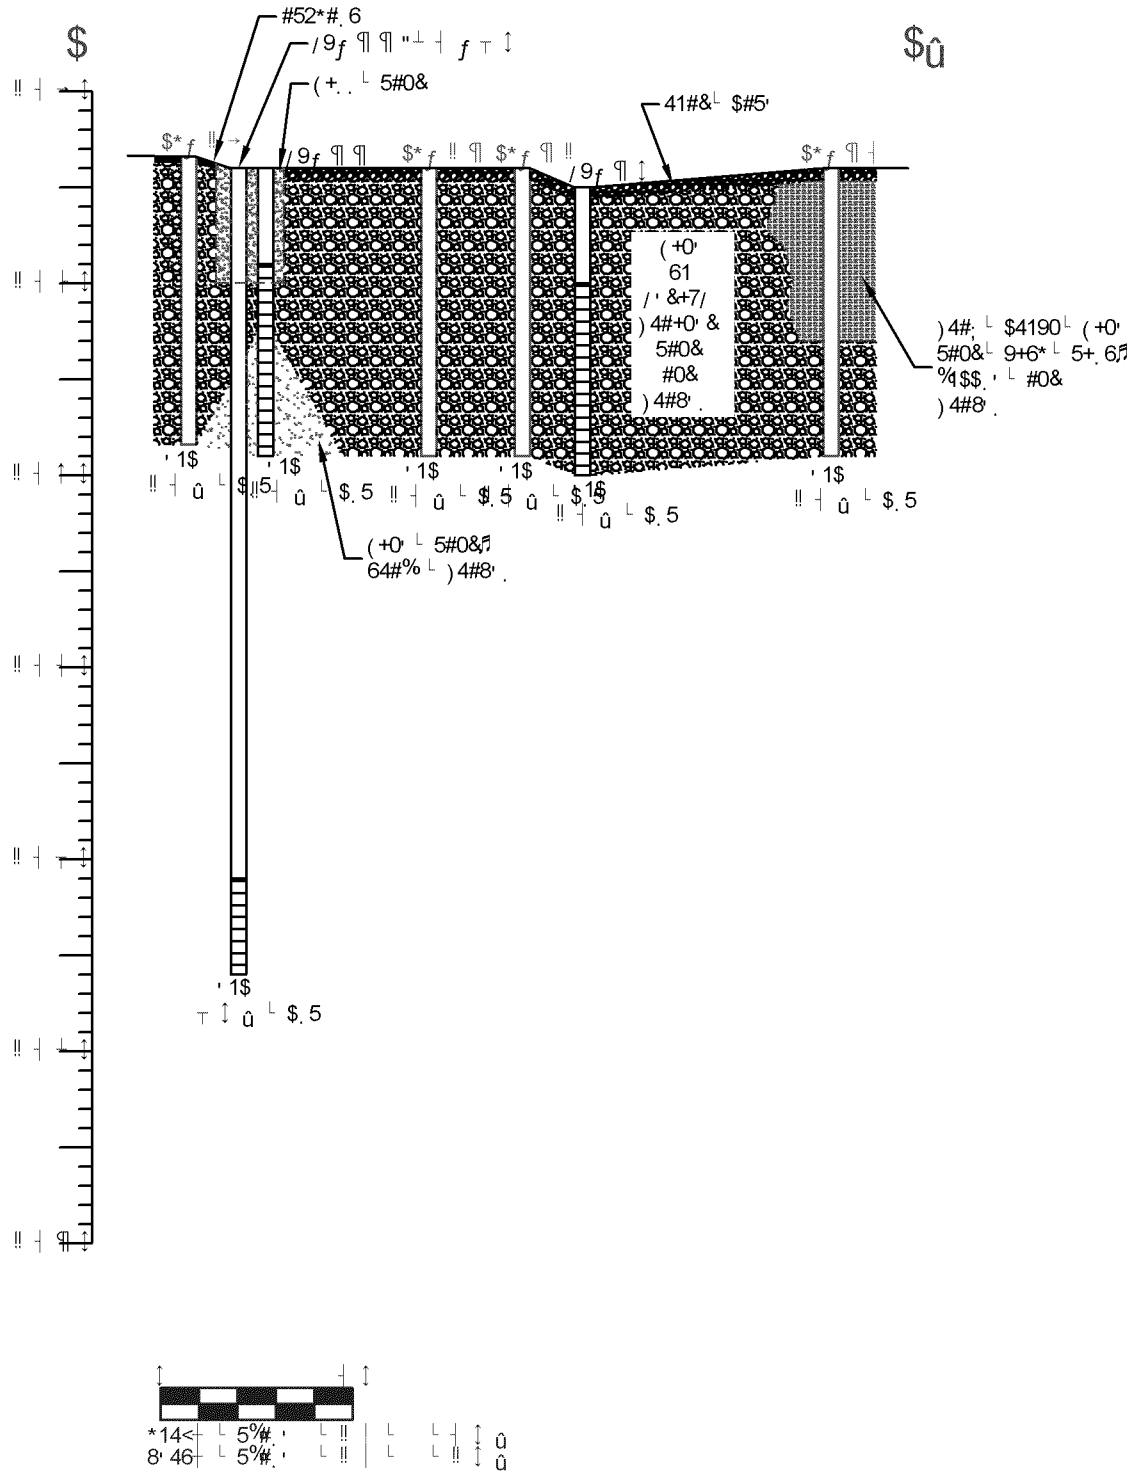
REI CIVIL & ENVIRONMENTAL ENGINEERING, SURVEYING	TOWER STANDARD 14267 HIGHWAY 70 WEST LAC DU FLAMBEAU, WISCONSIN	
FIGURE 3A : GEOLOGIC CROSS SECTION A – A'		
PROJECT No. 0903	DRAWN BY: TAW	DATE: 5/20/2016

The soil borings performed during the investigation indica te the site geology mainly consists of sands and gravels. Bedrock was not encountered during the investigation. Figures 3a-b present the geologic cross section s of the soils identified at the site.
