Current Conditions Report

Tower Standard
14267 State Highway 70 West
Lac du Flambeau, WI

BRRTS #03-64-127899
PECFA #54538-9517-67
REI Project #903

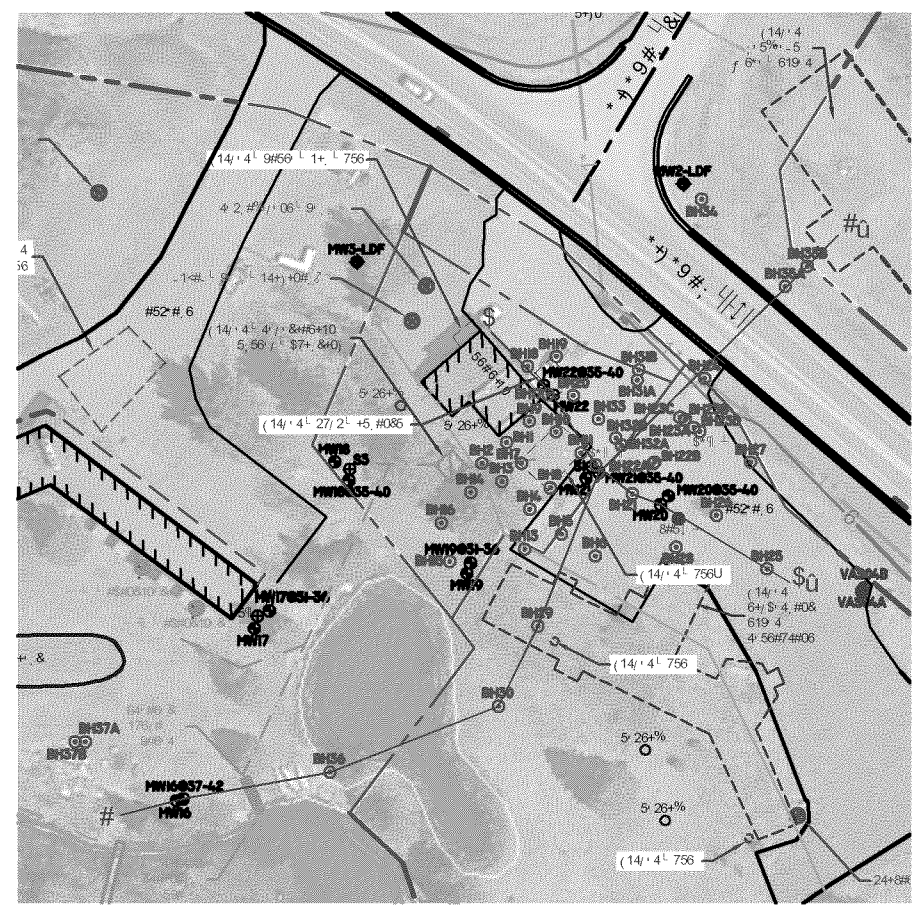
REI CIVIL & ENVIRONMENTAL ENGINEERING, SURVEYING	TOWER STANDARD 14267 HIGHWAY 70 WEST LAC DU FLAMBEAU, WISCONSIN	
FIGURE 3A : GEOLOGIC CROSS SECTION A – A'		
PROJECT No. 0903	DRAWN BY: TAW	DATE: 5/20/2016

The soil borings performed during the investigation indica te the site geology mainly consists of sands and gravels. Bedrock was not encountered during the investigation. Figures 3a-b present the geologic cross section s of the soils identified at the site.
