1.30 mg/L- Dissolved Oxygen
Screen Interval (VAS)
Screen Interval (Monitor Well)
Shallow Potentiometric Surface
Benzene Plume Countour
ND = Not Detected
NR = No Reading
All Benzene values exceed Wisconsin Enforcement Standard (ES) values
WESTON SOLUTIONS
2501 Jolly Road
Suite 100
Okemos, Michigan
48864
GEOLOGICAL CROSS SECTION B–B'
WITH 2014–2015 BENZENE PLUME DEPICTION
HASKELL LAKE AREA
Lac du Flambeau, Vilas County, Wisconsin
SCALE: AS NOTED
DRAWN: EPM
DATE: 6/14
CHECKED BY: PB
FIGURE 7
J:\Figure 7 (B-B') Benzene.dwg
J:\Figure 7 (B-B') Benzene.dwg, 5/5/2016 1:31:30 PM

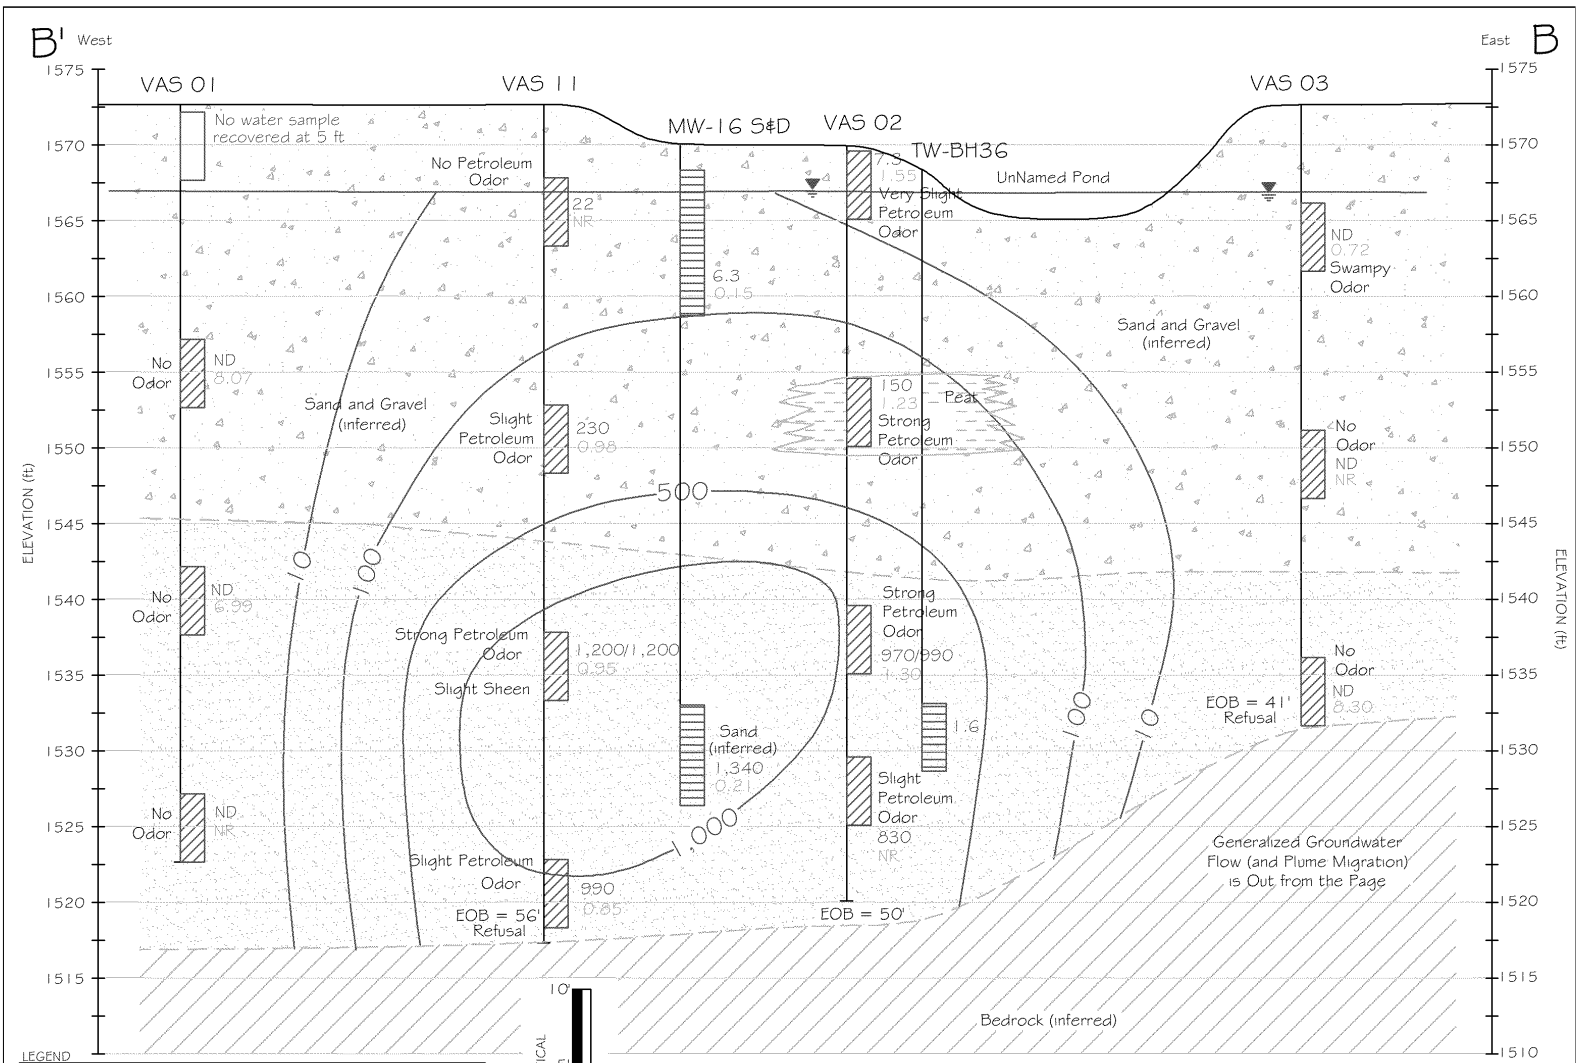
B' West
East B
VAS 01
VAS 11
MW-16 S&D
VAS 02
TW-BH36
VAS 03
No water sample recovered at 5 ft
No Petroleum Odor
UnNamed Pond
7.3
1.55
Very Slight Petroleum Odor
22
NR

6.3
0.15
ND
0.72
Swampy Odor
Sand and Gravel (inferred)
No Odor
ND
8.07
Sand and Gravel (inferred)
Slight Petroleum Odor
230
0.98
150
1.23
Peat
Strong Petroleum Odor
No Odor
ND
NR
500
10
100
No Odor
ND

6.99
Strong Petroleum Odor
1,200/1,200
0.95
Slight Sheen
Strong Petroleum Odor
970/990
1.30
No Odor
ND
8.30
EOB = 41' Refusal
Sand (inferred)
1,340
0.21
1.6
Slight Petroleum Odor
830
NR
No Odor
ND
NR
1,000
Slight Petroleum Odor
990

0.85
EOB = 56' Refusal
EOB = 50'
Generalized Groundwater Flow (and Plume Migration) is Out from the Page
Bedrock (inferred)
ELEVATION (ft)
1575
1570
1565
1560
1555
1550
1545
1540
1535
1530
1525
1520
1515
1510
VERTICAL
10'
5'
0
0
25'
50'
HORIZONTAL
LEGEND
EOB = End of Boring
ug/L = micro grams per liter
VAS = Vertical Aquifer Sample
ppb = Parts per Billion
230 ug/L- Benzene Concentration (ppb) 2014
1,340 ug/L- Benzene Concentration (ppb) 2015
