UST Inspection Checklist

1. Facility Name: Meleen's Sports Center
2. Owner: Paul Meleen
3. Operator: "
5. Contact Person: "
6. UST Site Phone #: 320-532-3717

6. Date of Visit: 4-25-13 7. Marketer: X Non-Marketer: ___
8. Site Arrival/Departure (Time): 11:40 / 1:30
9. Facility Address: 38666 Hwy 169 Onamia, MN 56359
10: Team Members: Scott Hansen

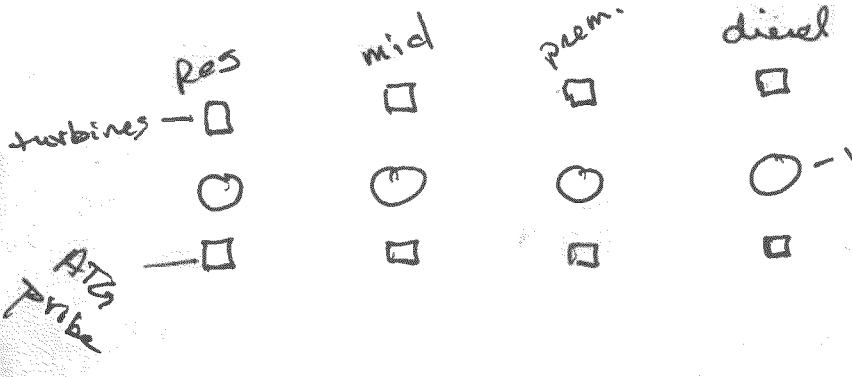
ultimate leaking photos above shear valve dirt - smelled wet/

* flappers good on all 4 tanks
* sumps all dry - should be cleaned up - remove soil around them.
