RCRA FOCUSED COMPLIANCE INSPECTION REPORT

FACILITY NAME:	**MID AMERICA IBC**
FACILITY U.S. EPA ID NO.:	None
FACILITY TYPE:	Non-Notifier
FACILITY ADDRESS:	2300 West Cornell Street Milwaukee, Wisconsin 53209
U.S. EPA REPRESENTATIVE:	Walt Francis
DATE OF INSPECTION:	February 24, 2017
NAICS CODE:	332439 – Other Metal Container Manufacturing

An unannounced Compliance Evaluation Inspection (CEI) at Mid-America Steel Drum located at 3950 South Pennsylvania Avenue in St. Francis, Wisconsin ("MASD-SF" or "Facility"), took place on February 28, 2017. This CEI was conducted in cooperation with the Wisconsin Department of Natural Resources (WDNR) and the Pipeline and Hazardous Materials Safety Administration (PHMSA). This joint effort was made in response to a whistle-blower complaint published in articles in the Milwaukee Journal Sentinel in February, 2017, and in response to letters of concern from Wisconsin politicians.

An unannounced Compliance Evaluation Inspection (CEI) at Mid-America Steel Drum located at 8570 South Chicago Road in Oak Creek, Wisconsin ("MASD-OC" or "Facility"), took place on March 2, 2017. This CEI was conducted in cooperation with the Wisconsin Department of Natura

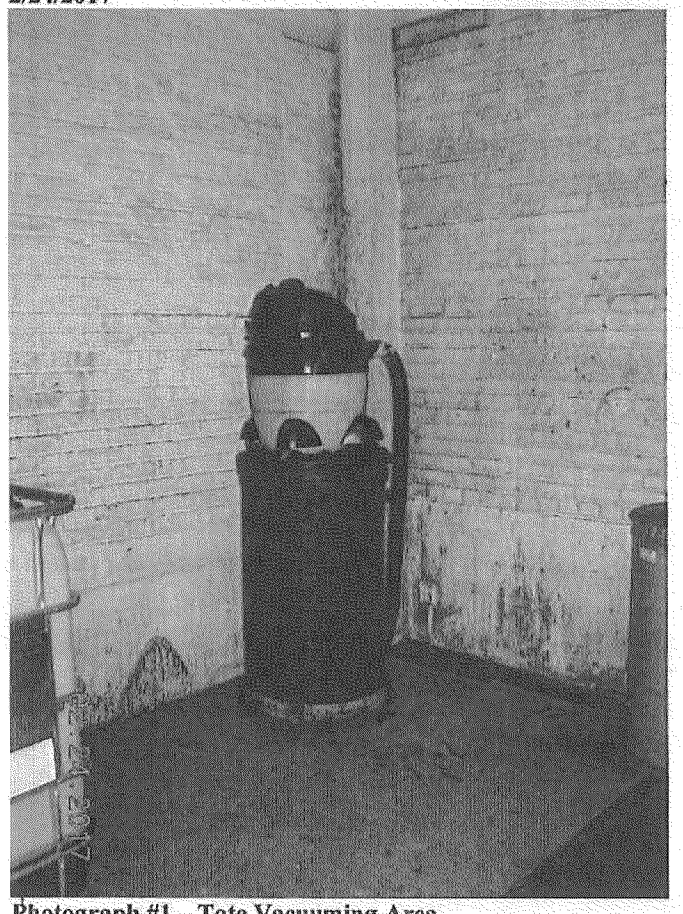
Photograph #1 – Tote Vacuuming Area

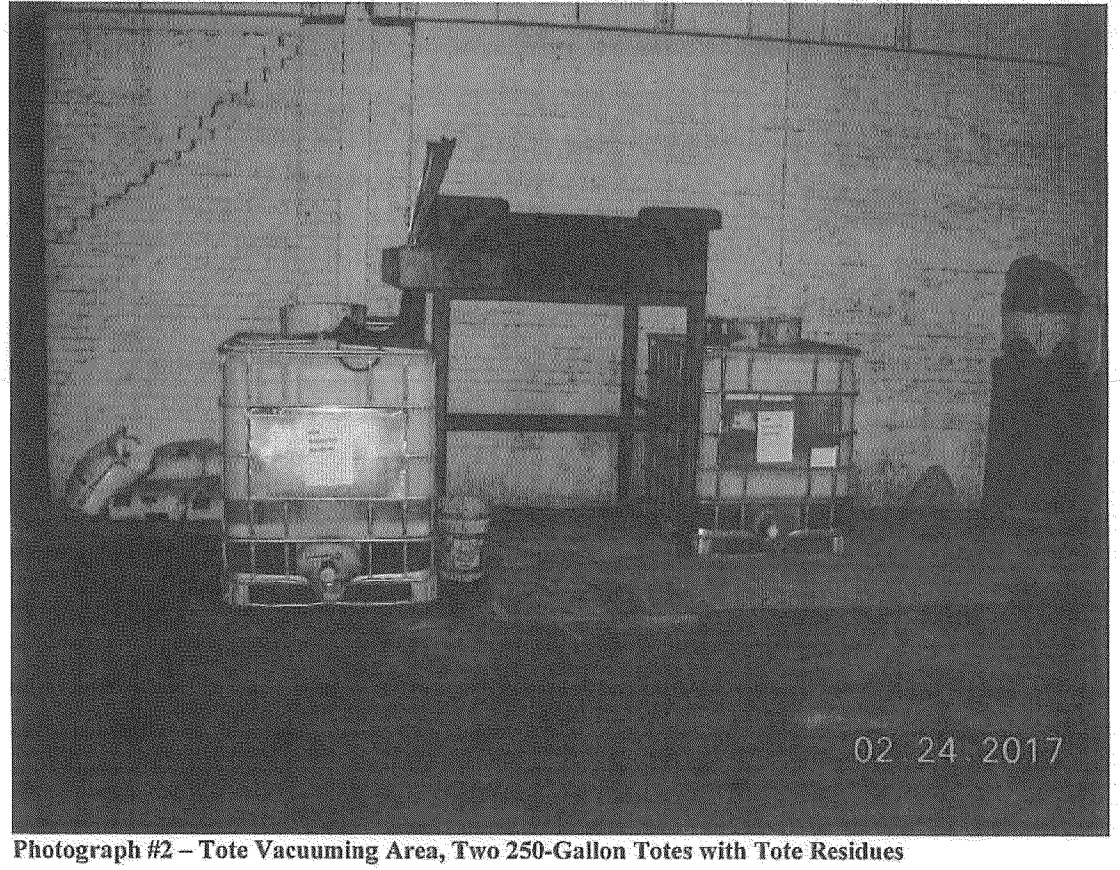
Photograph #2 – Tote Vacuuming Area, Two 250-Gallon Totes with Tote Residues

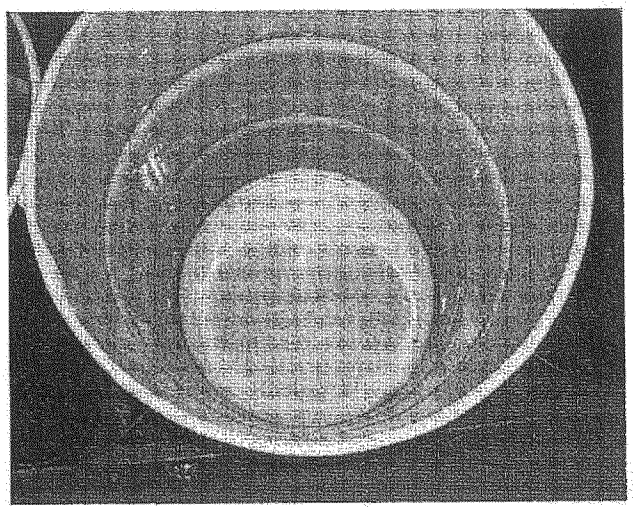
This photograph was taken in the room where the lids are cut off of tight-head drums. This container held a pourable amount of viscous material that had accumulated at the bottom of the container.
