RCRA FOCUSED COMPLIANCE INSPECTION REPORT

FACILITY NAME:	**MID AMERICA IBC**
FACILITY U.S. EPA ID NO.:	None
FACILITY TYPE:	Non-Notifier
FACILITY ADDRESS:	2300 West Cornell Street Milwaukee, Wisconsin 53209
U.S. EPA REPRESENTATIVE:	Walt Francis
DATE OF INSPECTION:	February 24, 2017
NAICS CODE:	332439 – Other Metal Container Manufacturing

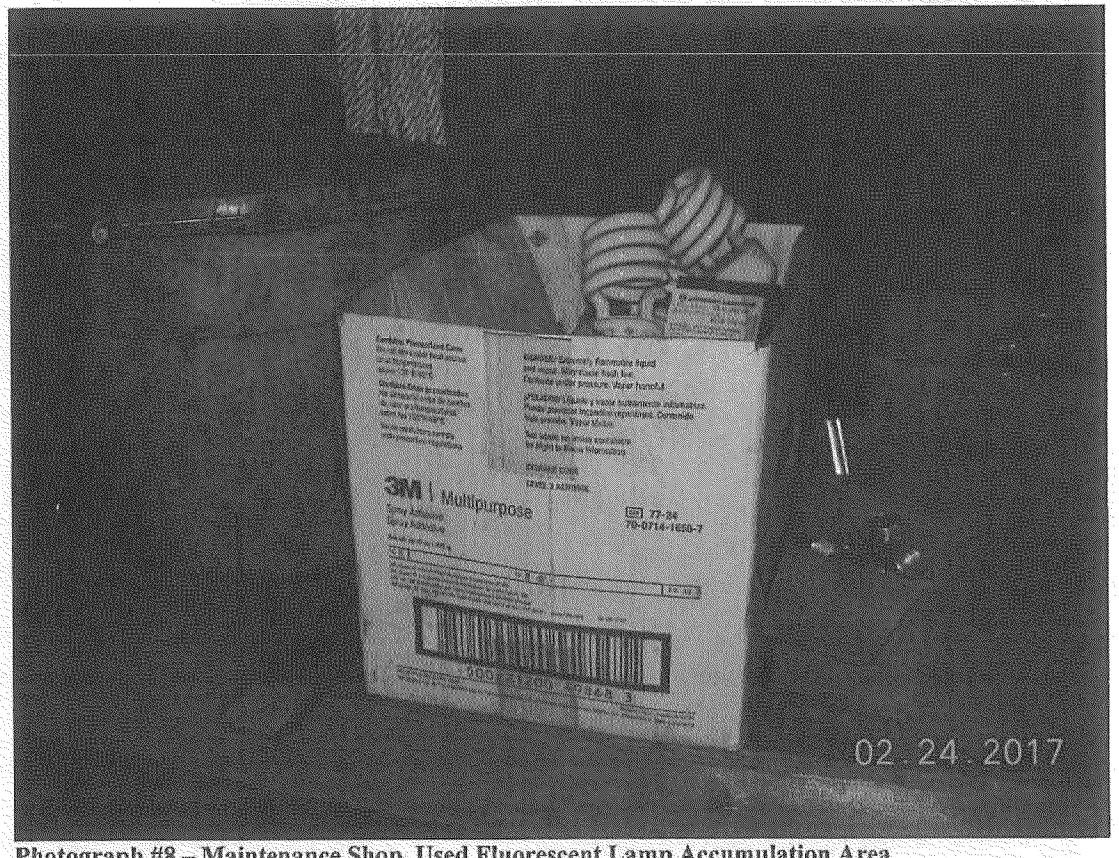
Photograph #8 – Maintenance Shop, Used Fluorescent Lamp Accumulation Area

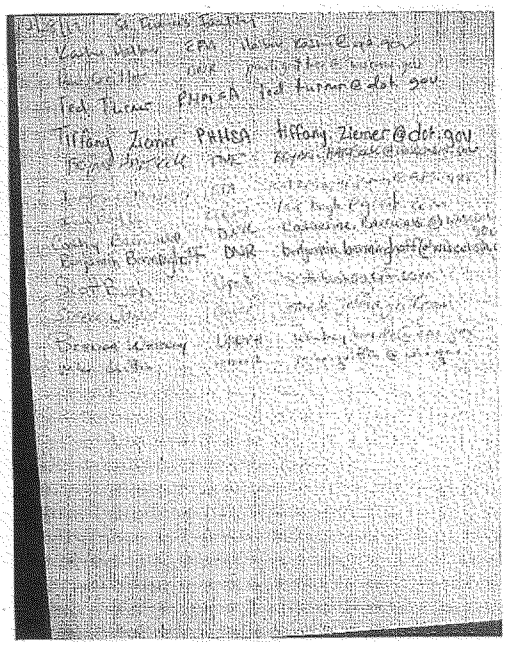
Photograph 1

Initial photograph of sign-in sheet for the inspection.

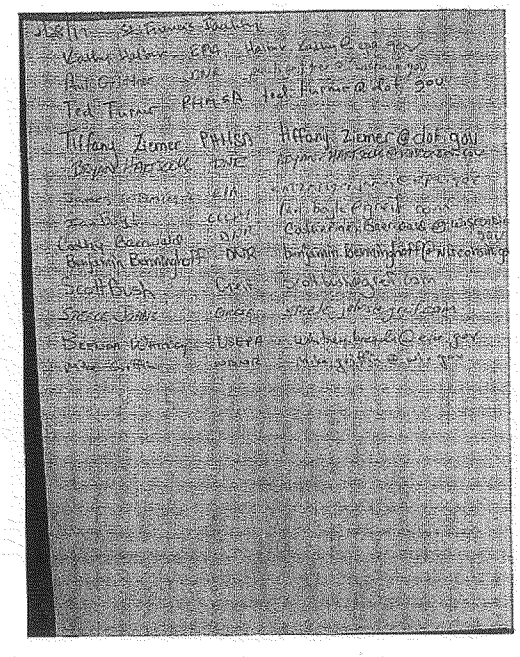
Photograph 2

Duplicate of Photograph 1.

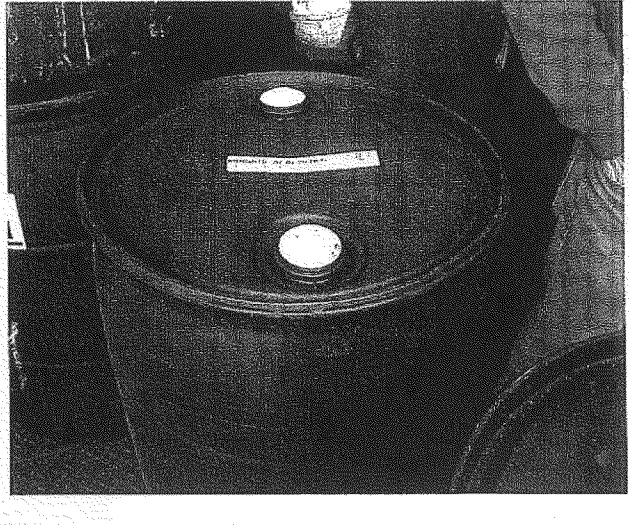
Photograph 6

This 55-gallon drum was staged on the truck dock. Visible fumes were emanating from the bung cap. The drum had contained acid. According to Mr. Furgason, the bung cap had not been fastened tightly, and most likely some acid on the cap was reacting to moisture in the air.
