RCRA FOCUSED COMPLIANCE INSPECTION REPORT

FACILITY NAME:	**MID AMERICA IBC**
FACILITY U.S. EPA ID NO.:	None
FACILITY TYPE:	Non-Notifier
FACILITY ADDRESS:	2300 West Cornell Street Milwaukee, Wisconsin 53209
U.S. EPA REPRESENTATIVE:	Walt Francis
DATE OF INSPECTION:	February 24, 2017
NAICS CODE:	332439 – Other Metal Container Manufacturing

An unannounced Compliance Evaluation Inspection (CEI) at Mid-America Steel Drum located at 3950 South Pennsylvania Avenue in St. Francis, Wisconsin ("MASD-SF" or "Facility"), took place on February 28, 2017. This CEI was conducted in cooperation with the Wisconsin Department of Natural Resources (WDNR) and the Pipeline and Hazardous Materials Safety Administration (PHMSA). This joint effort was made in response to a whistle-blower complaint published in articles in the Milwaukee Journal Sentinel in February, 2017, and in response to letters of concern from Wisconsin politicians.

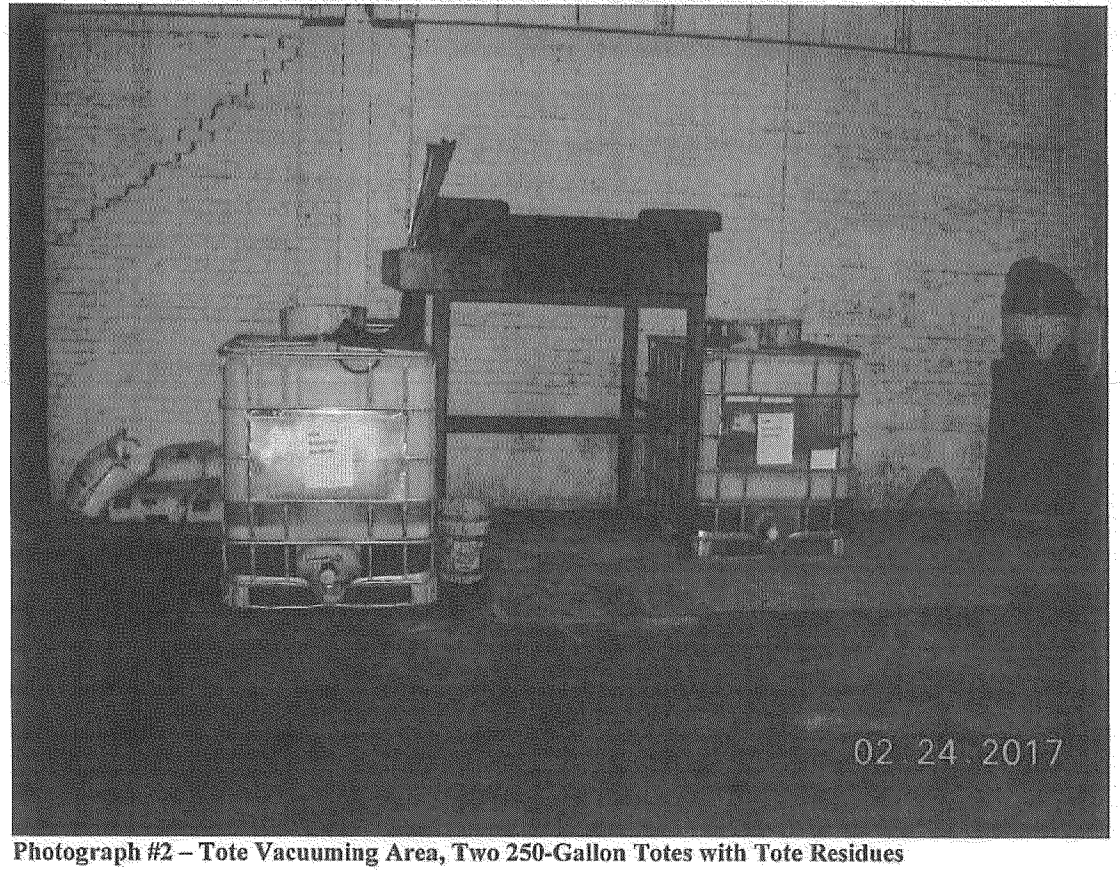
Photograph #2 – Tote Vacuuming Area, Two 250-Gallon Totes with Tote Residues
