RCRA FOCUSED COMPLIANCE INSPECTION REPORT

FACILITY NAME:	**MID AMERICA IBC**
FACILITY U.S. EPA ID NO.:	None
FACILITY TYPE:	Non-Notifier
FACILITY ADDRESS:	2300 West Cornell Street Milwaukee, Wisconsin 53209
U.S. EPA REPRESENTATIVE:	Walt Francis
DATE OF INSPECTION:	February 24, 2017
NAICS CODE:	332439 – Other Metal Container Manufacturing

An unannounced Compliance Evaluation Inspection (CEI) at Mid-America Steel Drum located at 3950 South Pennsylvania Avenue in St. Francis, Wisconsin ("MASD-SF" or "Facility"), took place on February 28, 2017. This CEI was conducted in cooperation with the Wisconsin Department of Natural Resources (WDNR) and the Pipeline and Hazardous Materials Safety Administration (PHMSA). This joint effort was made in response to a whistle-blower complaint published in articles in the Milwaukee Journal Sentinel in February, 2017, and in response to letters of concern from Wisconsin politicians.

An unannounced Compliance Evaluation Inspection (CEI) at Mid-America Steel Drum located at 8570 South Chicago Road in Oak Creek, Wisconsin ("MASD-OC" or "Facility"), took place on March 2, 2017. This CEI was conducted in cooperation with the Wisconsin Department of Natura

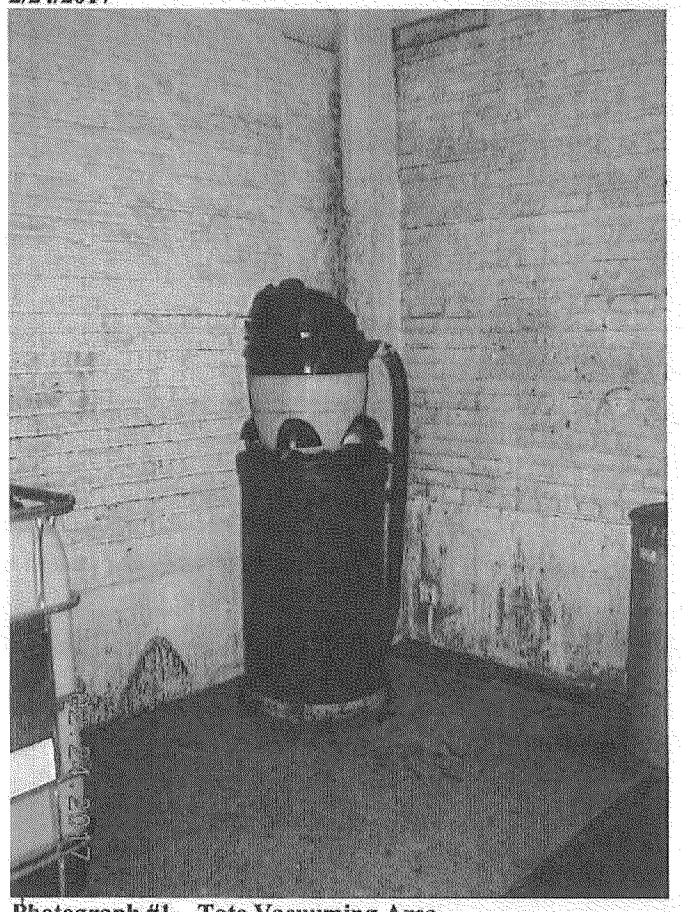
Photograph #1 – Tote Vacuuming Area

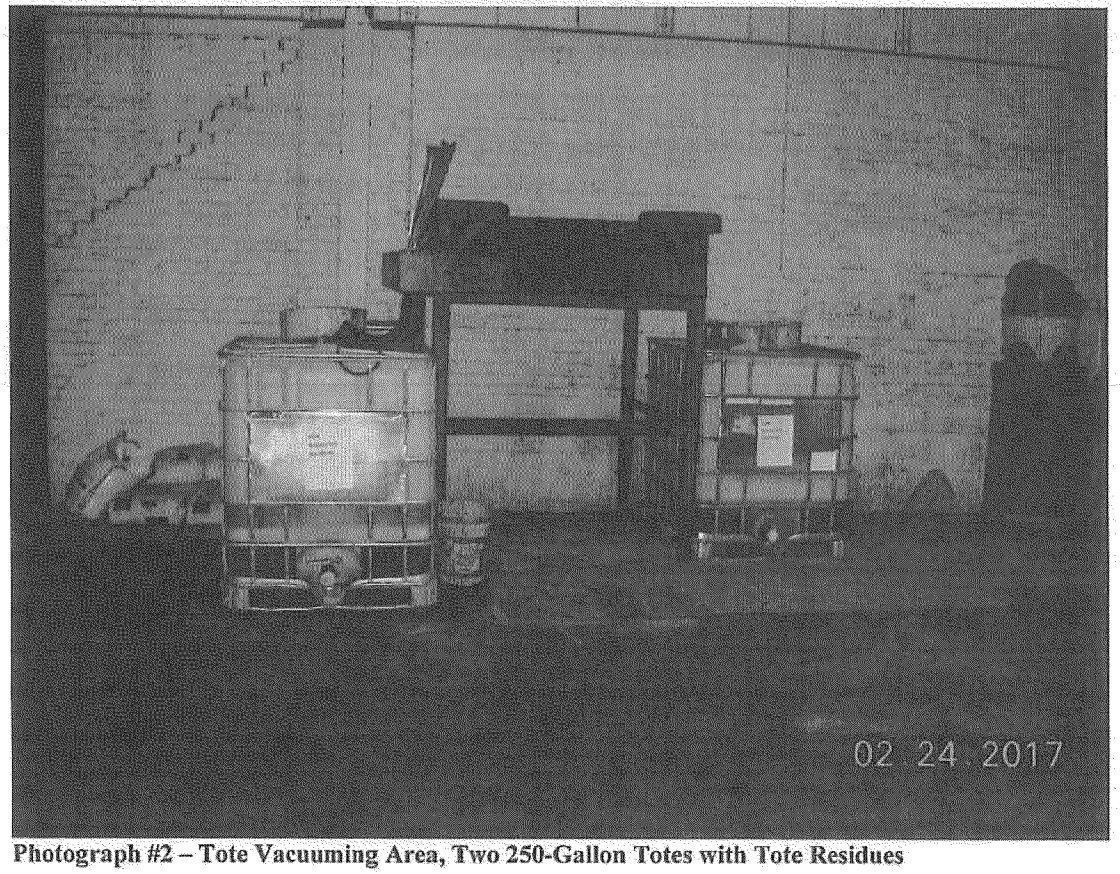
Photograph #2 – Tote Vacuuming Area, Two 250-Gallon Totes with Tote Residues

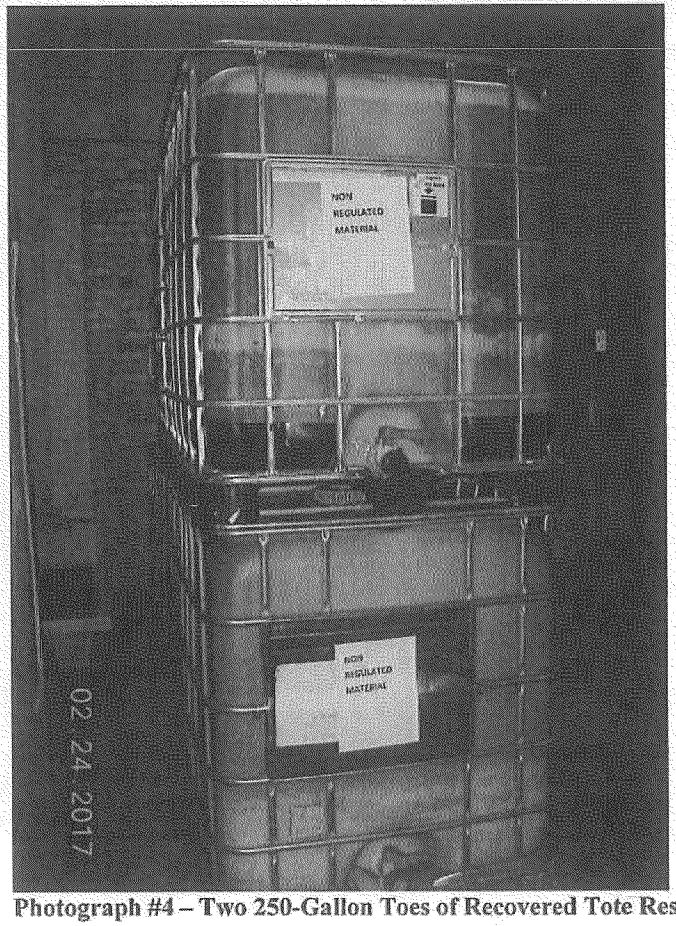
Photograph #4 – Two 250-Gallon Toes of Recovered Tote Residue

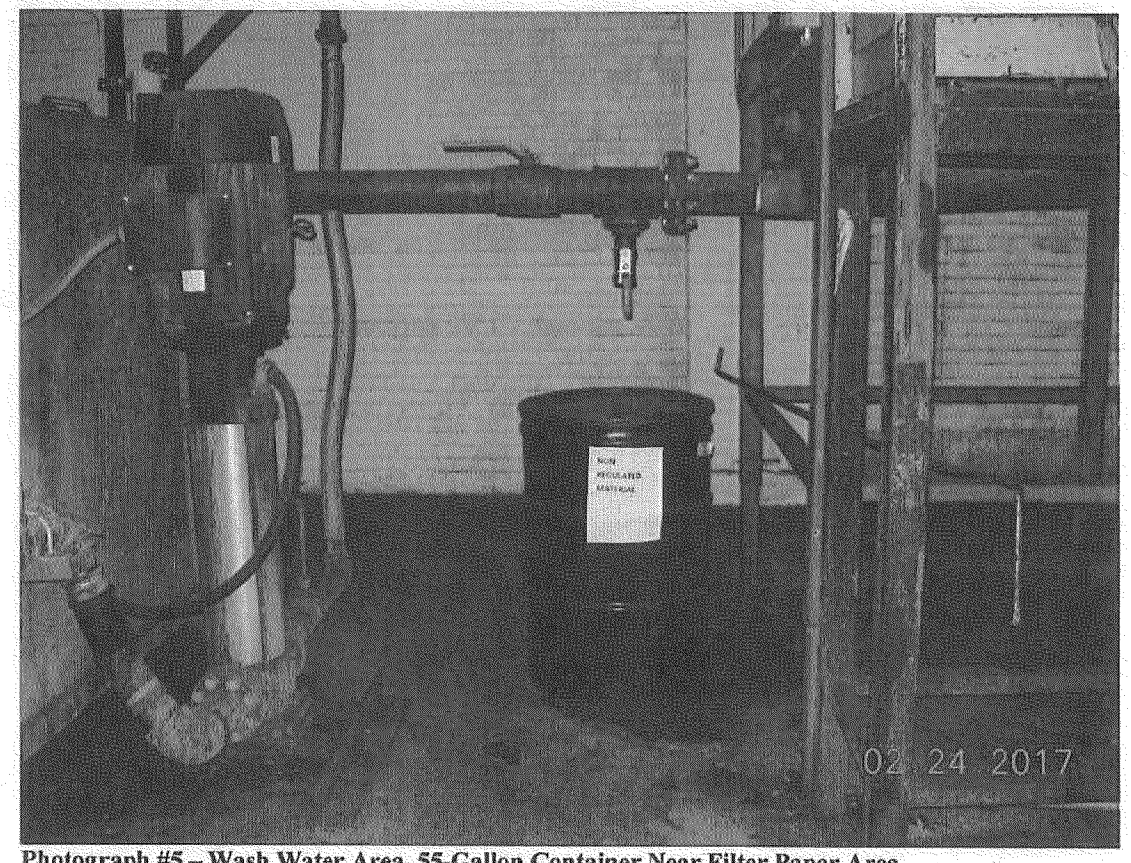
Photograph #5 – Wash Water Area, 55-Gallon Container Near Filter Paper Area

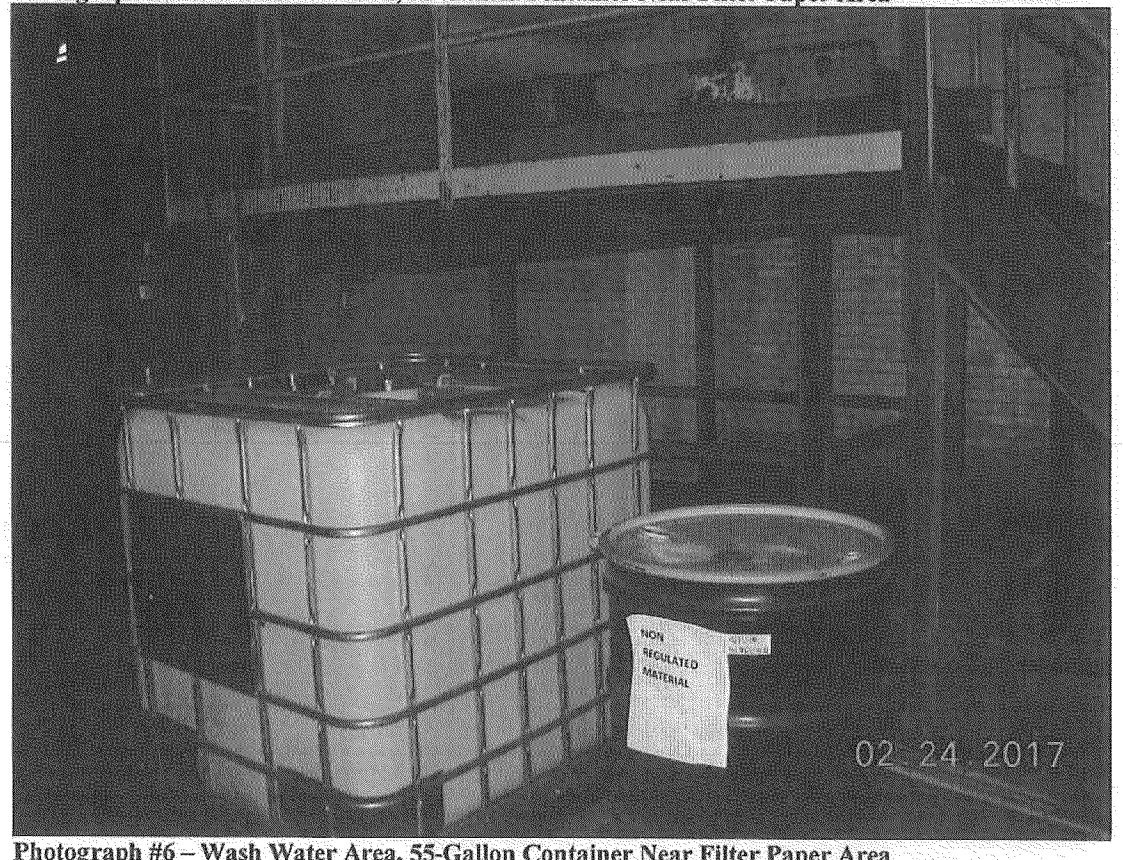
Photograph #6 – Wash Water Area, 55-Gallon Container Near Filter Paper Area

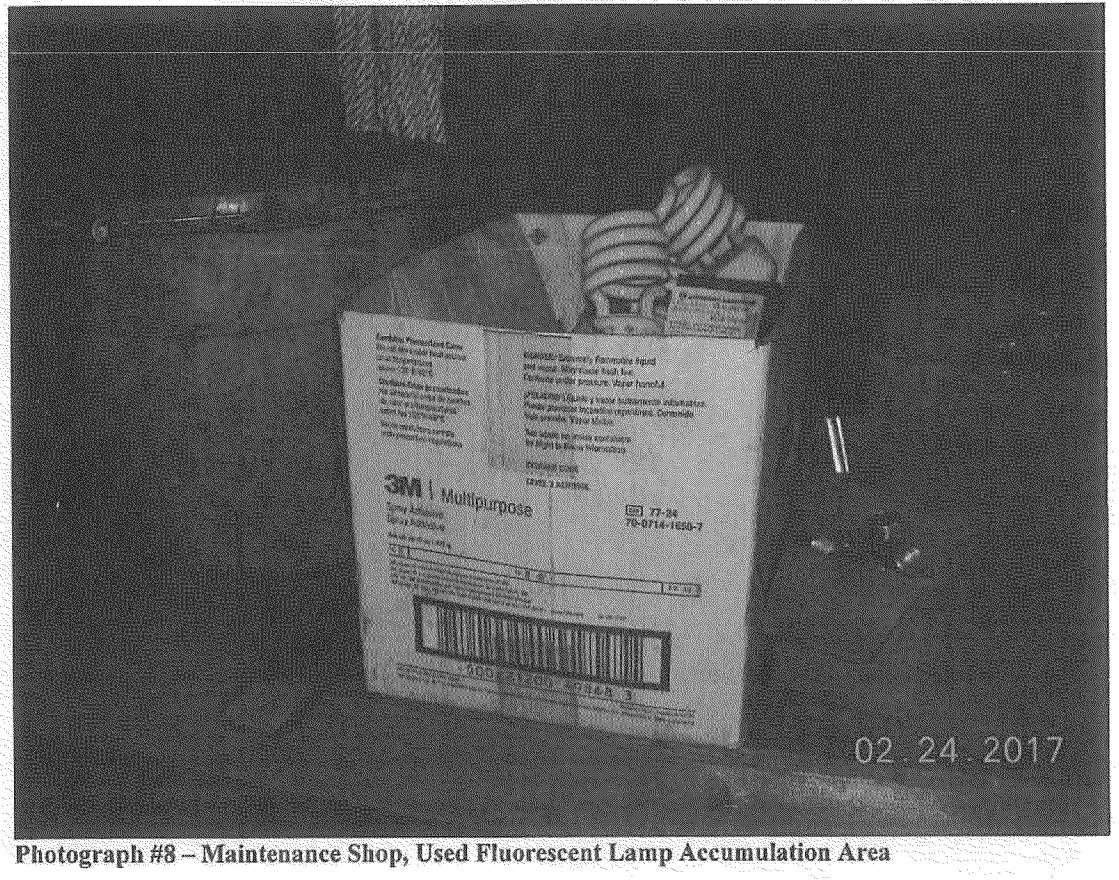
Photograph #8 – Maintenance Shop, Used Fluorescent Lamp Accumulation Area

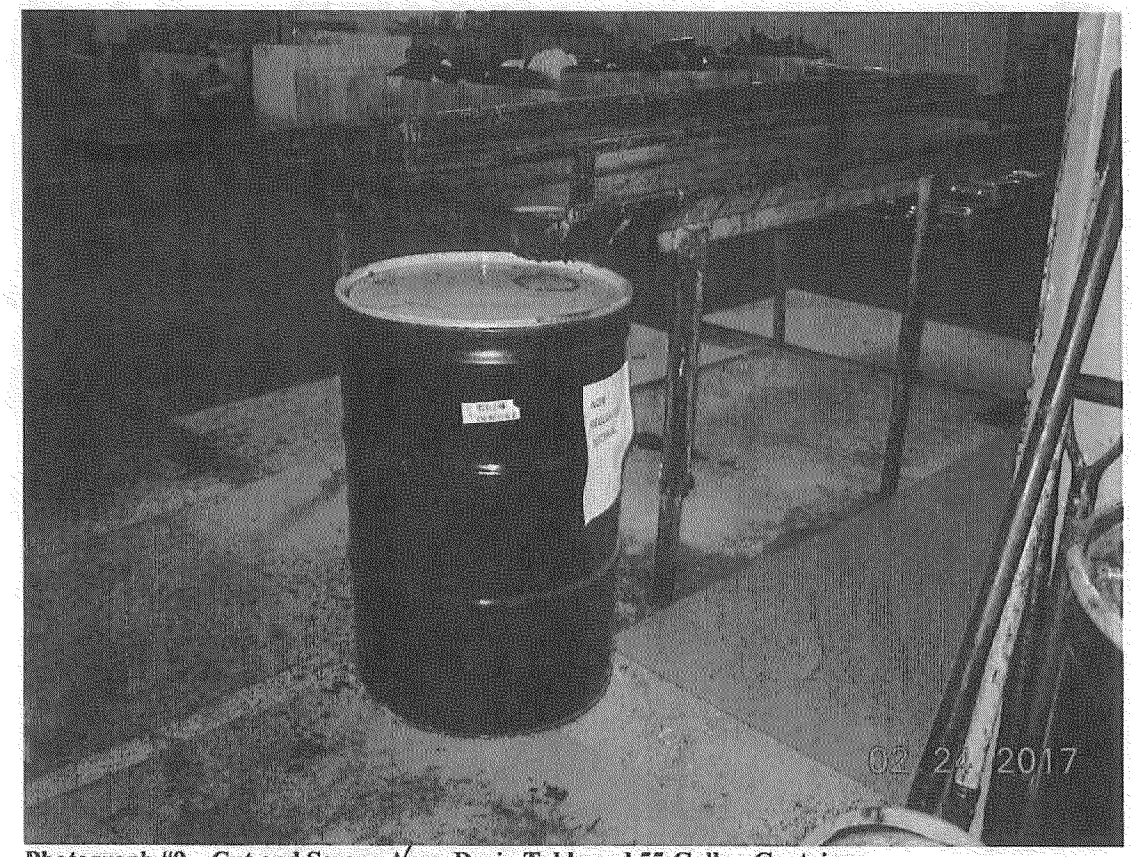
Photograph #9 – Cut and Scrape Area, Drain Table and 55-Gallon Container

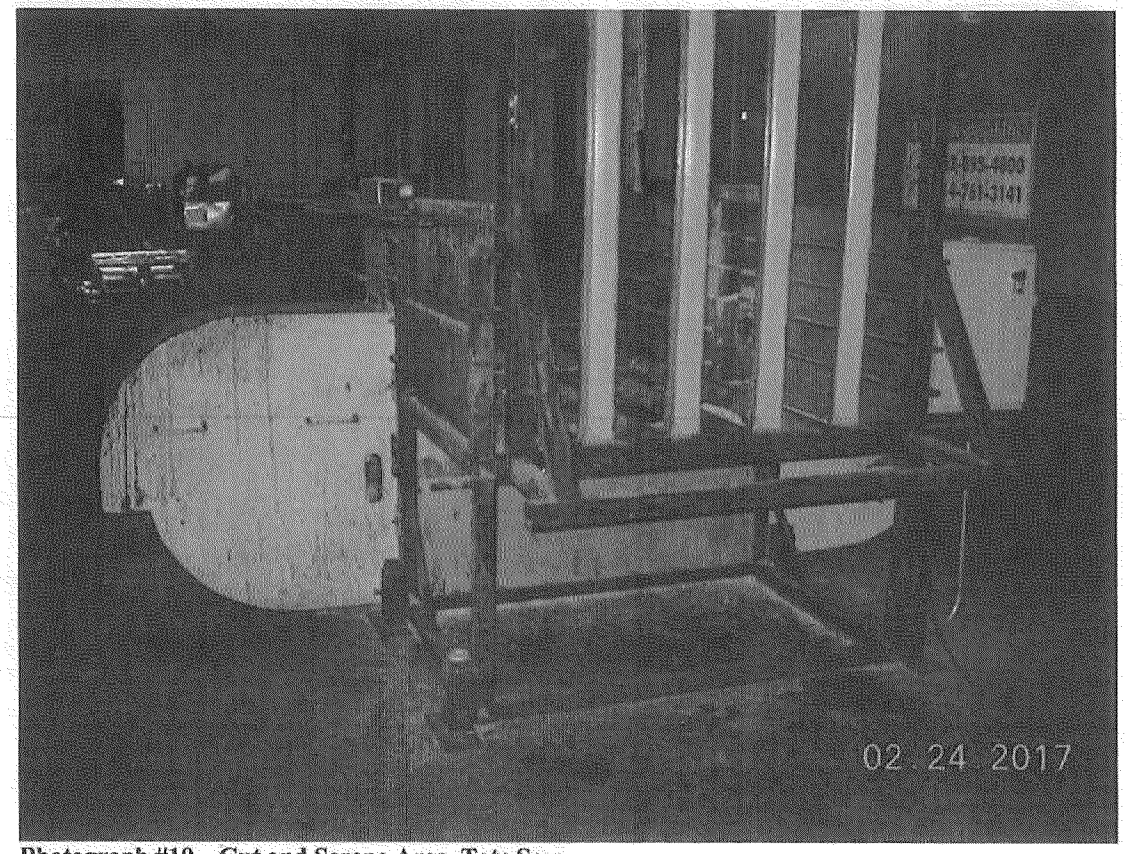
Photograph #10 – Cut and Scrape Area, Tote Saw

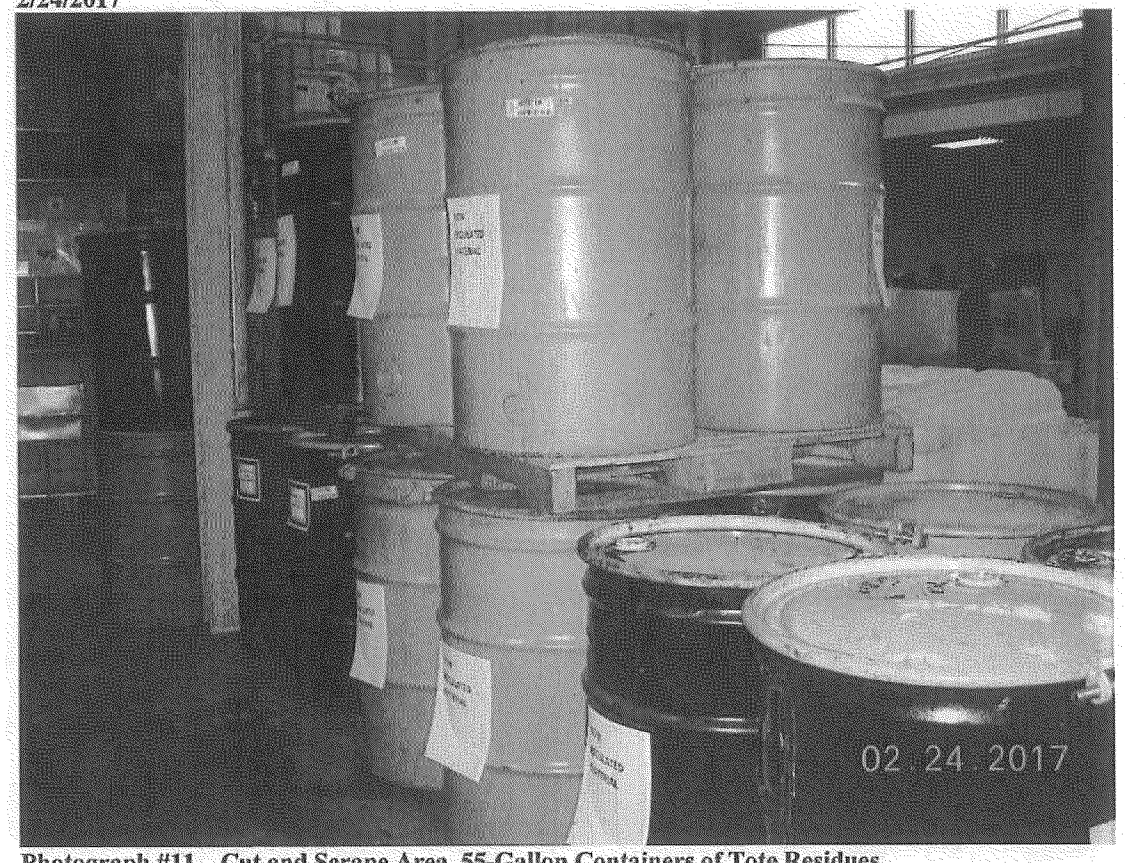
Photograph #11 – Cut and Scrape Area, 55-Gallon Containers of Tote Residues

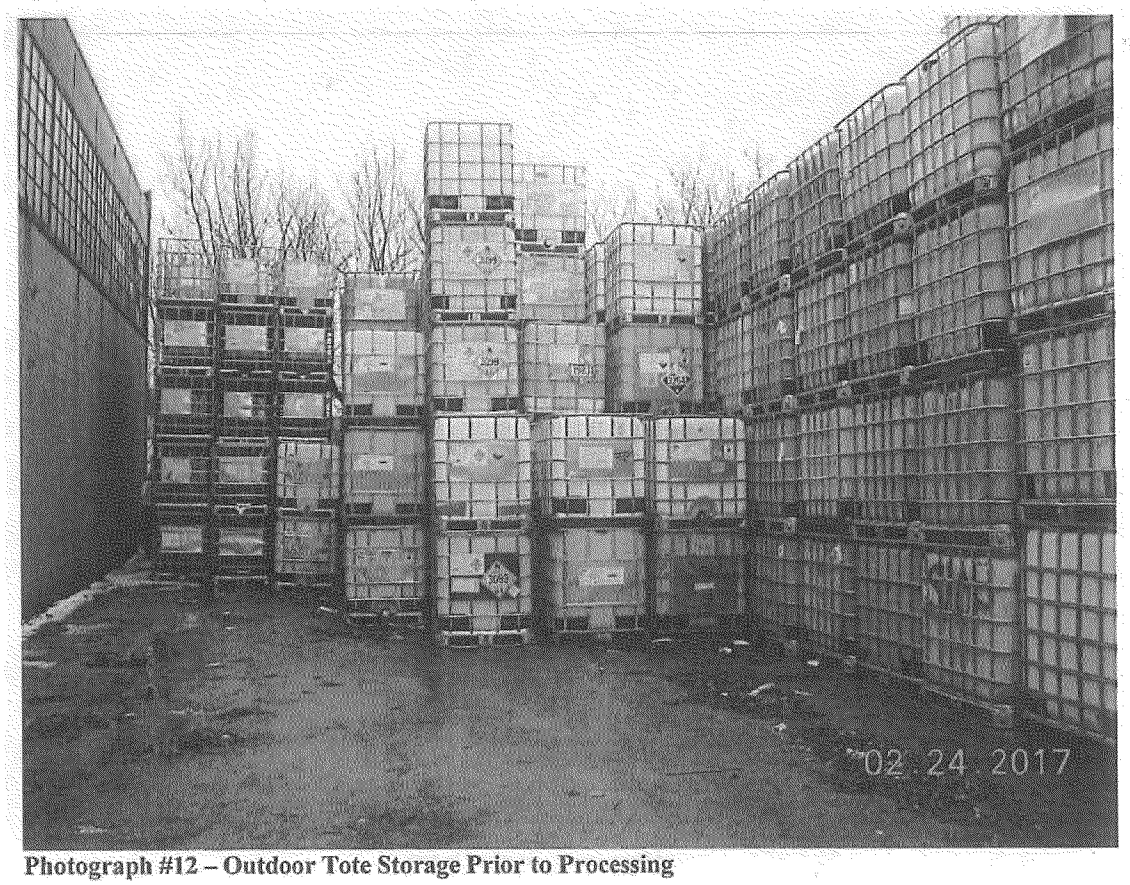
Photograph #12 – Outdoor Tote Storage Prior to Processing

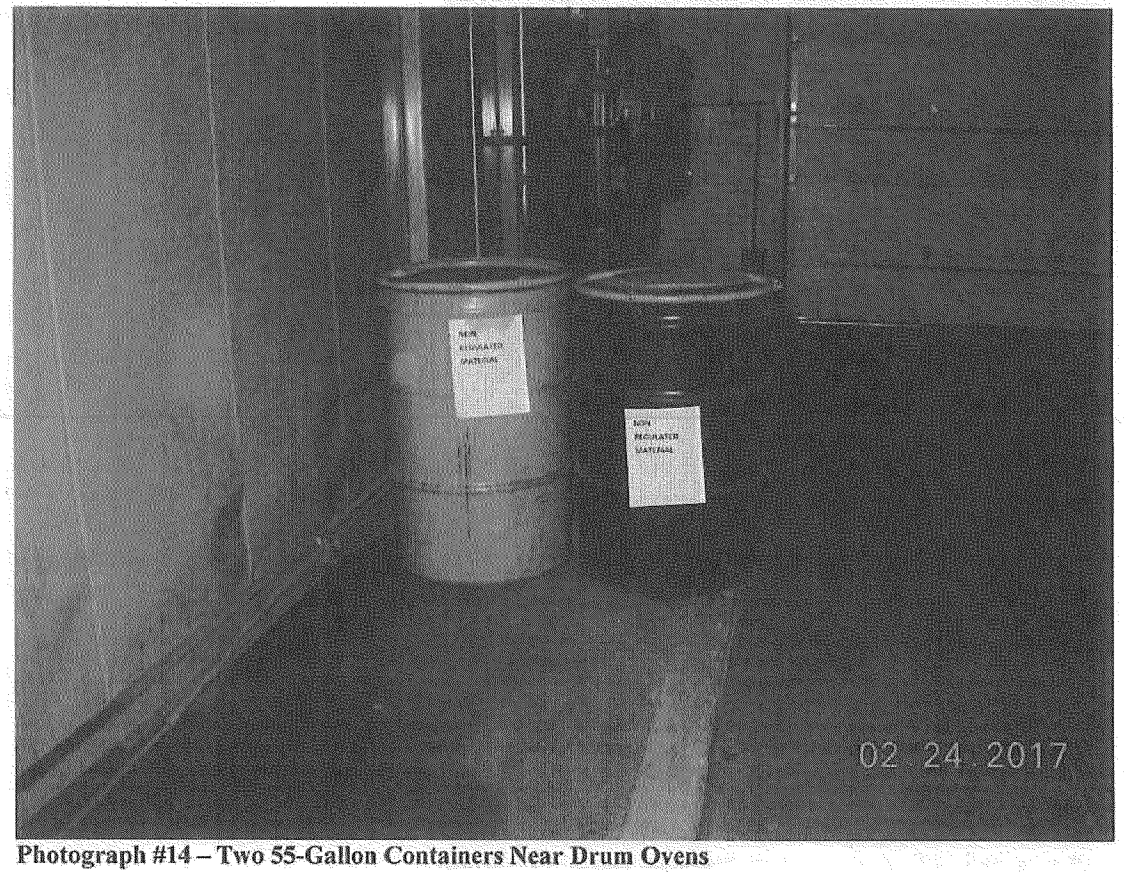
Photograph #14 – Two 55-Gallon Containers Near Drum Ovens

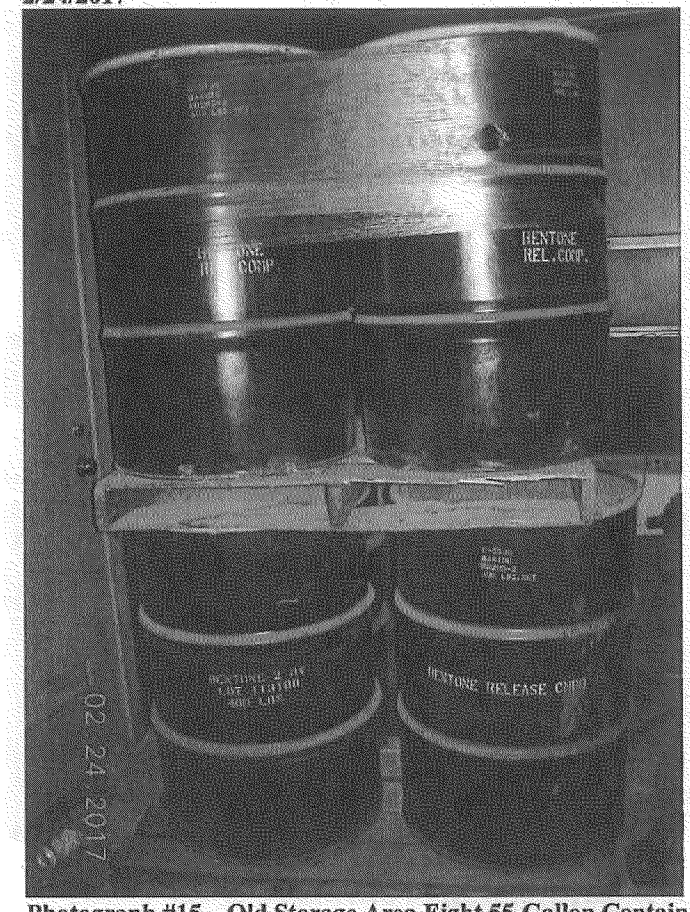
Photograph #15 – Old Storage Area Eight 55-Gallon Containers

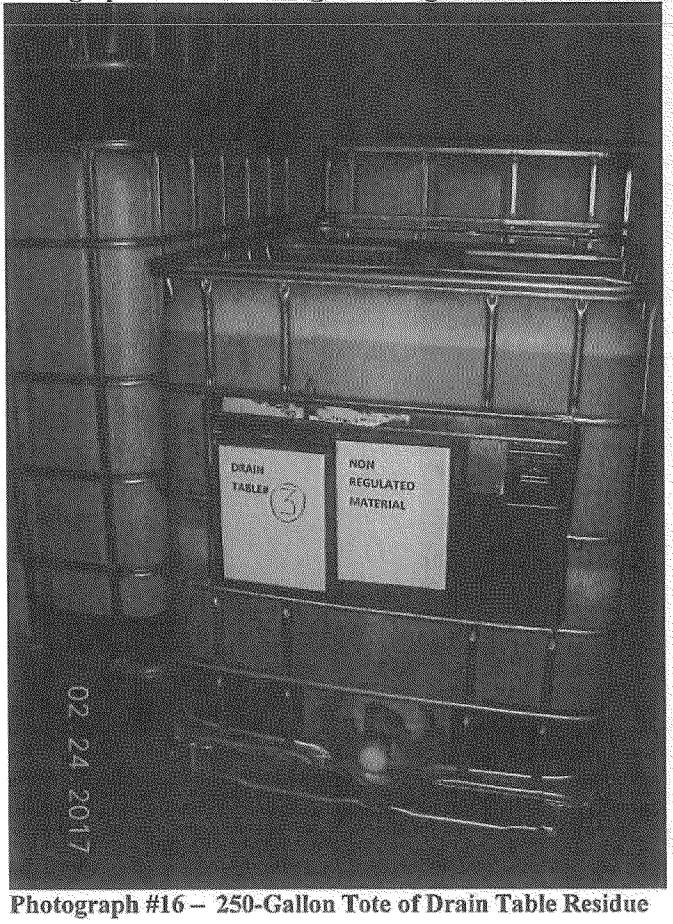
Photograph #16 – 250-Gallon Tote of Drain Table Residue

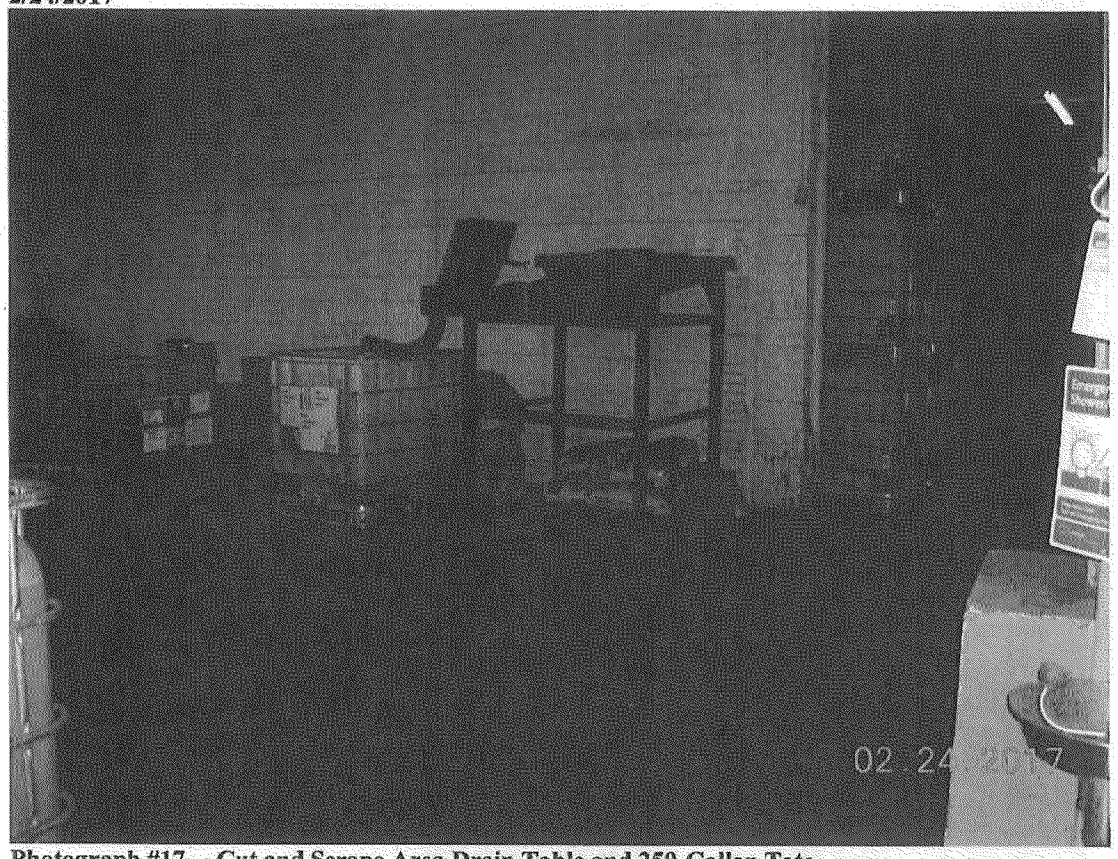
Photograph #17 – Cut and Scrape Area Drain Table and 250-Gallon Tote

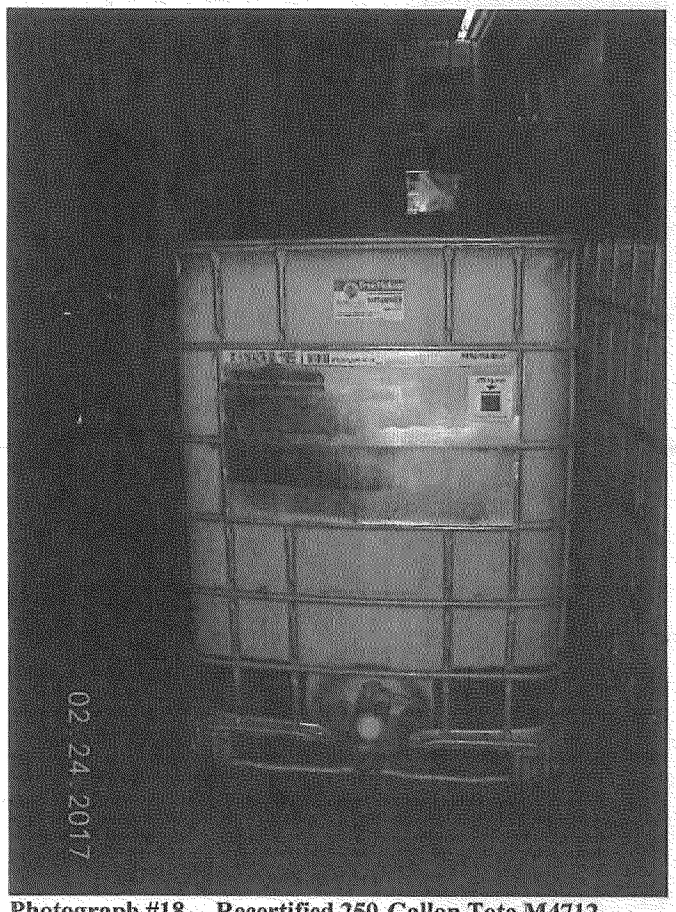
Photograph #18 – Recertified 250-Gallon Tote M4712

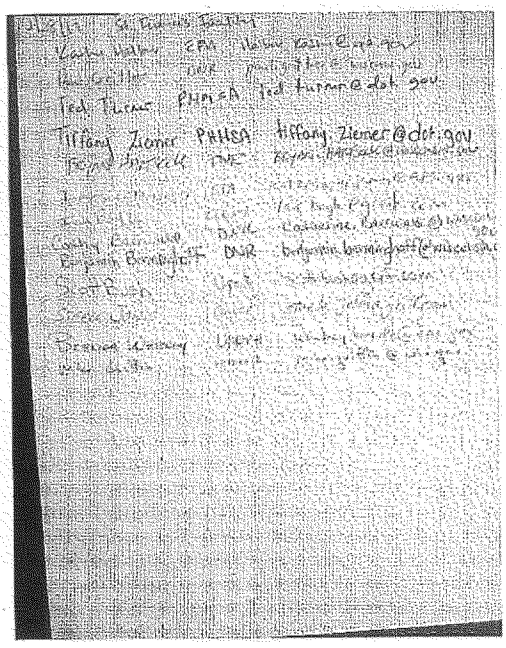
Photograph 1

Initial photograph of sign-in sheet for the inspection.

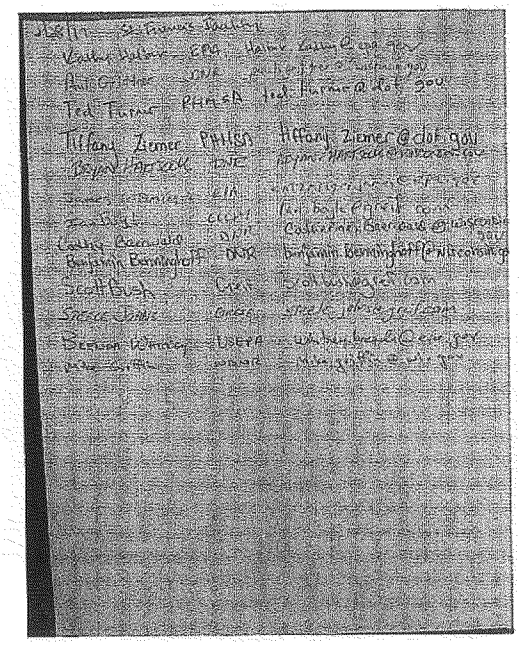
Photograph 2

Duplicate of Photograph 1.

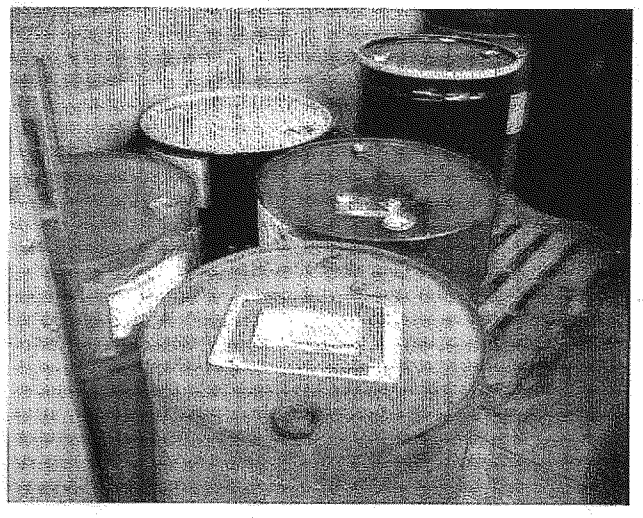
Photograph 3

Heavies are segregated off to the side of the dock. Five heavy drums were in storage at the time of the inspection. The drums maintained their original labels and had not been opened or modified by MASD-SF. The drums were not marked with dates of receipt. Tractor trailers at the dock were opened so that we could see their contents. One of the trailers held bags of metasilicate pentahydrate which is a drum conditioner formerly used at the site for rust-preventions. Mr. Furgason stated that this material was still product. Another trailer of "non-cleanable" plastic drums was to be shredded. Mr. Furgason did not elaborate on the definition of "non-cleanable."

Five 55-gallon drums in various conditions were set aside on the truck dock as "Heavies." These containers were not marked with individual labels indicating that they were to be returned to the vendor. However, they were in an area that was demarked for Heavies.

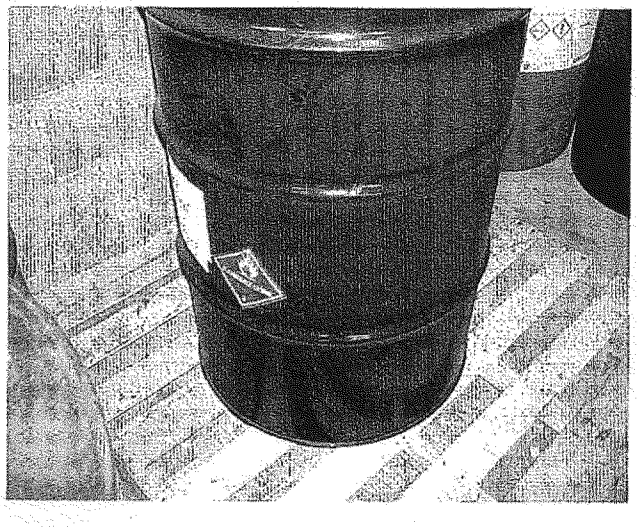
Photograph 4

One of the Heavy containers had a "Flammable Liquid" label. This particular container had a seal around the bung clasp indicating that it was a product that had never been used.

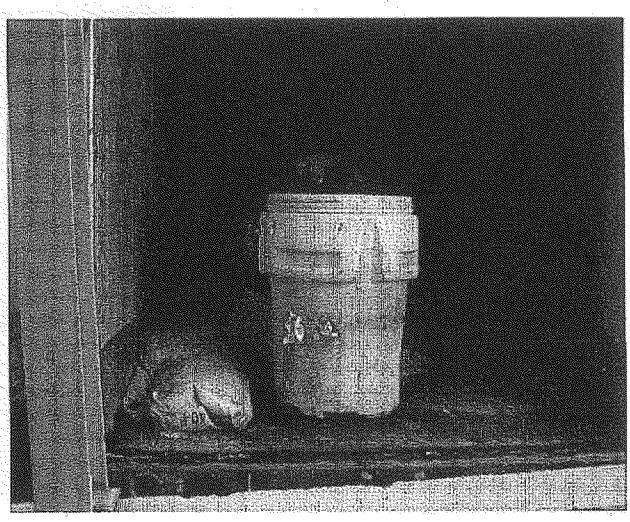
A trailer backed up to the dock contained a pallet of Metasilicate Pentahydrate. According to Mr. Furgason, this material is used as a rust inhibiting drum conditioner.

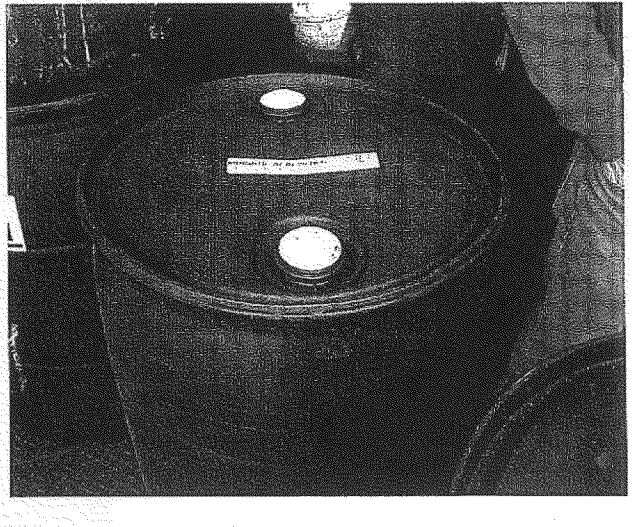
Photograph 6

This 55-gallon drum was staged on the truck dock. Visible fumes were emanating from the bung cap. The drum had contained acid. According to Mr. Furgason, the bung cap had not been fastened tightly, and most likely some acid on the cap was reacting to moisture in the air.

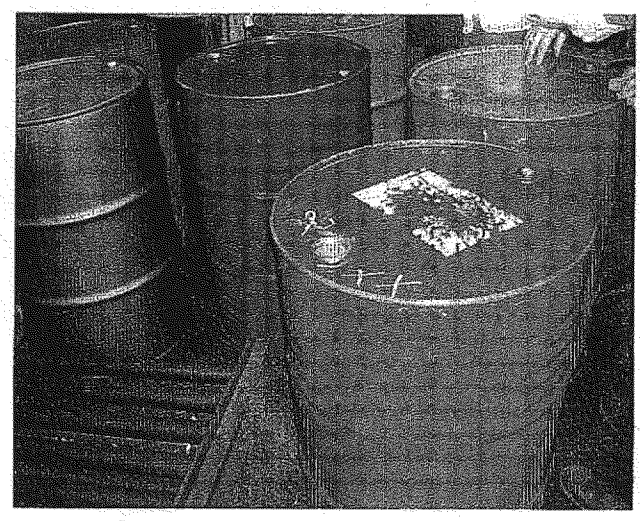
Photograph 7

The drums proceeded to rust inspection. The rusty drums are processed through the muriatic acid wash. The acid is rinsed out of the drums with water from the first hot water tank. I observed some drums that had been removed from the acid wash operation that were fuming out of the open bung rings. These containers were contaminated with VOCs as indicated by odors and by readings on the Multi-RAE. Also, acid in contact with moisture, as with the drums observed on the dock, will fume. The drums were otherwise empty.

Each of the drums in this photograph had been processed through an acid wash and hot water rinse to remove rust. The two red 55-gallon drums in the forefront of this photograph were fuming. The white fumes can be seen in the bung hole of the foremost drum. These containers smelled strongly of organics though they were empty.

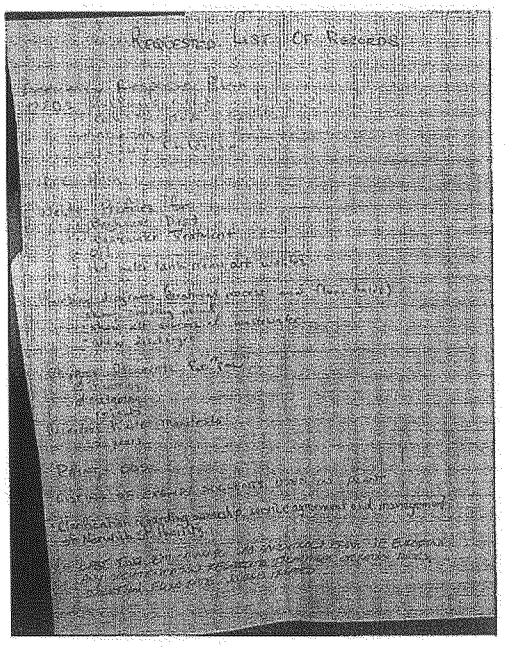
Photograph 10

This photograph is of the "Requested List of Records" that was provided to Facility counsel at the close-out meeting.

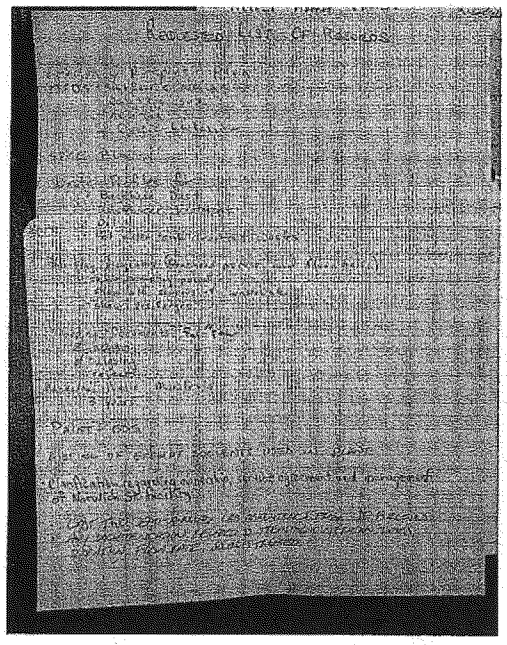
Photograph 11

Duplicate of Photograph 10.

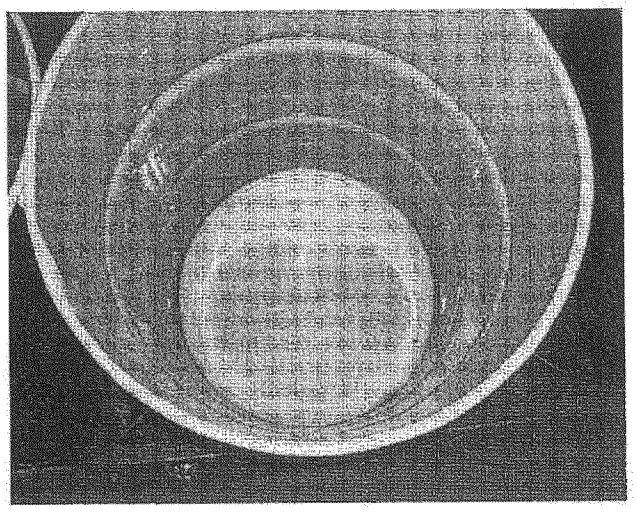
This photograph was taken in the room where the lids are cut off of tight-head drums. This container held a pourable amount of viscous material that had accumulated at the bottom of the container.
