U.S. ENVIRONMENTAL PROTECTION AGENCY
Region 5, Land and Chemicals Division
RCRA Branch, LR-8J
77 West Jackson Boulevard
Chicago, Illinois 60604

FOCUSED COMPLIANCE INSPECTION REPORT

INSPECTION DATE:	July 17, 2017
SITE NAME:	Container Life Cycle Management, LLC d/b/a Mid-America Steel Drum, Inc.
ADDRESS:	3950 South Pennsylvania Avenue St. Francis, Wisconsin 53235
EPA ID NUMBER:	WIR 000 131 367
RCRA STATUS:	Small Quantity Generator (2017)
NAICS CODE:	332439 Other Metal Container Manufacturing
FACILITY CONTACT:	Mark Furgason Plant Manager
EPA CONTACT:	Brian Kennedy Environmental Engineer Compliance Section 2 RCRA Branch Land and Chemicals Division

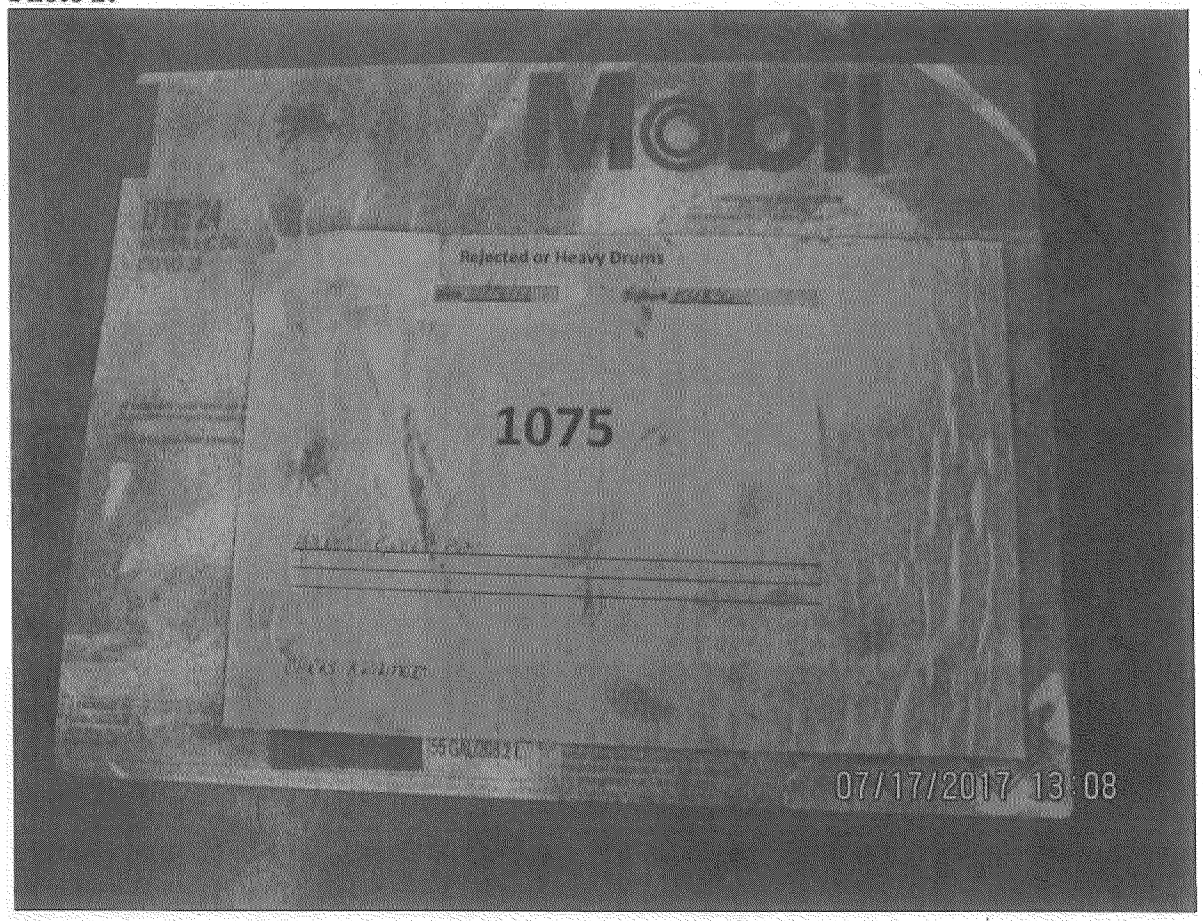
Photo 2:

Inspector Whitney and I proceeded to the "heavies" storage area where MASD segregates incoming drums that "feel" heavy because of liquid inside the drum. There were approximately 60 drums in the heavies area, each with a neon yellow reject label on the lid (See Photo 1 in the Inspection Photographs attachment). The labels stated "Rejected or Heavy Drum" and were marked with a tracking number and the customer that sent the drum. The vast majority of these labels had no date. For those labels with a date, the earliest observed was April 17, 2017 (Photo 2).

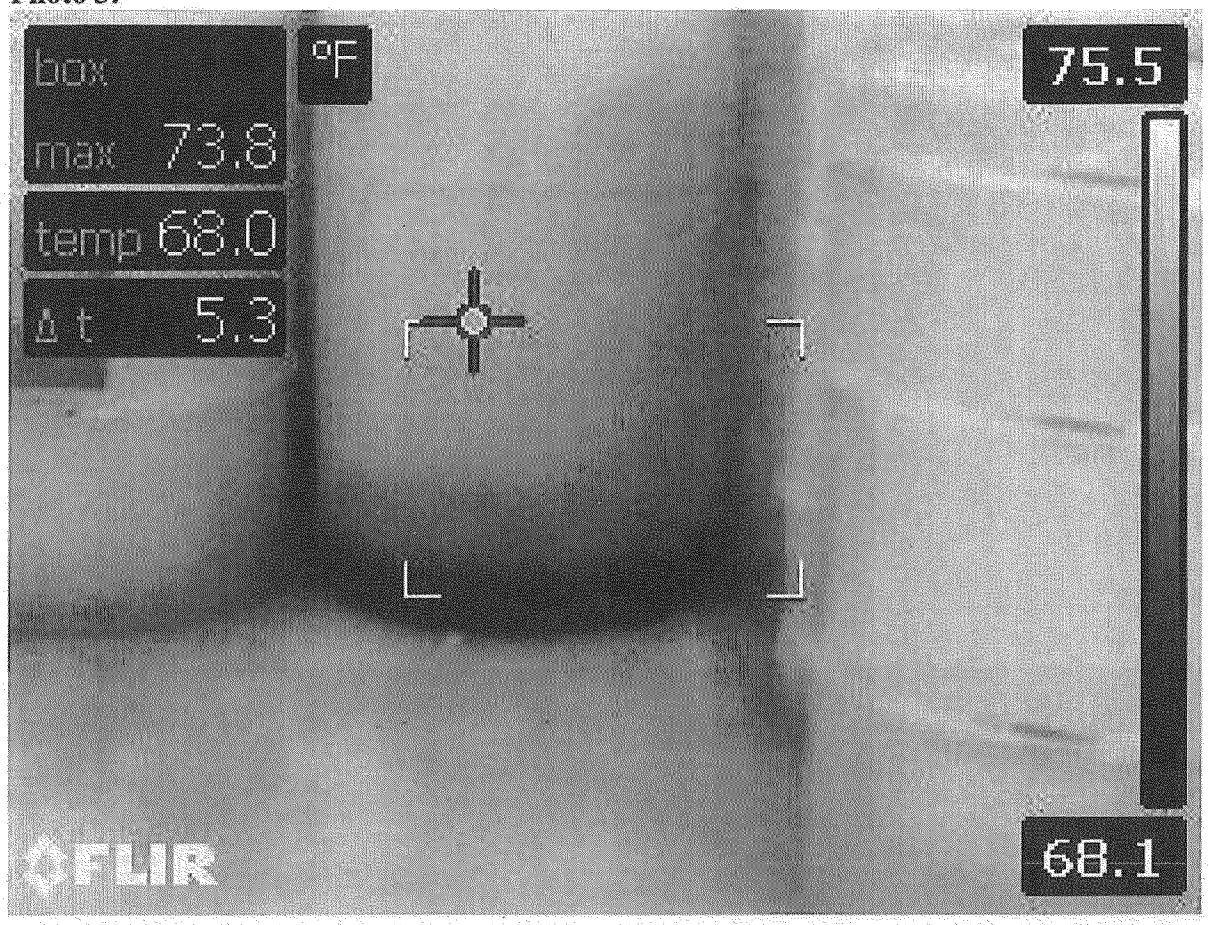
Photo 3:

Inspector Whitney attempted to use the FLIR camera to observe liquids inside the heavy drums. On a high contrast setting ("white hot"), the FLIR camera was able to image the liquid level inside at least one steel drum (Photo 3). It was confirmed that the FLIR camera was imaging the liquid inside the drum by tilting and holding the drum at an angle and observing the resultant contrast change along the lower drum wall. It appeared the FLIR camera was able to image the liquid level inside plastic "poly" drums, but the contrast was less clear (Photo 4). The highest mercury vapor reading in the heavies dock was 300 nanograms per cubic meter, or approximately 0.04 parts per billion.

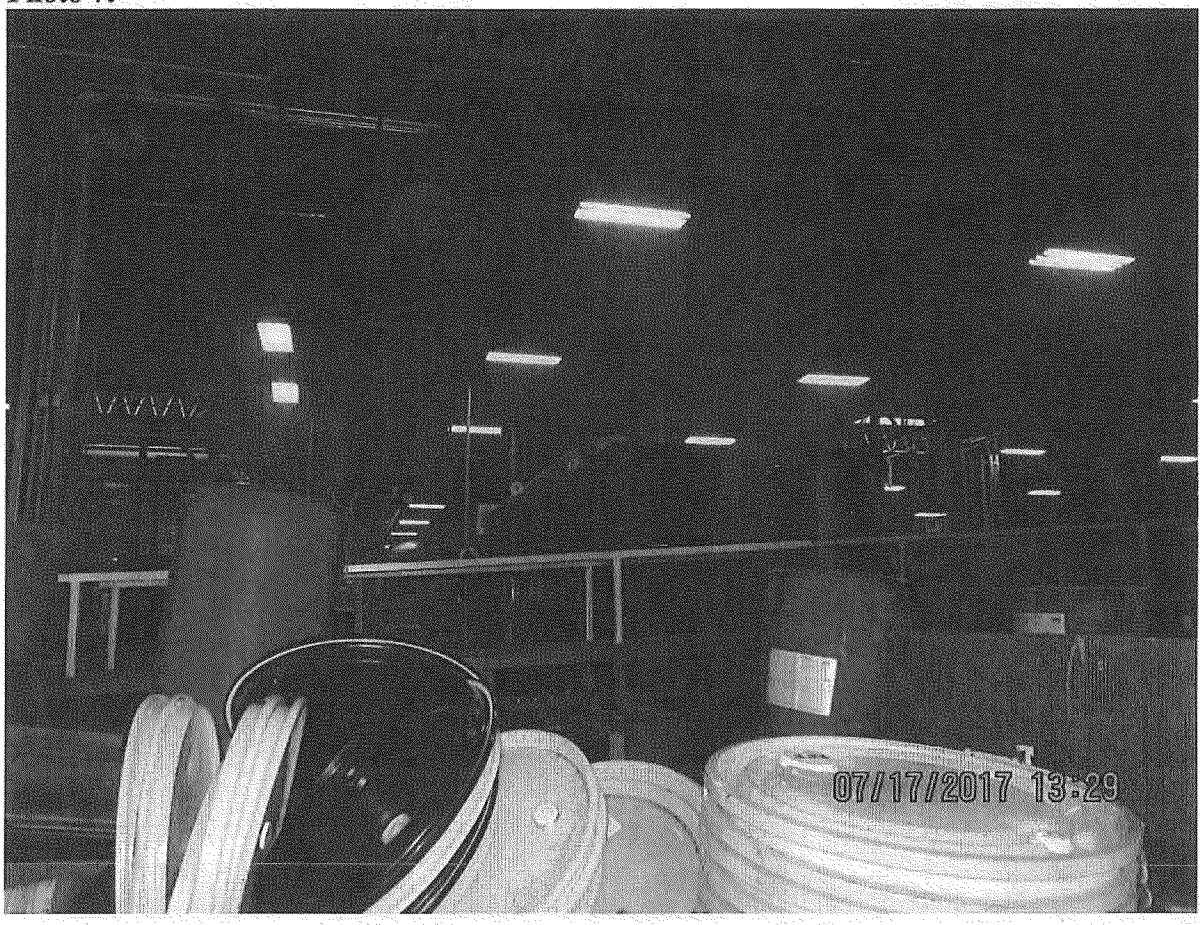
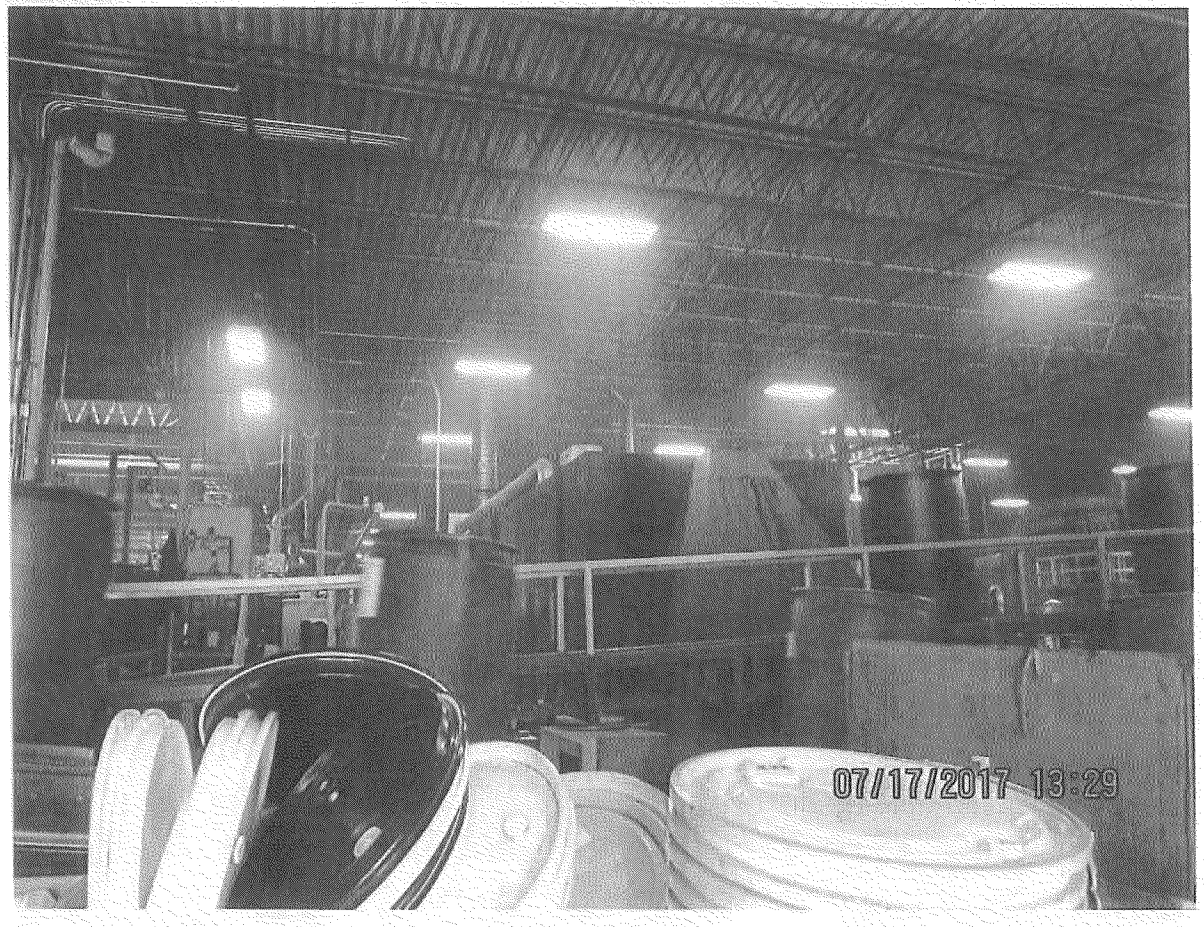
The tour proceeded back inside to MASD's poly drum processing area. Inspector Whitney, with Mr. Furgason, used the FLIR to observe poly drums being unloaded from trailers and placed on the processing line. Inspector Whitney did not observe images of liquid levels in these drums through the FLIR. I observed smoke exiting a process unit in this area. The smoke rose inside the

facility and contributed to a standing haze (Photos 7 and 8). Mr. Laabs explained that the unit was the bake oven for newly-painted steel drums, which cures the coating MASD applies to drums after they pass inspection. Smoke was emanating from the exit of the bake oven where steel drums exit on a conveyor line. I asked Mr. Laabs what the smoke could be and he speculated that it was a combination of combustion byproducts and paint particles. The smoke was white in color and looked similar to the smoke seen outside the facility on South Pennsylvania Avenue. A video of the smoke was taken using the digital camera (See video file MVI_0653.mov). Inspector Whitney imaged the smoke with the FLIR camera. It did not appear to have measurable volatiles content.

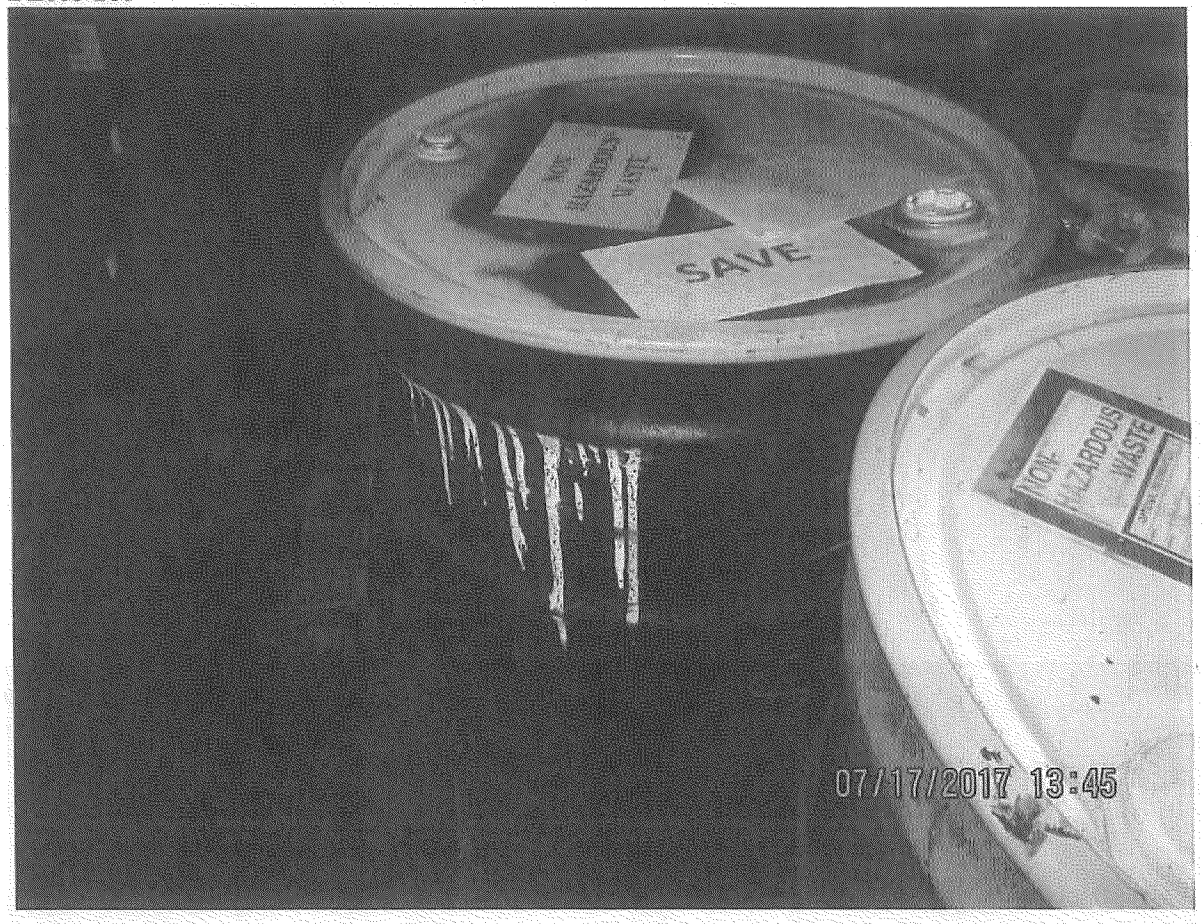
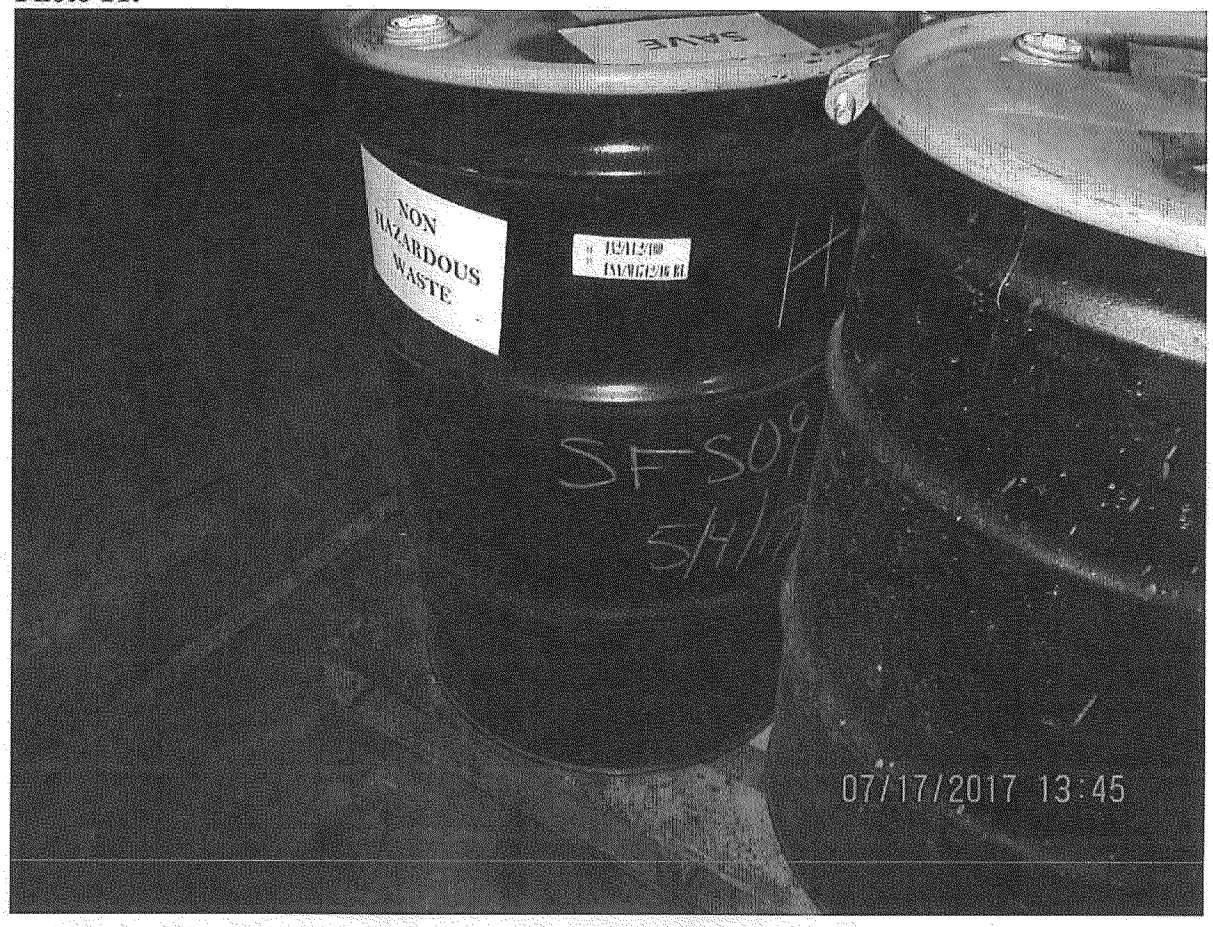
Continuing west near the wastewater treatment area, I observed two 55-gallon drums that were previously sampled by EPA during a site visit on May 4, 2017. The drum samples were "SFS08" and "SFS09." Both drums were marked as "Non Hazardous Waste" and "SAVE" (Photos 10 and 11). Near these two drums was another 55-gallon steel drum marked as "Non Hazardous Waste" that appeared to be leaking onto the ground (Photo 12). I attempted to screen the leak with pH indicator paper but the result was inconclusive (Photo 13).
