UNITED STATES ENVIRONMENTAL PROTECTION AGENCY
REGION 5
77 W. JACKSON BOULEVARD
CHICAGO, ILLINOIS 60604

RCRA FOCUSED COMPLIANCE INSPECTION REPORT

FACILITY NAME:	**MID AMERICA IBC**
FACILITY U.S. EPA ID NO.:	None
FACILITY TYPE:	Non-Notifier
FACILITY ADDRESS:	2300 West Cornell Street Milwaukee, Wisconsin 53209
U.S. EPA REPRESENTATIVE:	Walt Francis
DATE OF INSPECTION:	February 24, 2017
NAICS CODE:	332439 – Other Metal Container Manufacturing

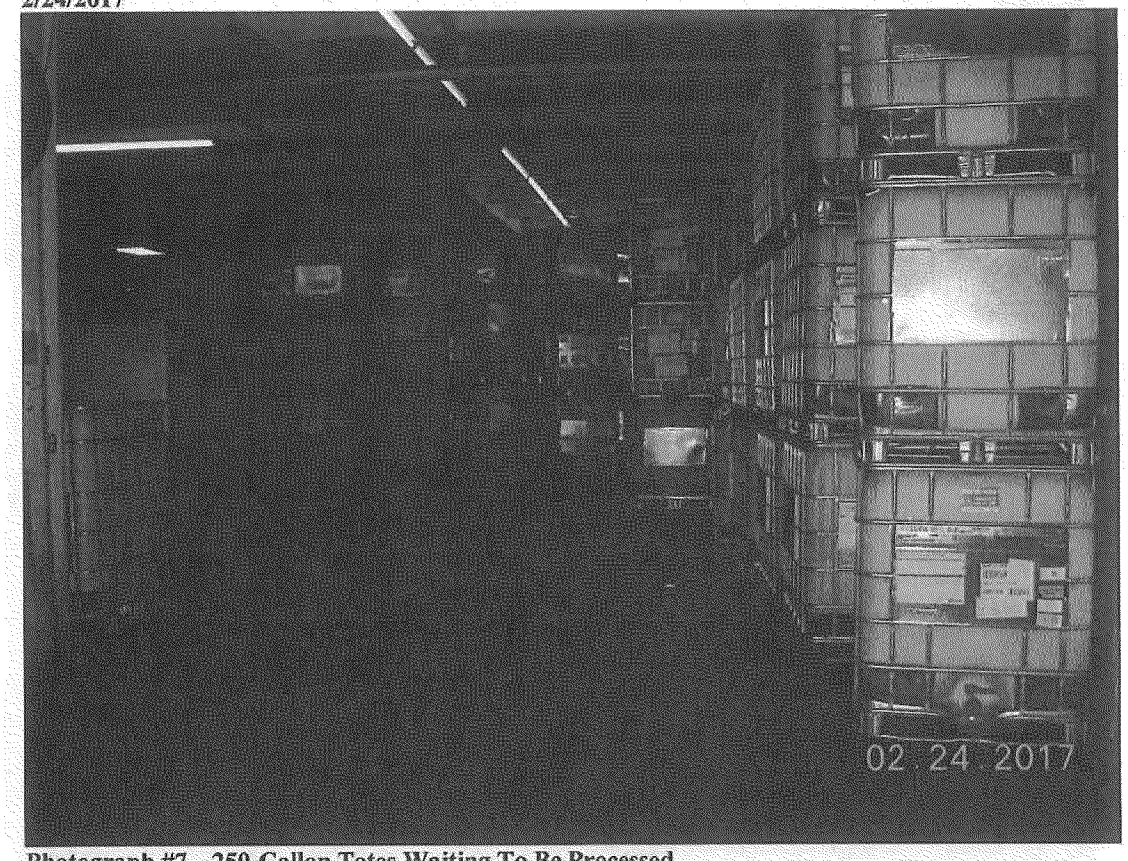
Photograph #7 – 250-Gallon Totes Waiting To Be Processed

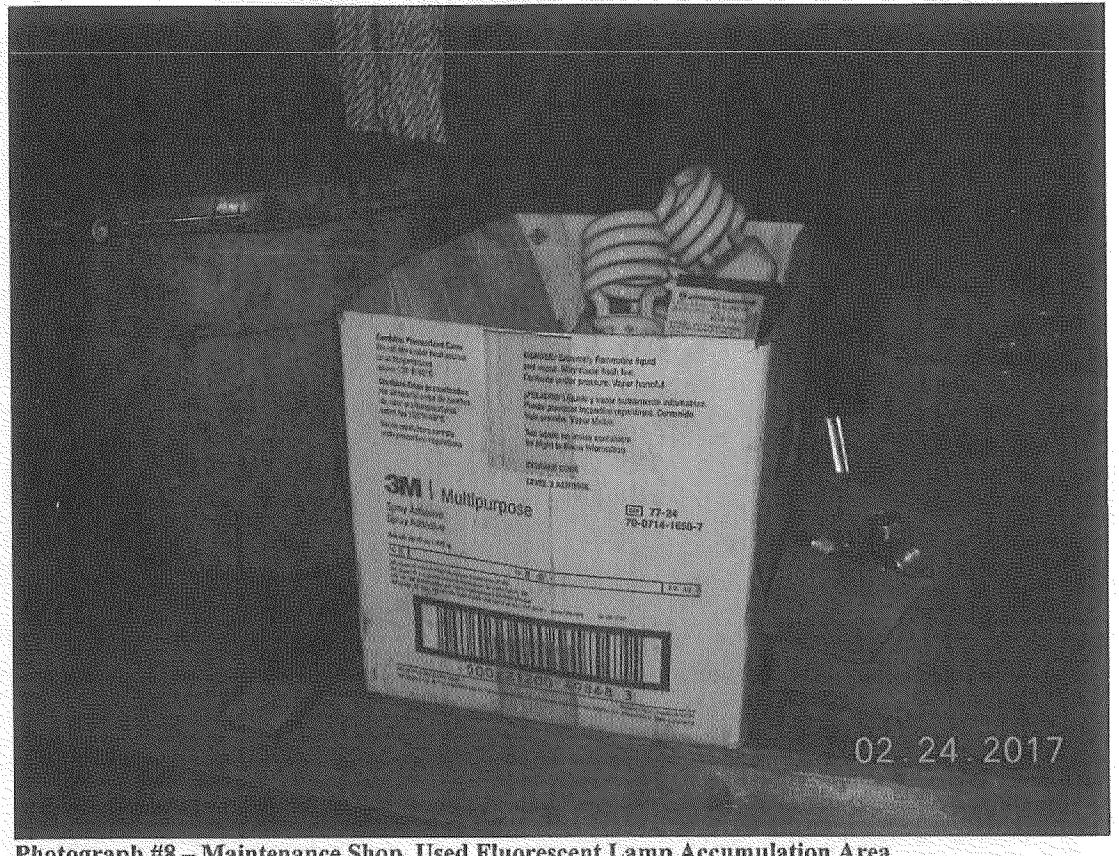
Photograph #8 – Maintenance Shop, Used Fluorescent Lamp Accumulation Area

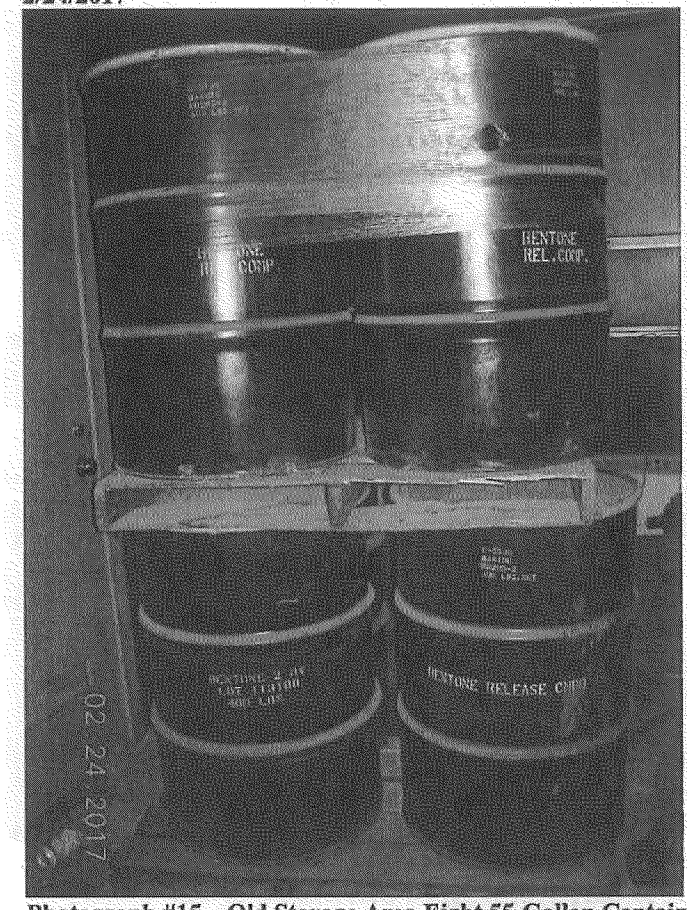
Photograph #15 – Old Storage Area Eight 55-Gallon Containers

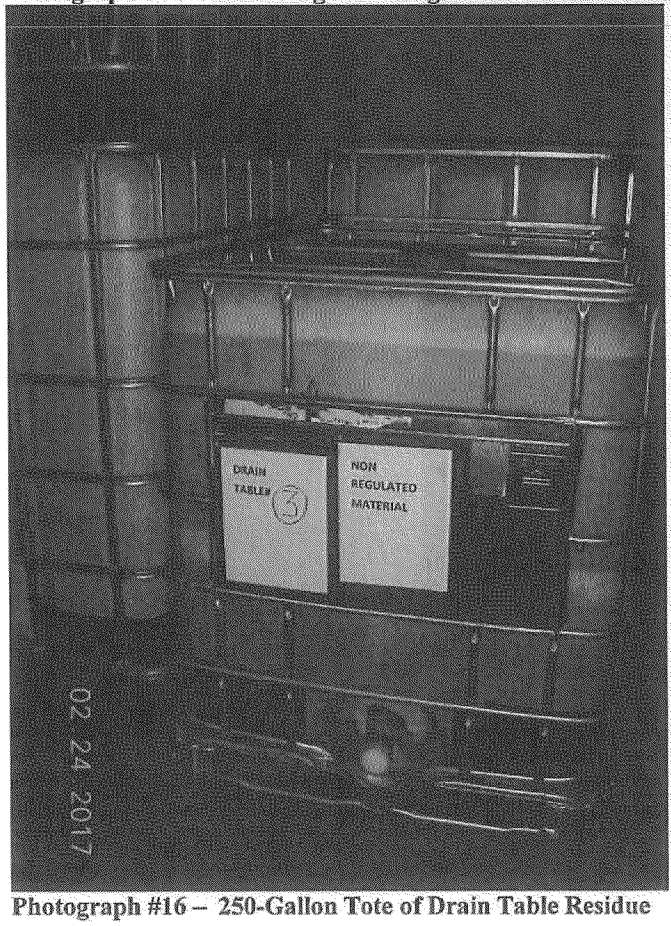
Photograph #16 – 250-Gallon Tote of Drain Table Residue
