UNITED STATES ENVIRONMENTAL PROTECTION AGENCY
REGION 5
77 W. JACKSON BOULEVARD
CHICAGO, ILLINOIS 60604

RCRA FOCUSED COMPLIANCE INSPECTION REPORT

FACILITY NAME:	**MID AMERICA IBC**
FACILITY U.S. EPA ID NO.:	None
FACILITY TYPE:	Non-Notifier
FACILITY ADDRESS:	2300 West Cornell Street Milwaukee, Wisconsin 53209
U.S. EPA REPRESENTATIVE:	Walt Francis
DATE OF INSPECTION:	February 24, 2017
NAICS CODE:	332439 – Other Metal Container Manufacturing

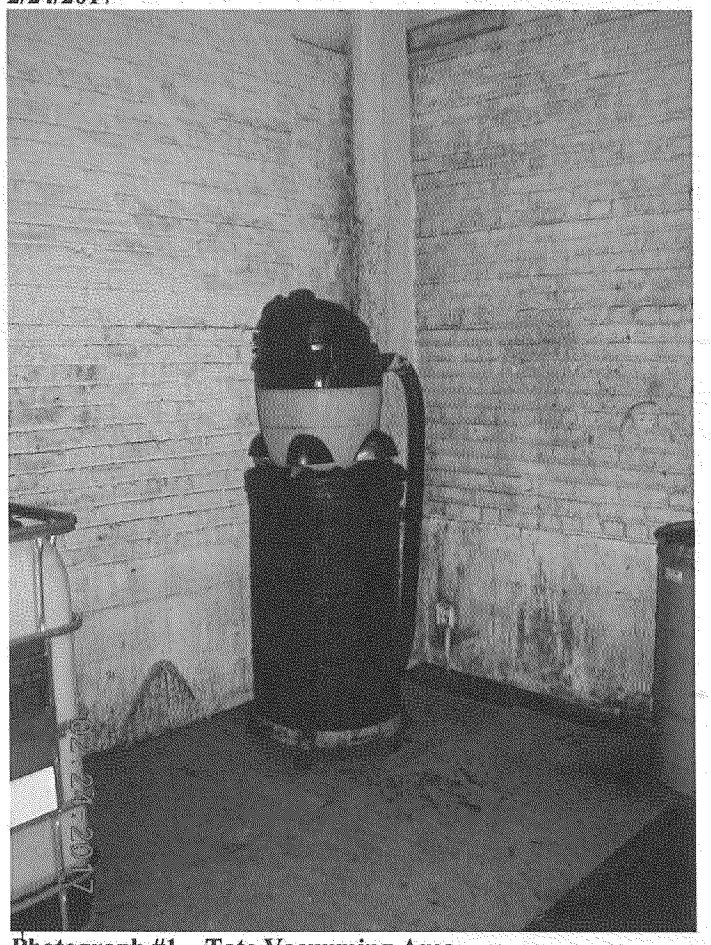
Photograph #1 – Tote Vacuuming Area

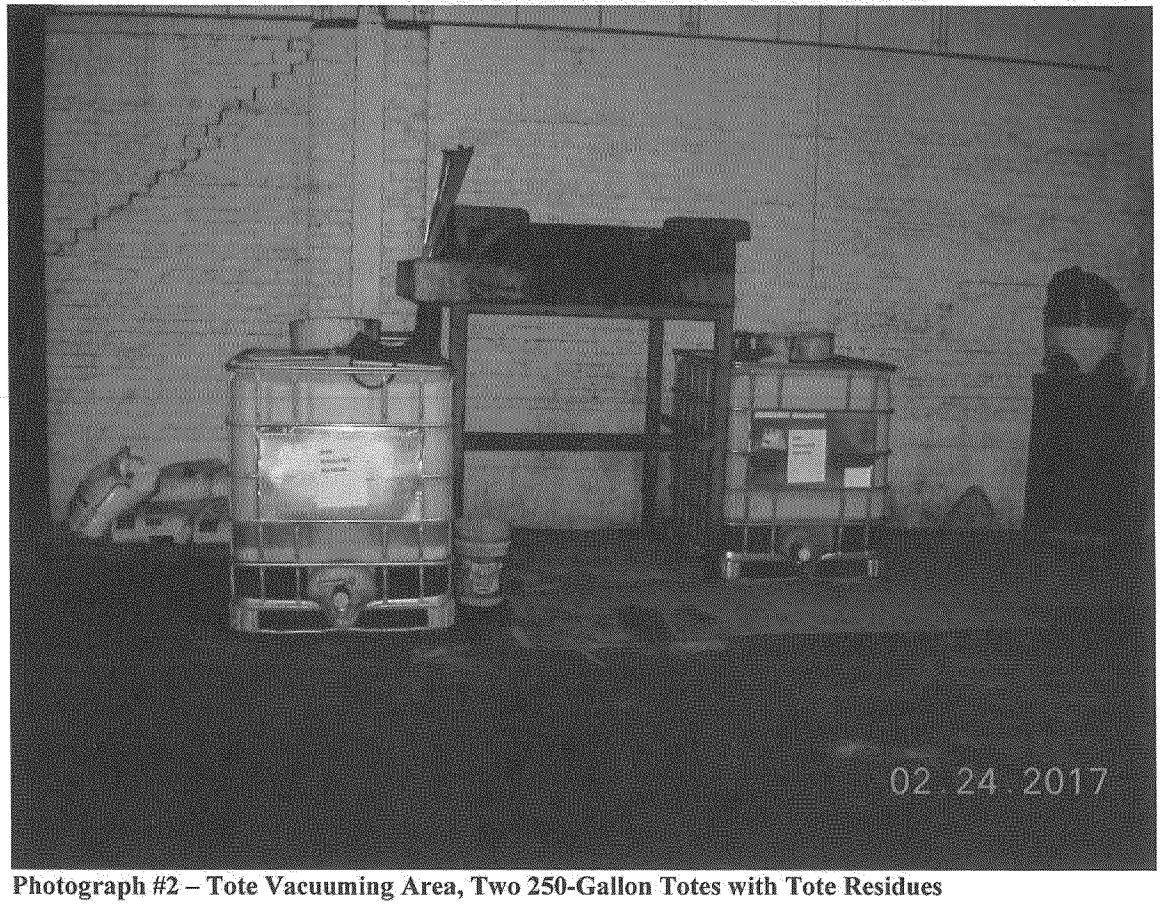
Photograph #2 – Tote Vacuuming Area, Two 250-Gallon Totes with Tote Residues

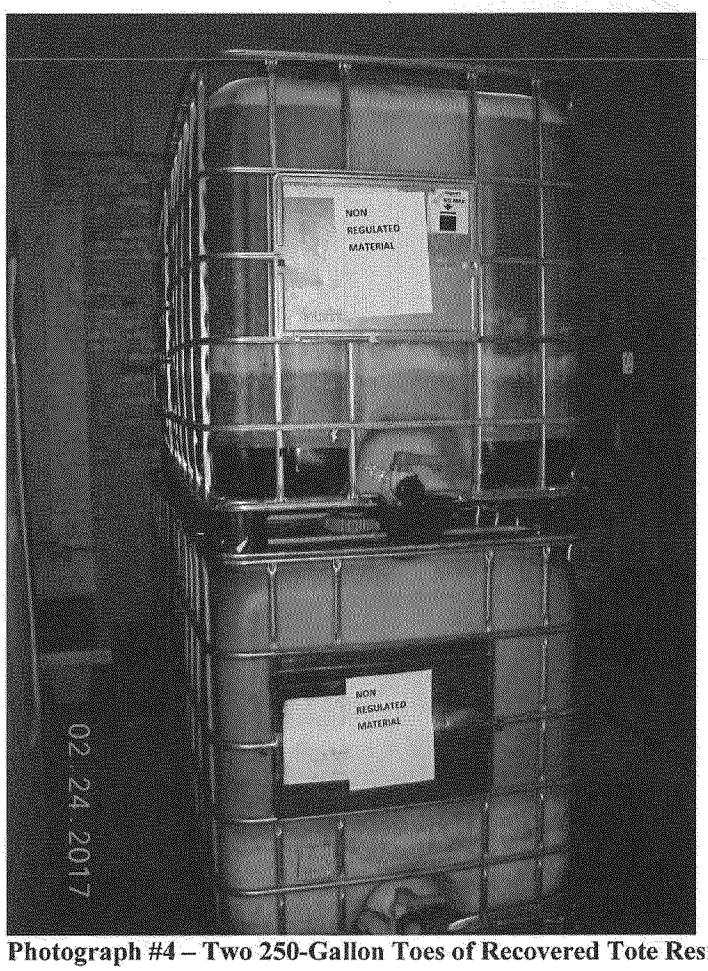
and water. Mr. Knash then took the inspectors to the filter paper area and wash tanks, see photographs 3, 5, and 6. Inspector Francis observed four 250-gallon totes in this area waiting to be shipped to Badger Disposal, see photograph number 4. Mr. Knash told Inspector Francis that the totes contained tote vacuumed residues. The walkthrough continued to the Maintenance Shop. Inspector Francis observed a box of used compact fluorescent bulbs, see photograph number 8. The walkthrough continued to the "Drain Table". Residues from 250-gallon totes are drained into 55-gallon drums, see photographs 9 and 11. Mr. Knash showed the inspectors the tote cutting area, see photograph number 10. The walkthrough continued outside. Mr. Knash showed the inspectors totes waiting for processing, see photograph numbers 12 and 13. The walkthrough continued indoors, where Mr. Knash showed the inspectors two drum drying ovens and two 55-gallon containers, see photograph number 14. The inspection continued to an older area of the facility. Inspector Francis observed eight 55-galllon containers, see photograph number 15. The walkthrough continued back to the lunch room area. Inspector Francis observed one 250-gallon tote of "Drain Table Residue" waiting to be shipped out and the Cut and Scrape Area Drain Table, and a "Recertified 250-Gallon Tote M4712, see photograph numbers 16, 17, and 18.

Photograph #4 – Two 250-Gallon Toes of Recovered Tote Residue

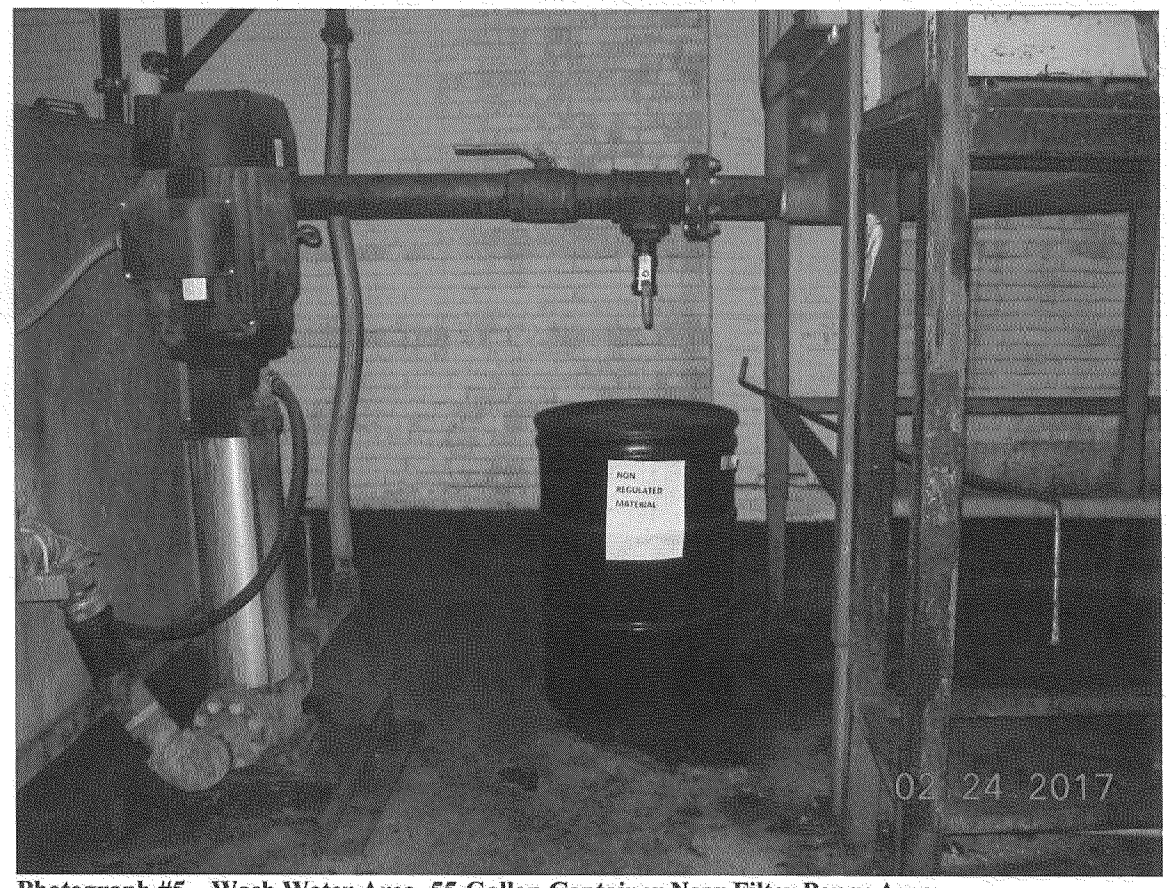
Photograph #5 – Wash Water Area, 55-Gallon Container Near Filter Paper Area

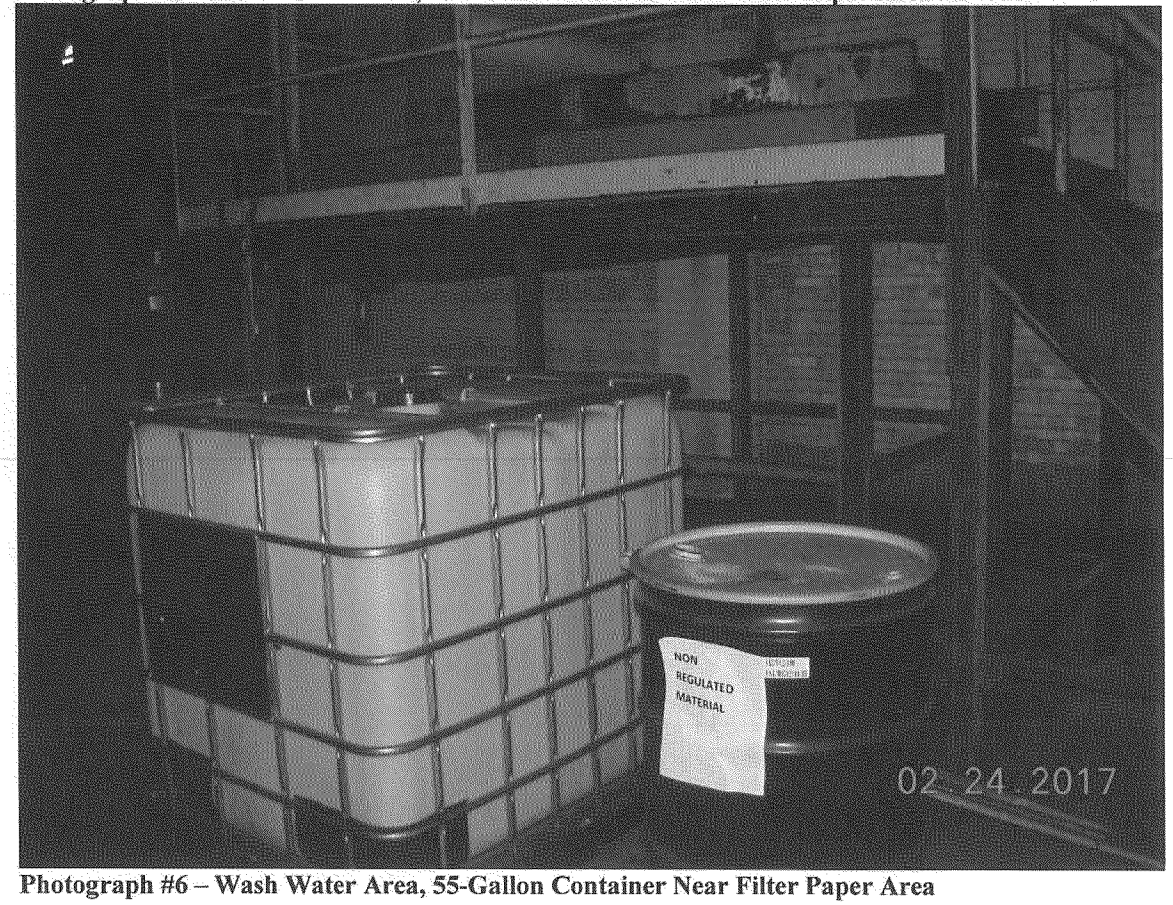
Photograph #6 – Wash Water Area, 55-Gallon Container Near Filter Paper Area

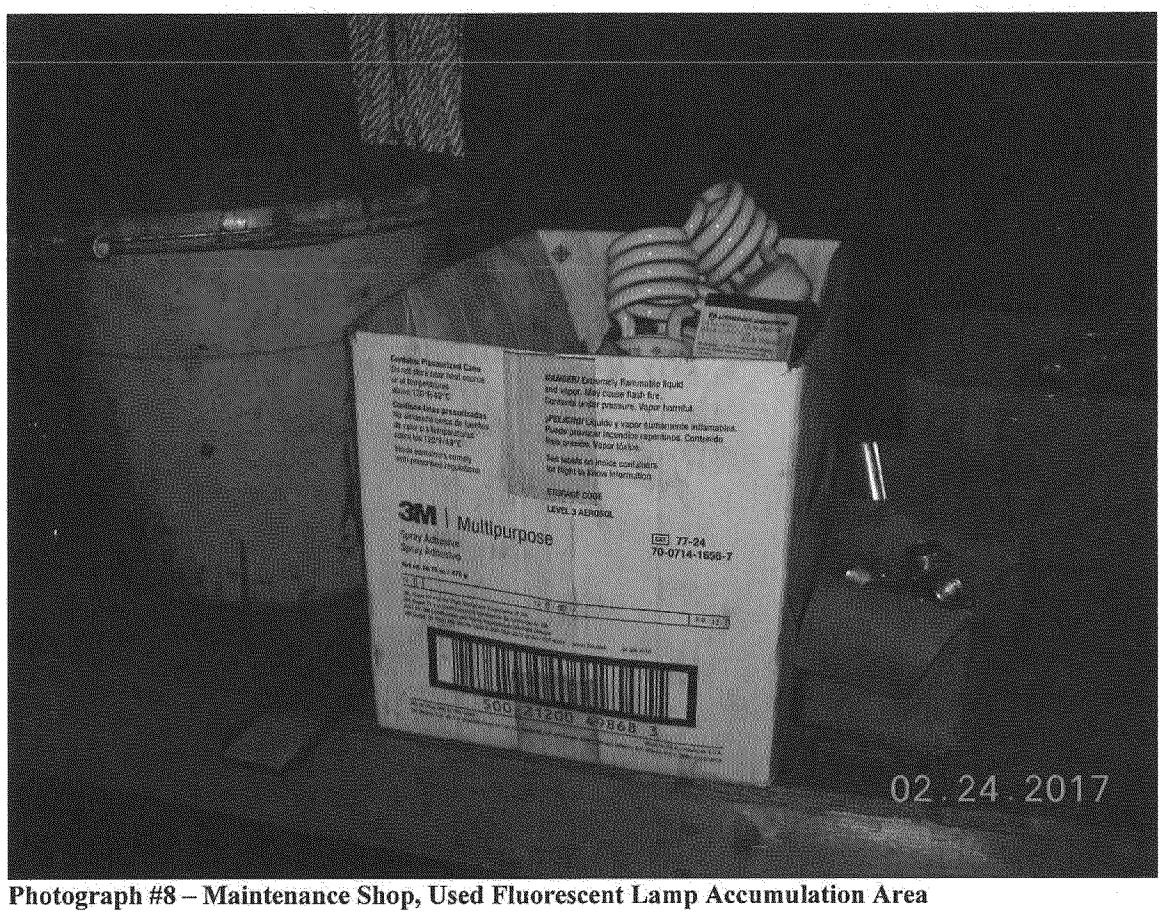
Photograph #8 – Maintenance Shop, Used Fluorescent Lamp Accumulation Area

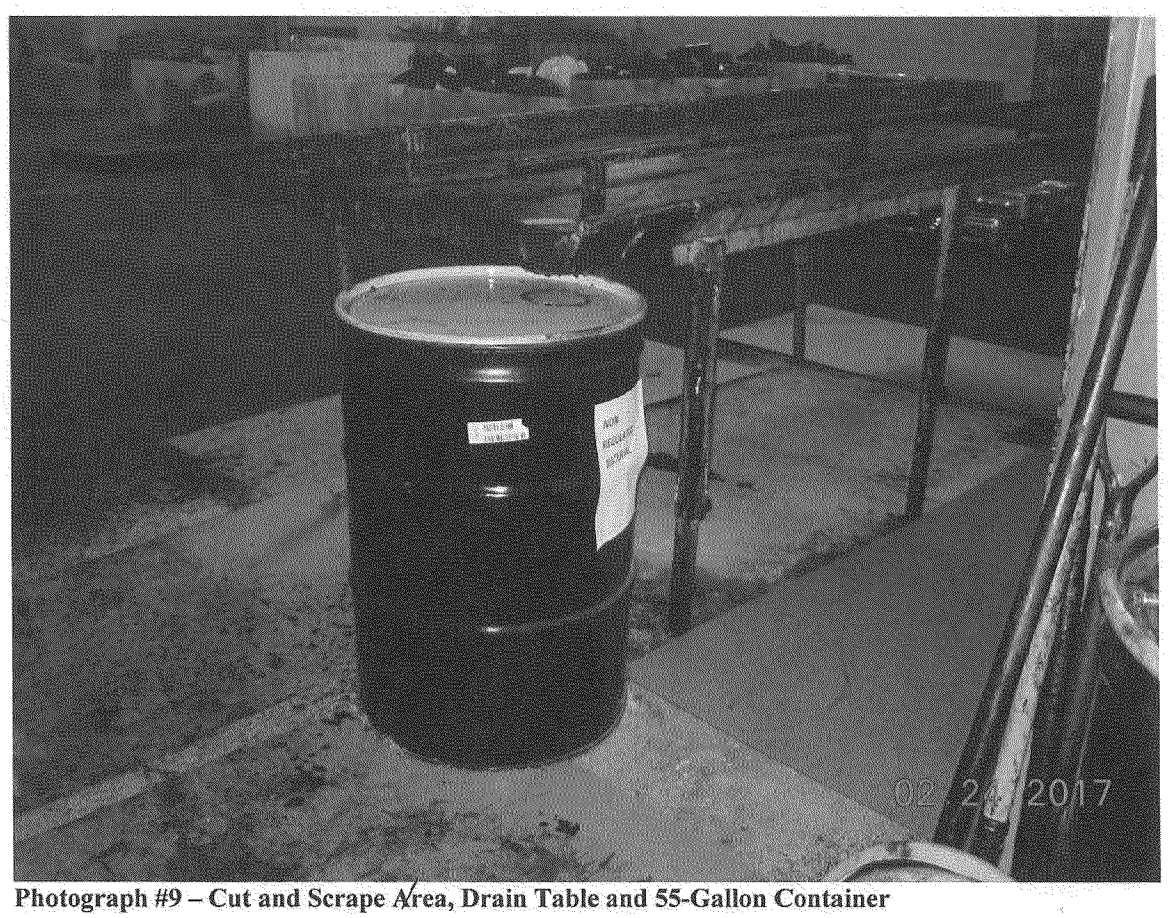
Photograph #9 – Cut and Scrape Area, Drain Table and 55-Gallon Container

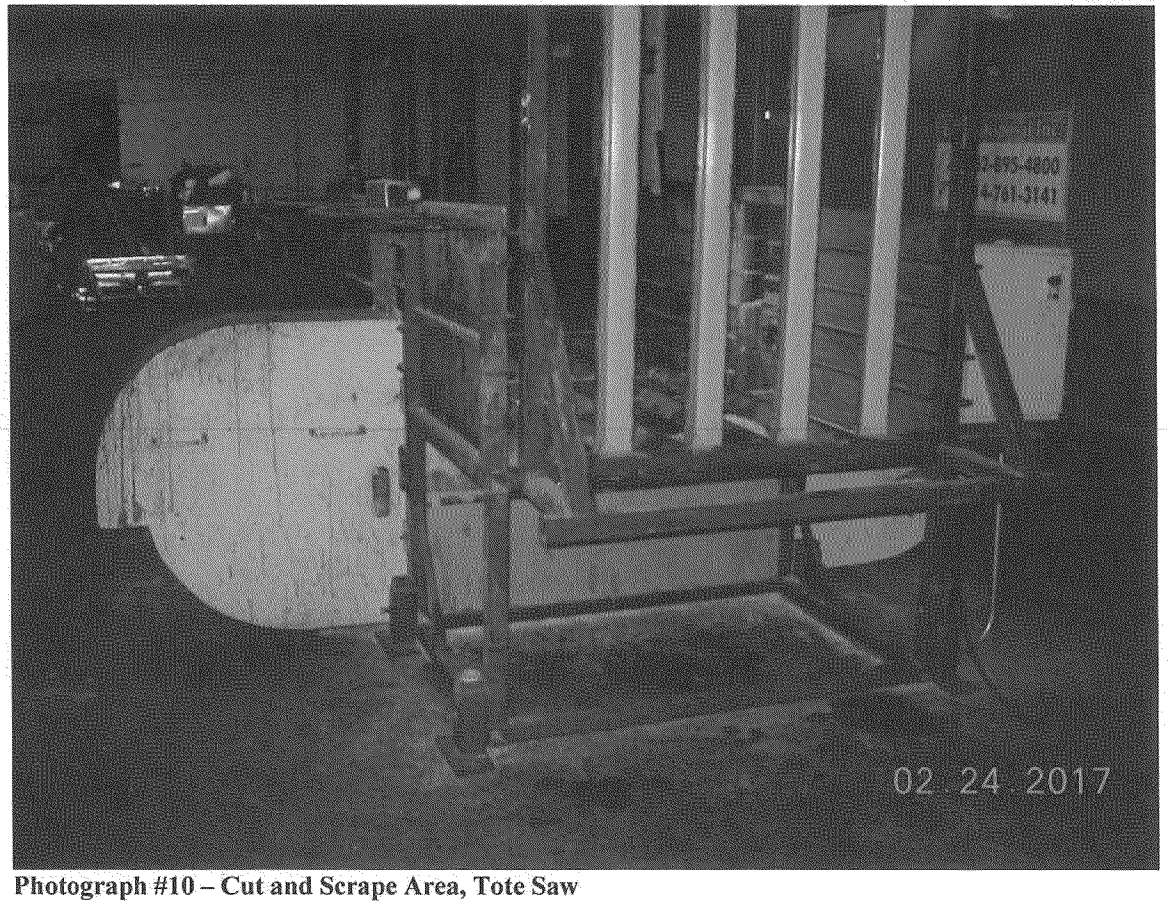
Photograph #10 – Cut and Scrape Area, Tote Saw

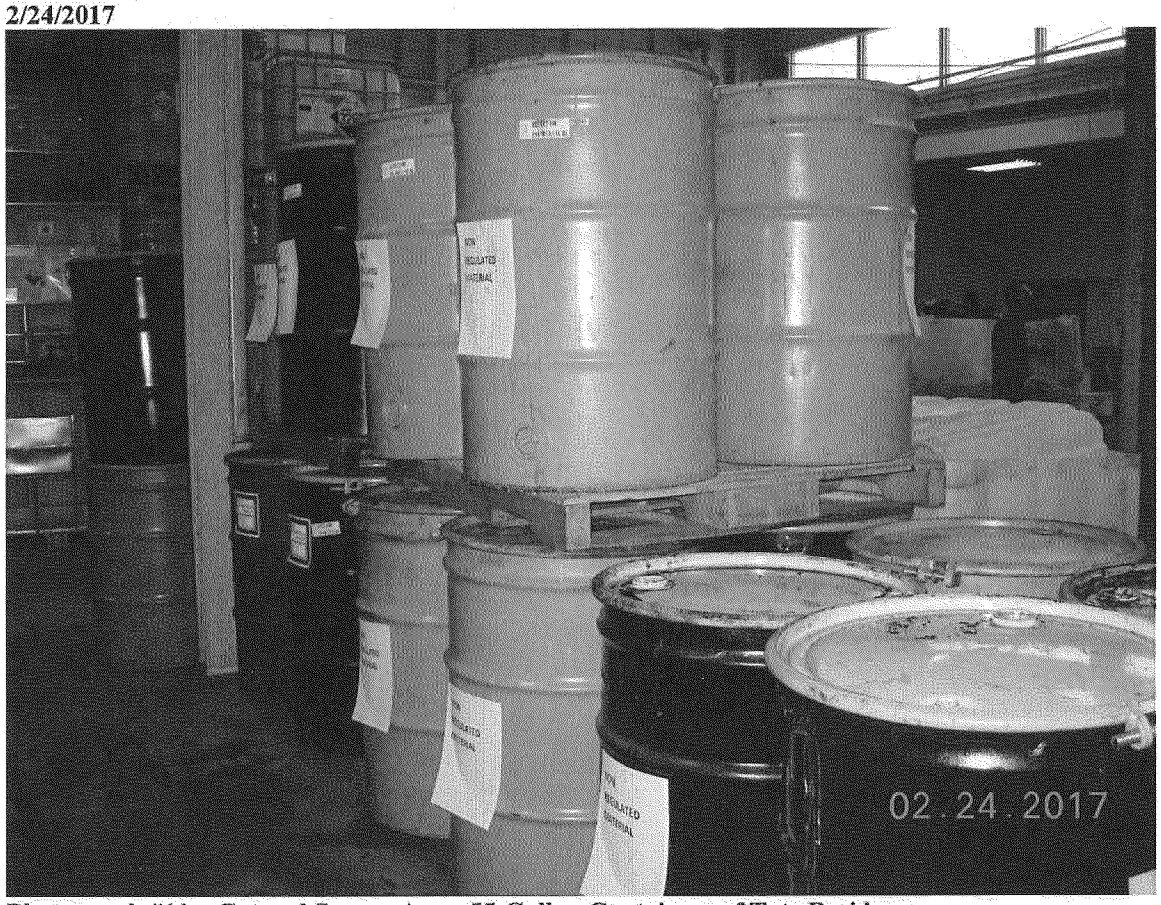
Photograph #11 – Cut and Scrape Area, 55-Gallon Containers of Tote Residues

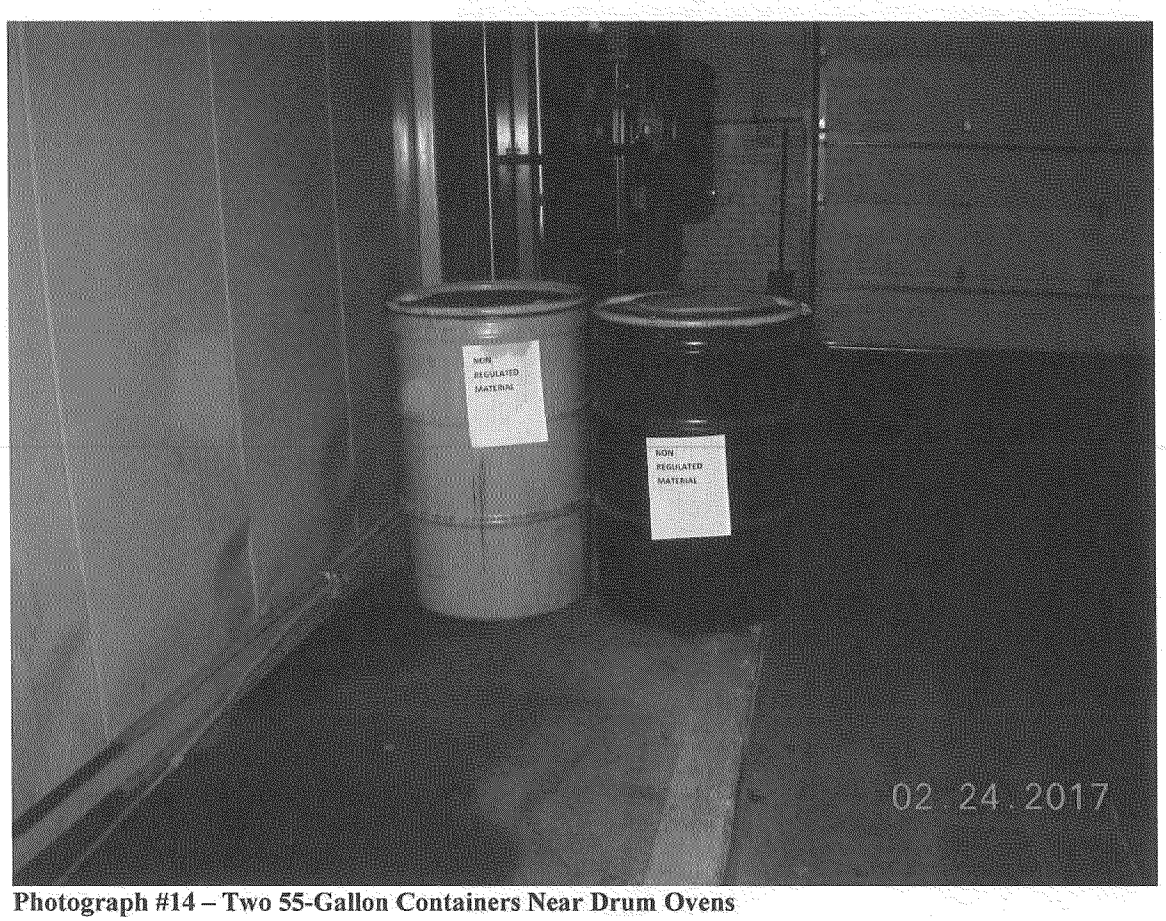
Photograph #14 – Two 55-Gallon Containers Near Drum Ovens

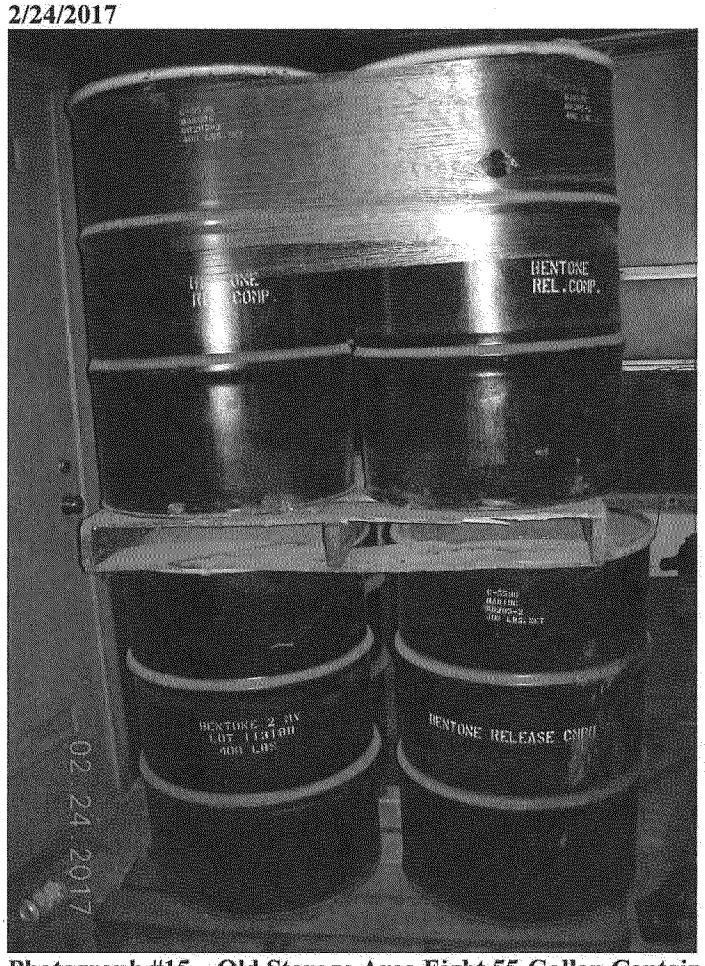
Photograph #15 – Old Storage Area Eight 55-Gallon Containers

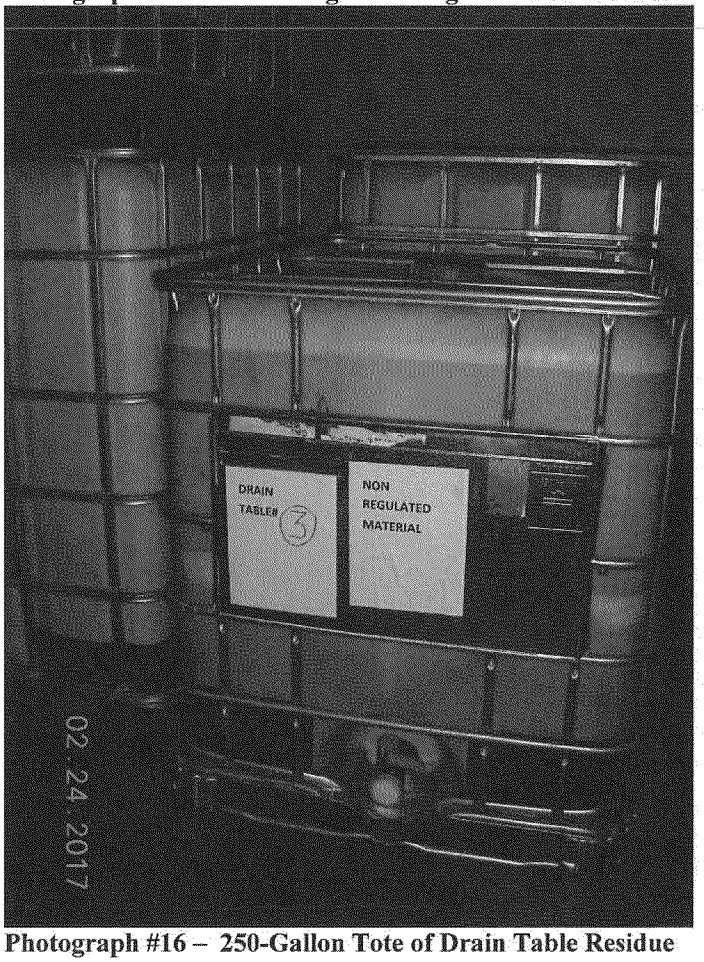
Photograph #16 – 250-Gallon Tote of Drain Table Residue

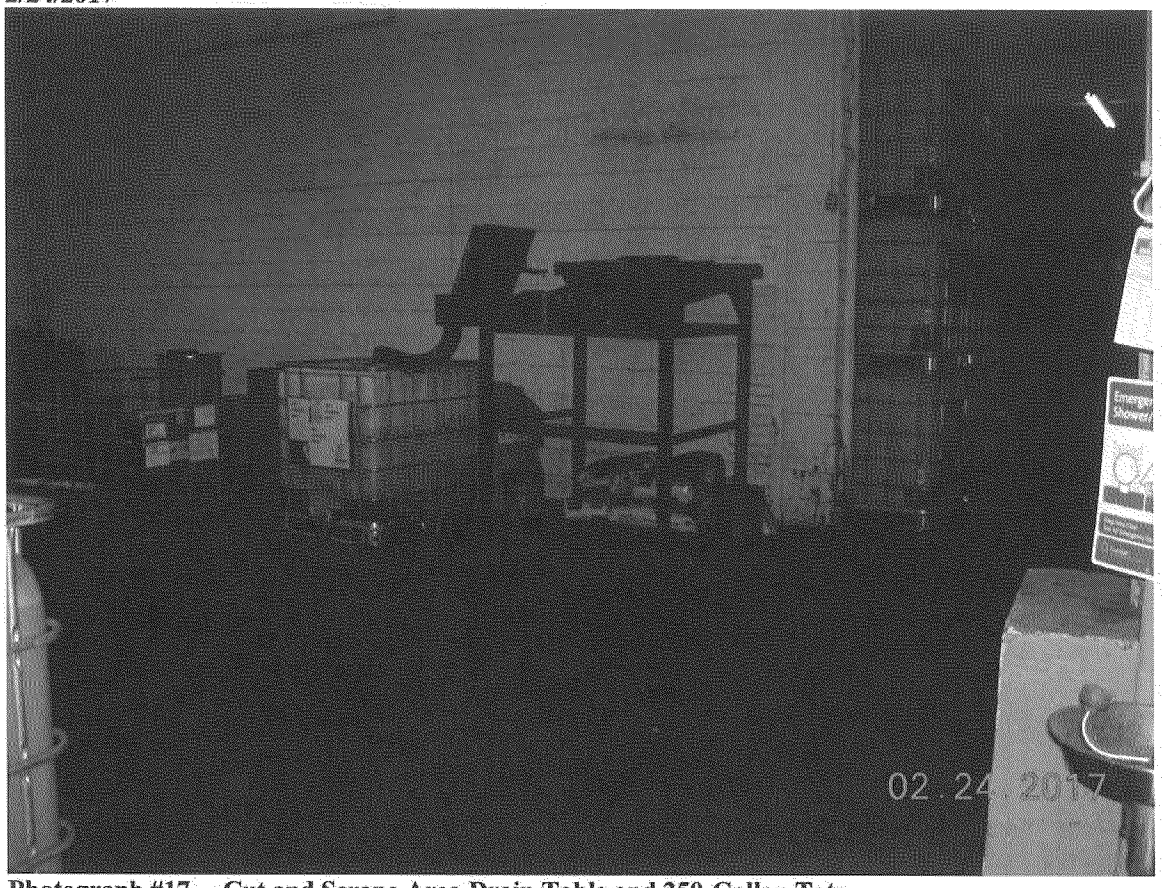
Photograph #17 – Cut and Scrape Area Drain Table and 250-Gallon Tote
