UNITED STATES ENVIRONMENTAL PROTECTION AGENCY
REGION 5
77 WEST JACKSON BOULEVARD
CHICAGO, ILLINOIS 60604

Compliance Evaluation Inspection Report

Date of Inspection:	March 2, 2017
Facility Name:	Mid-America Steel Drum
Facility Address:	8570 South Chicago Road Oak Creek, Wisconsin 53154
EPA RCRA ID Number:	WID045953189
Generator Status:	Small Quantity Generator
Facility Contact:	Michael Higgins – General Manager
EPA Representatives:	Brenda Whitney - Environmental Engineer RCRA Branch Compliance Section 2 Land and Chemicals Division
Prepared By:	Brenda Whitney – Environmental Engineer — Date: 3-23-17
Approved By:	Julie Morris – Chief, Compliance Section 2 — Date: 3/27/17

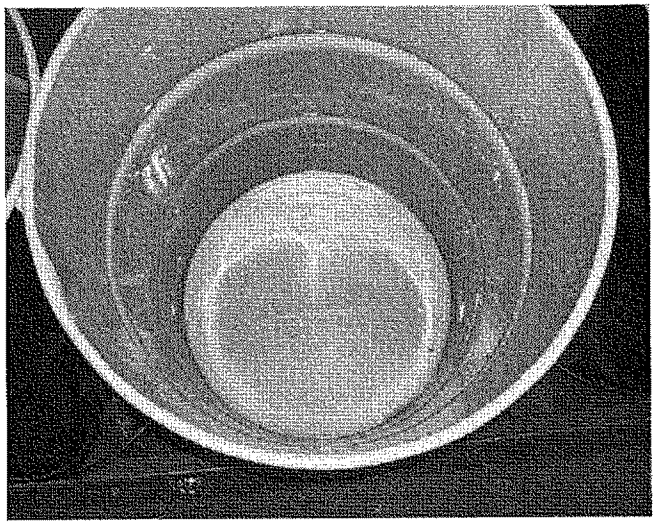
Photograph 9

This photograph was taken in the room where the lids are cut off of tight-head drums. This container held a pourable amount of viscous material that had accumulated at the bottom of the container.
