U.S. ENVIRONMENTAL PROTECTION AGENCY
Region 5, Land and Chemicals Division
RCRA Branch, LR-8J
77 West Jackson Boulevard
Chicago, Illinois 60604

FOCUSED COMPLIANCE INSPECTION REPORT

INSPECTION DATE:	July 17, 2017
SITE NAME:	Container Life Cycle Management, LLC d/b/a Mid-America Steel Drum, Inc.
ADDRESS:	3950 South Pennsylvania Avenue St. Francis, Wisconsin 53235
EPA ID NUMBER:	WIR 000 131 367
RCRA STATUS:	Small Quantity Generator (2017)
NAICS CODE:	332439 Other Metal Container Manufacturing
FACILITY CONTACT:	Mark Furgason Plant Manager
EPA CONTACT:	Brian Kennedy Environmental Engineer Compliance Section 2 RCRA Branch Land and Chemicals Division

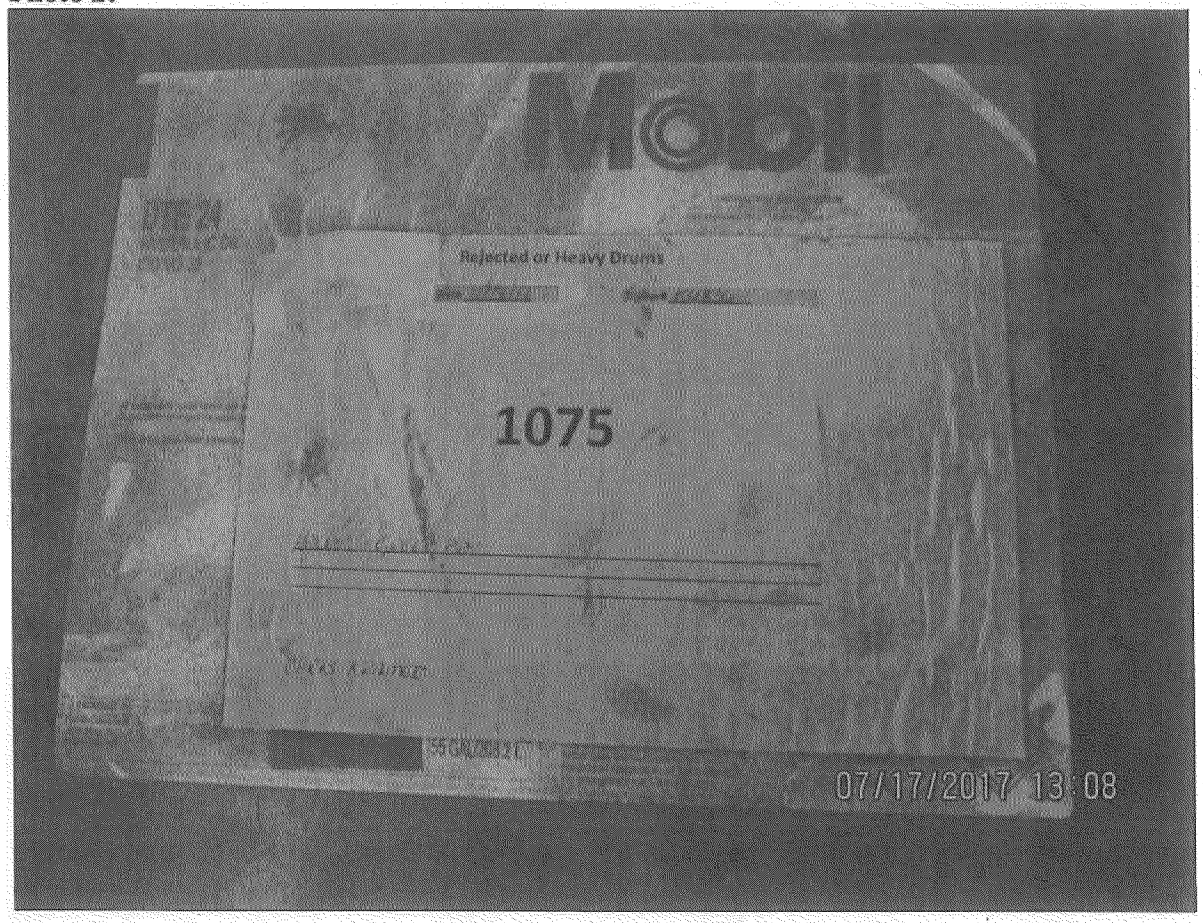
Photo 2:

Inspector Whitney and I proceeded to the "heavies" storage area where MASD segregates incoming drums that "feel" heavy because of liquid inside the drum. There were approximately 60 drums in the heavies area, each with a neon yellow reject label on the lid (See Photo 1 in the Inspection Photographs attachment). The labels stated "Rejected or Heavy Drum" and were marked with a tracking number and the customer that sent the drum. The vast majority of these labels had no date. For those labels with a date, the earliest observed was April 17, 2017 (Photo 2).
