INSPECTION REPORT

REPORT DATE: 1/22/2013 **INCIDENT NO:** 1172013-1

OWNER/OPERATOR: Acock Operating LTD.
4201 FM 1960 West, Suite 245
Houston, TX 77068

Acock Operating Limited Facility

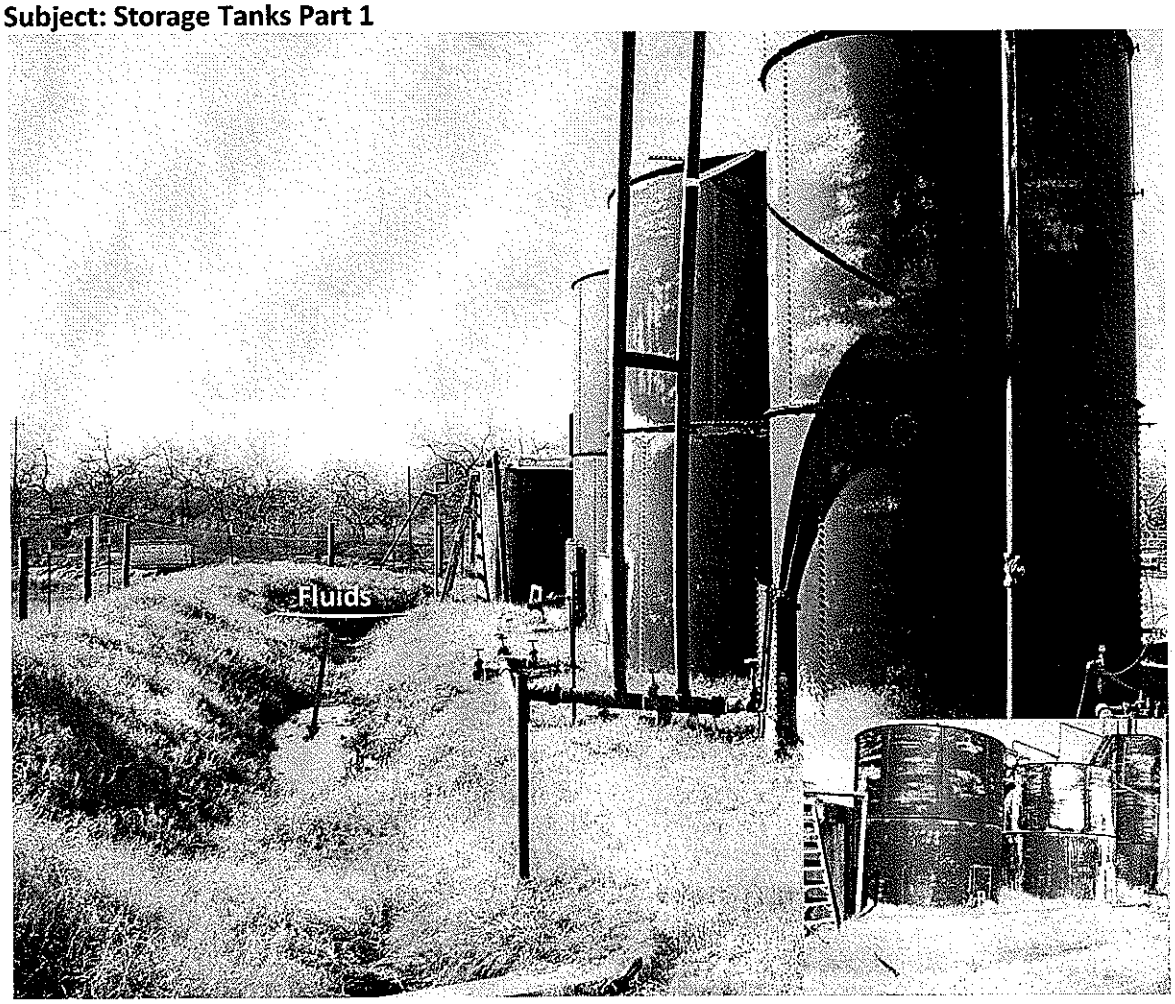
Acock Operating Limited Facility Photo 2

Photo #2. Facing North from Little Elm Creek. Found 4 storage tanks approximately 16 ft by 25 ft. There were fluids (produce wastewater and oil) around tanks and some oil sheens on water. Observed leaks coming from pumping unit and storage tanks, inappropriate berms around tanks, and oil staining from leaks on tanks.

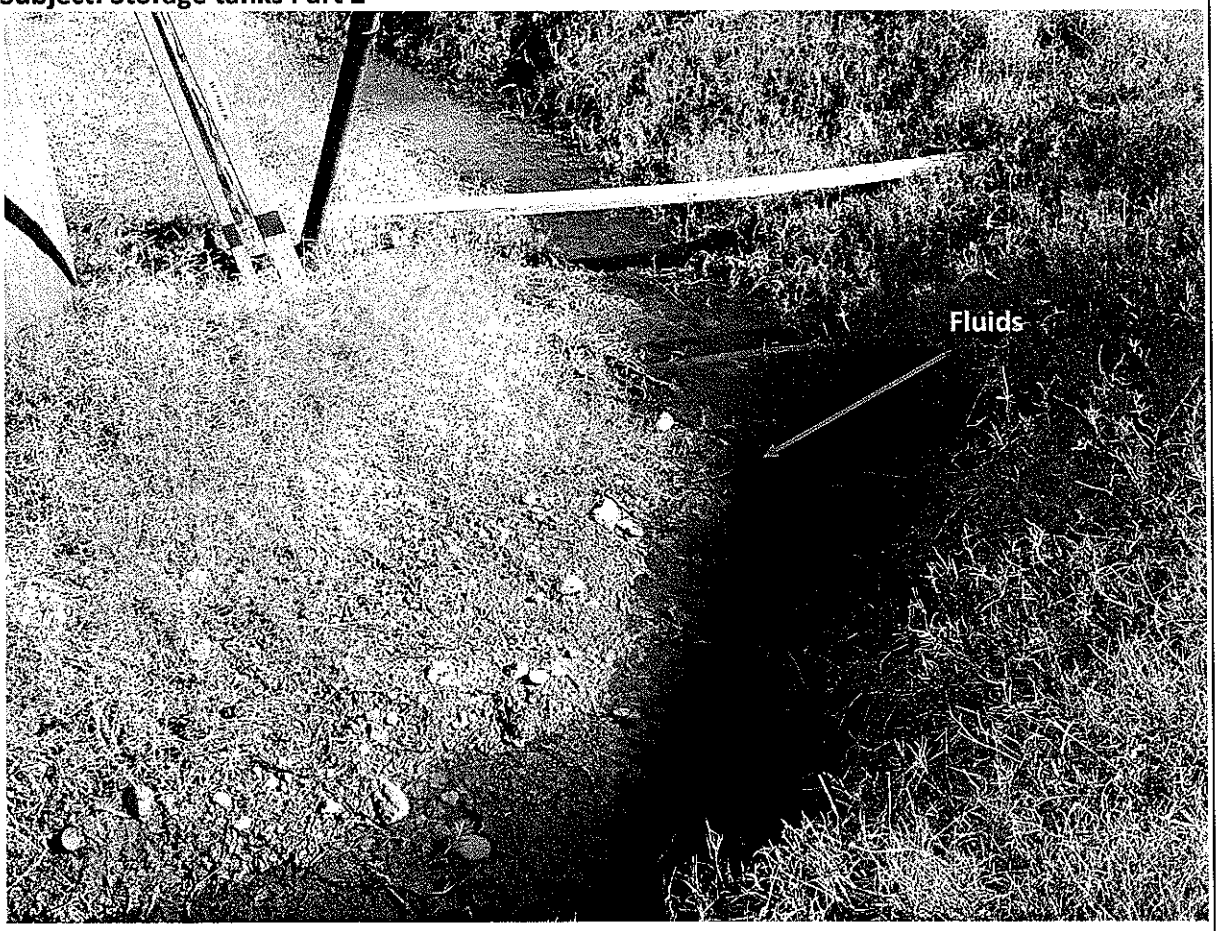
Acock Operating Limited Facility Photo 3

Photo #3. Facing North from Little Elm Creek. Found more fluids (produce wastewater and oil) around tanks.

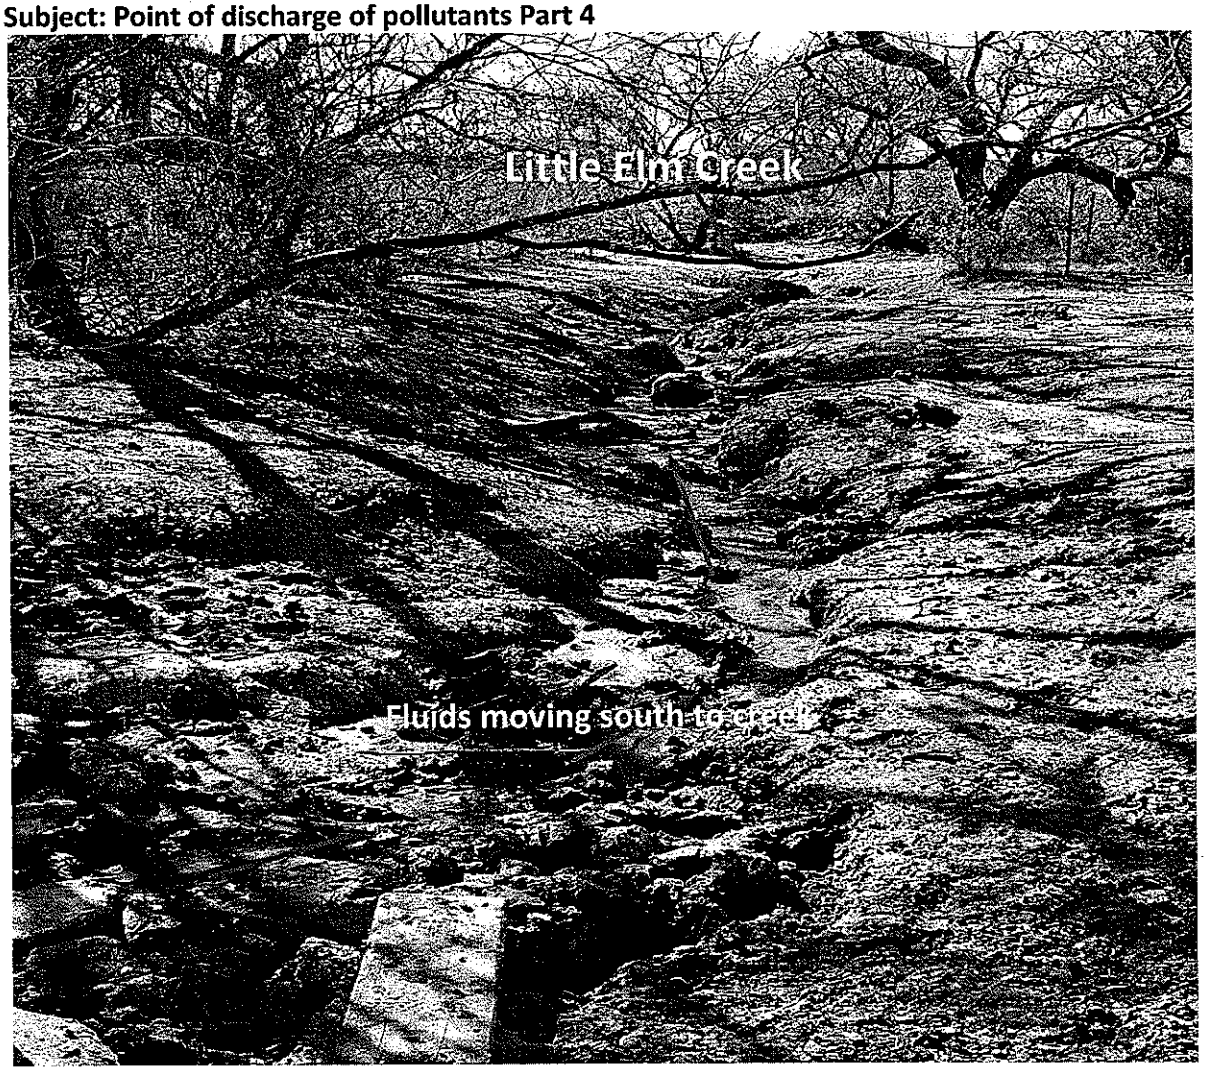
Acock Operating Limited Facility Photo 9

Photo #9. Facing South from tanks and pits. Produce wastewater and oil residues were discharging directly into Little Elm Creek. Continues flow of produced waste water getting into the creek.
