DRY WEATHER SCREENING

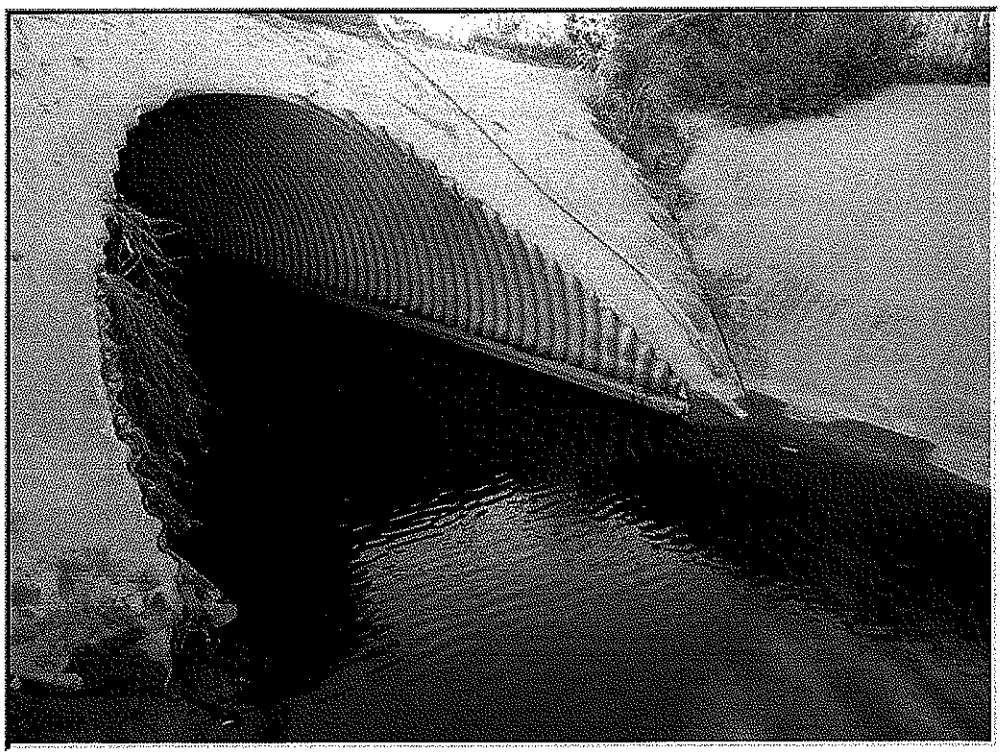
Location: 01 SAN JOSE DRAIN AT WOODWARD

SUSPECTED SOURCE irrigation

SUSPECTED PROBLEM TYPE Nuisance Flow

DISS OXYGEN, MG/L: 6 **OBSERV GROSS POLLUT:** papers, leaves

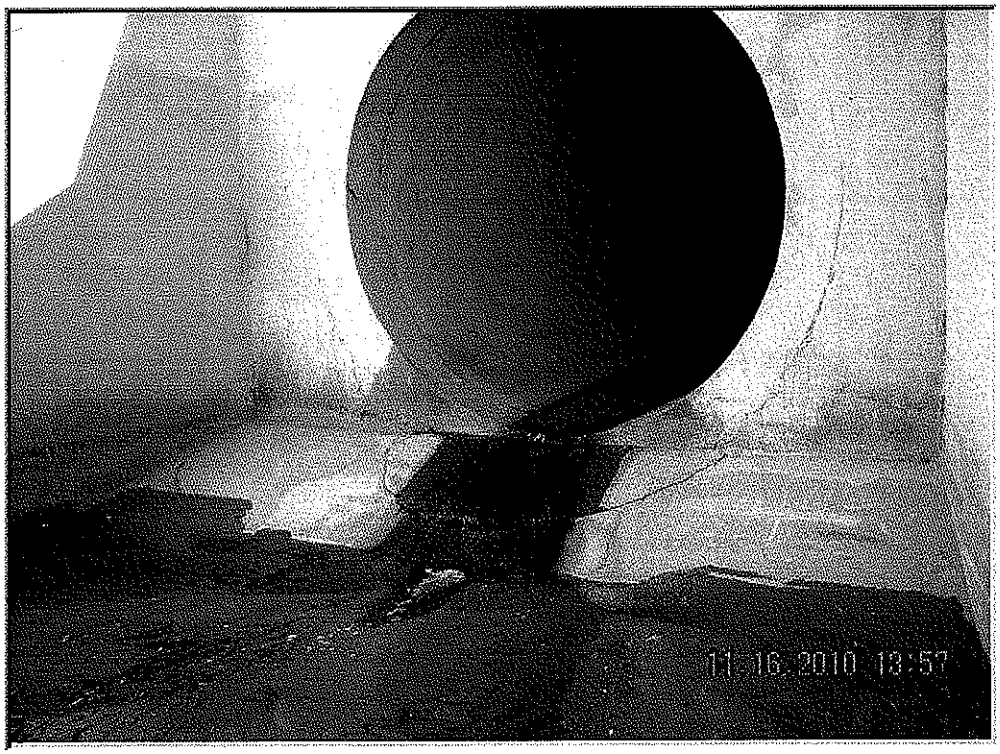
Location: 02 BROADWAY POND INFLOW CHANNEL

SUSPECTED SOURCE irrigation

SUSPECTED PROBLEM TYPE Nuisance Flow

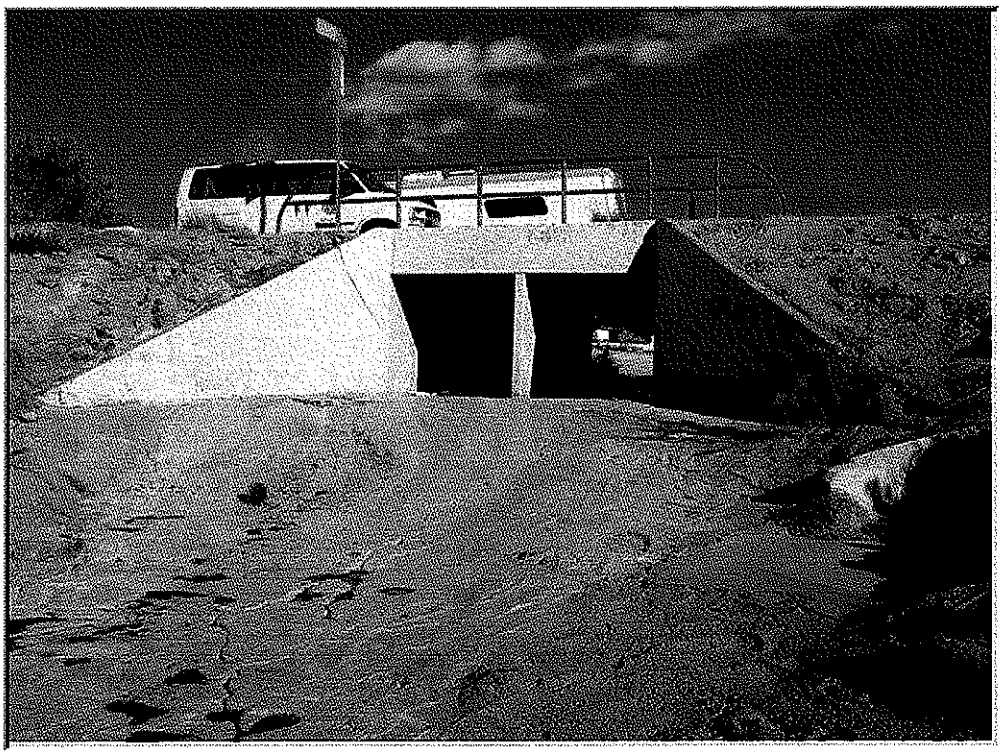
Location: 05 KIRTLAND CHANNEL AT SOUTH DIVERSION CHANNEL

FIELD NOTES no flow

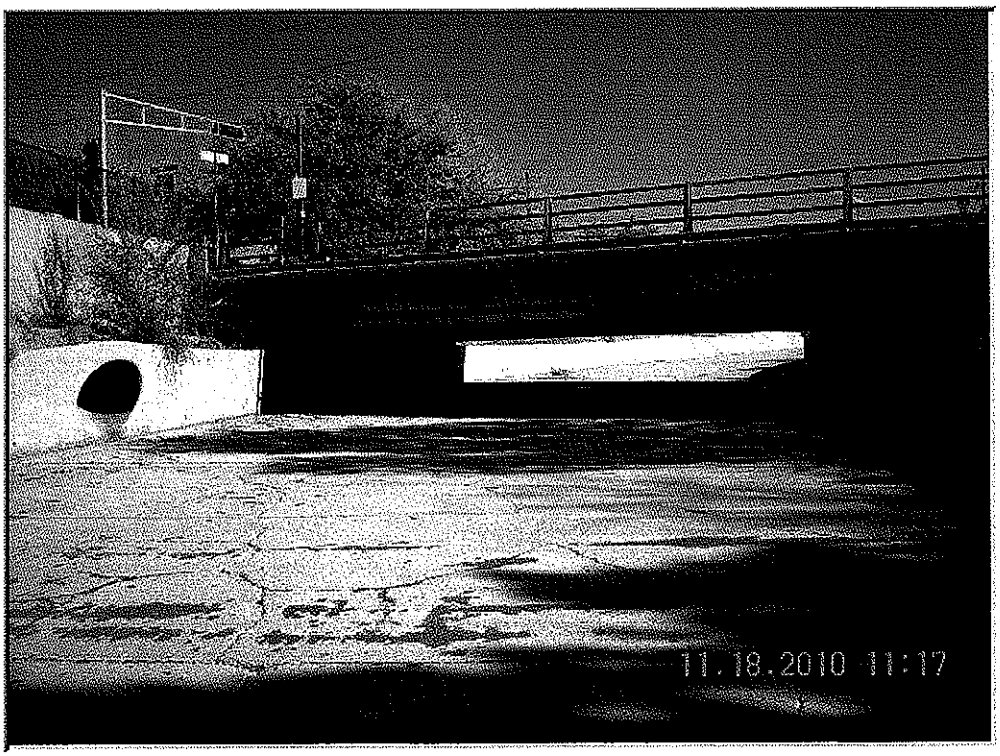
Location: 09 EMBUDO ARROYO AT PENNSYLVANIA

FIELD NOTES no flow

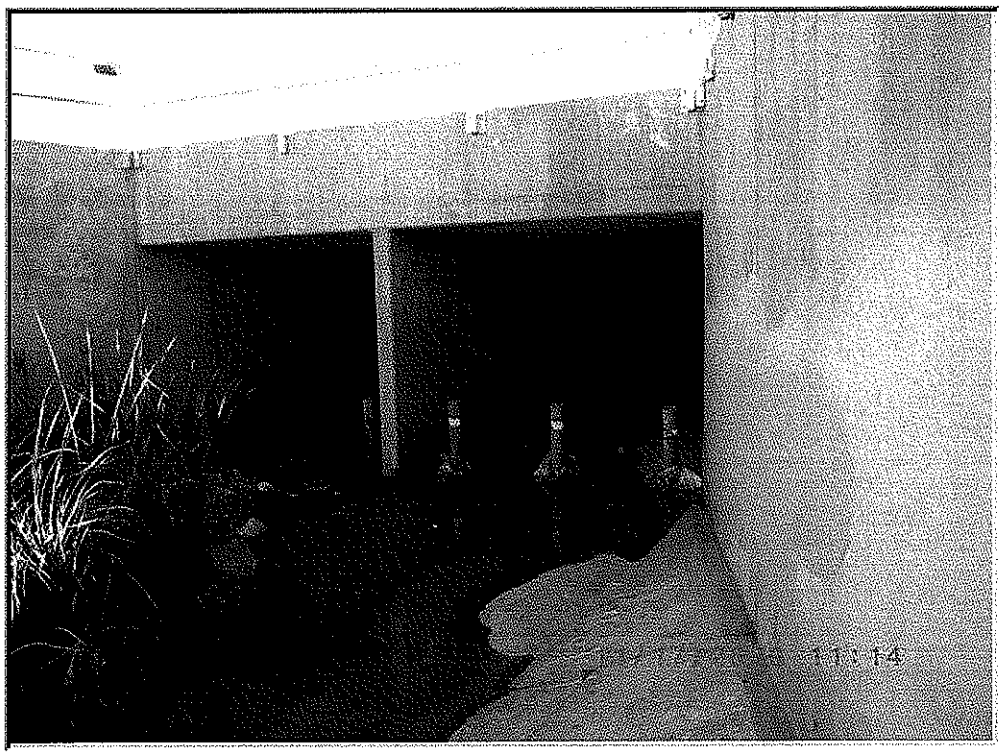
Location: 10 HIGHLANDS SYSTEM OUTFALL AT UNM HOSPITAL

DISS OXYGEN, MG/L: 6 **OBSERV GROSS POLLUT:** papers, leaves

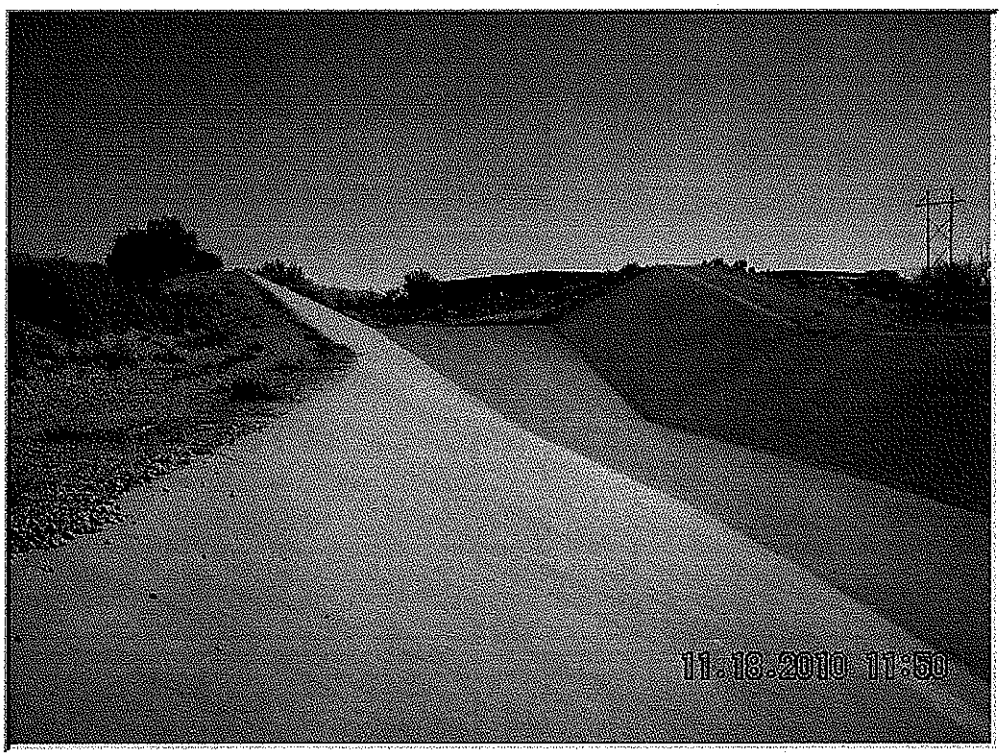
Location: 11 BEAR CANYON ARROYO AT NORTH DIVERSION CHANNEL-OSUNA

FIELD NOTES no flow

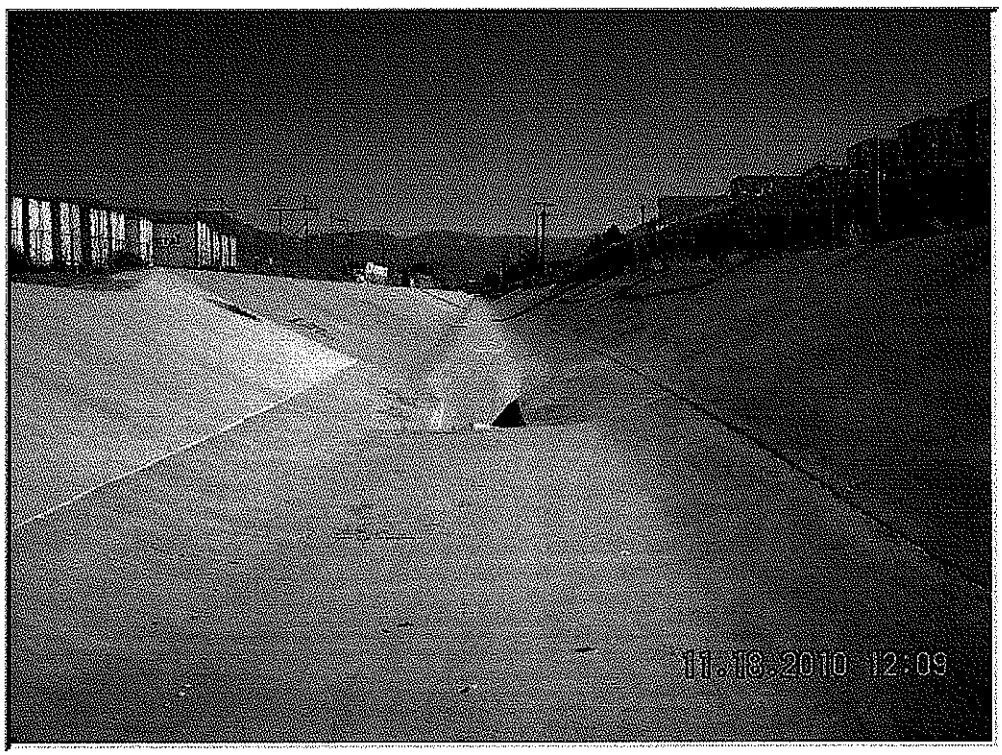
Location: 12 SOUTH PINO ARROYO AT WASHINGTON

FIELD NOTES no flow

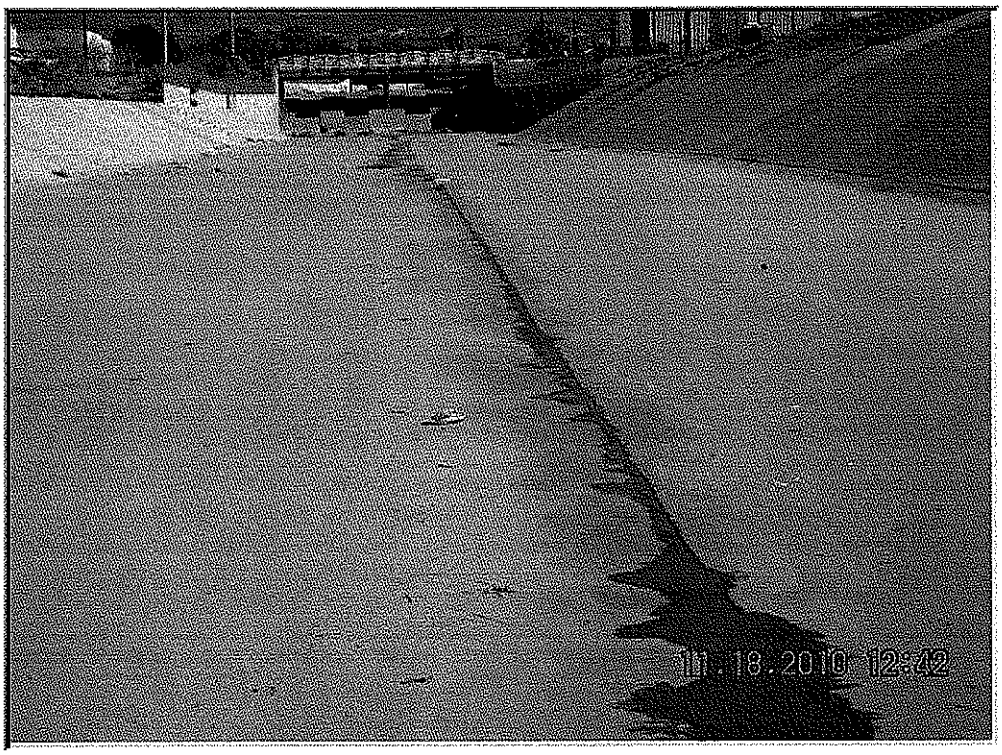
Location: 14 SOUTH DOMINGO BACA ARROYO AT WASHINGTON

SUSPECTED SOURCE Irrigation

SUSPECTED PROBLEM TYPE Nuisance Flow

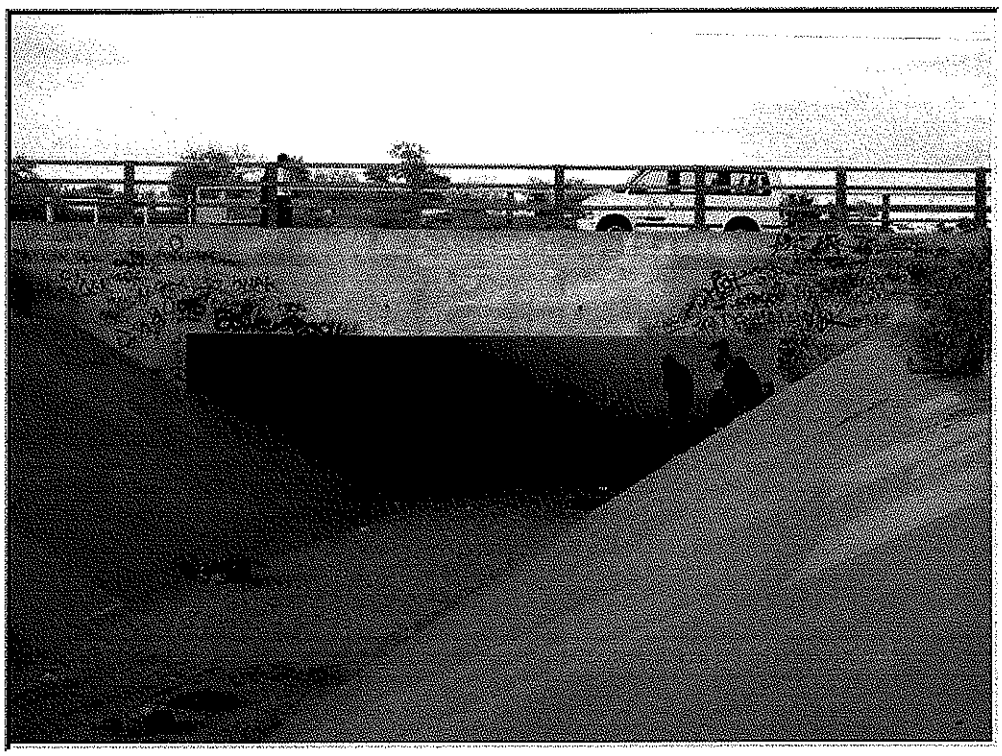
Location: 15 AMOLE DEL NORTE CHANNEL AT BLAKE RD

FIELD NOTES no flow

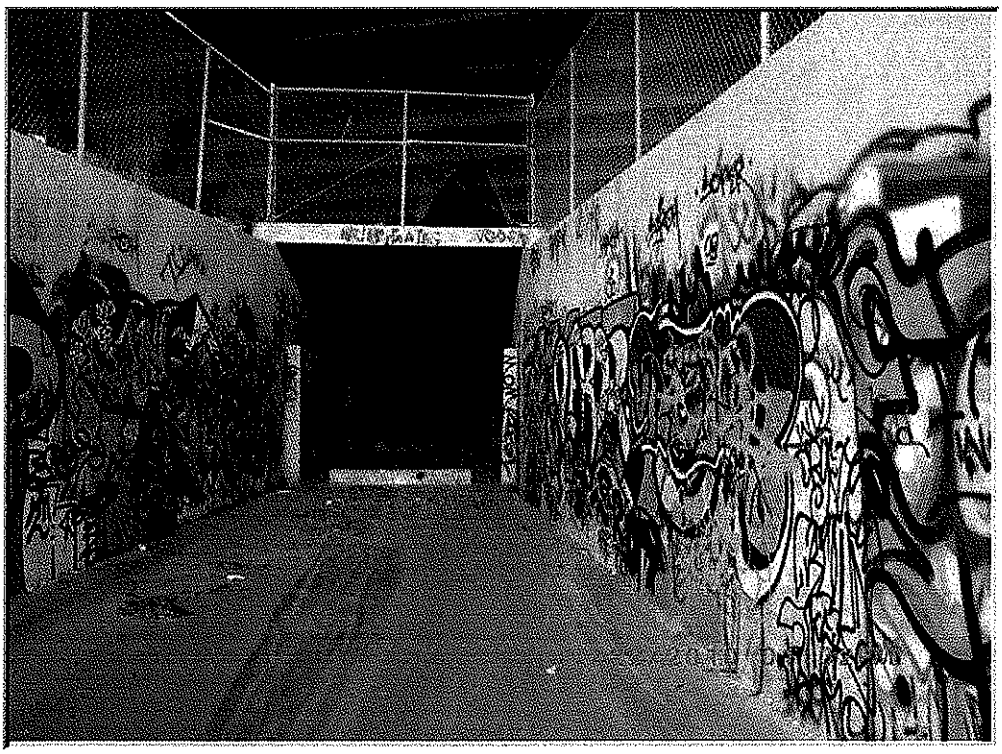
Location: 16 WEST BLUFF I-40 OUTFALL AT RIO GRANDE

FIELD NOTES no flow
