APPENDIX D
DRY WEATHER SCREENING RESULTS

Dry Weather Screening

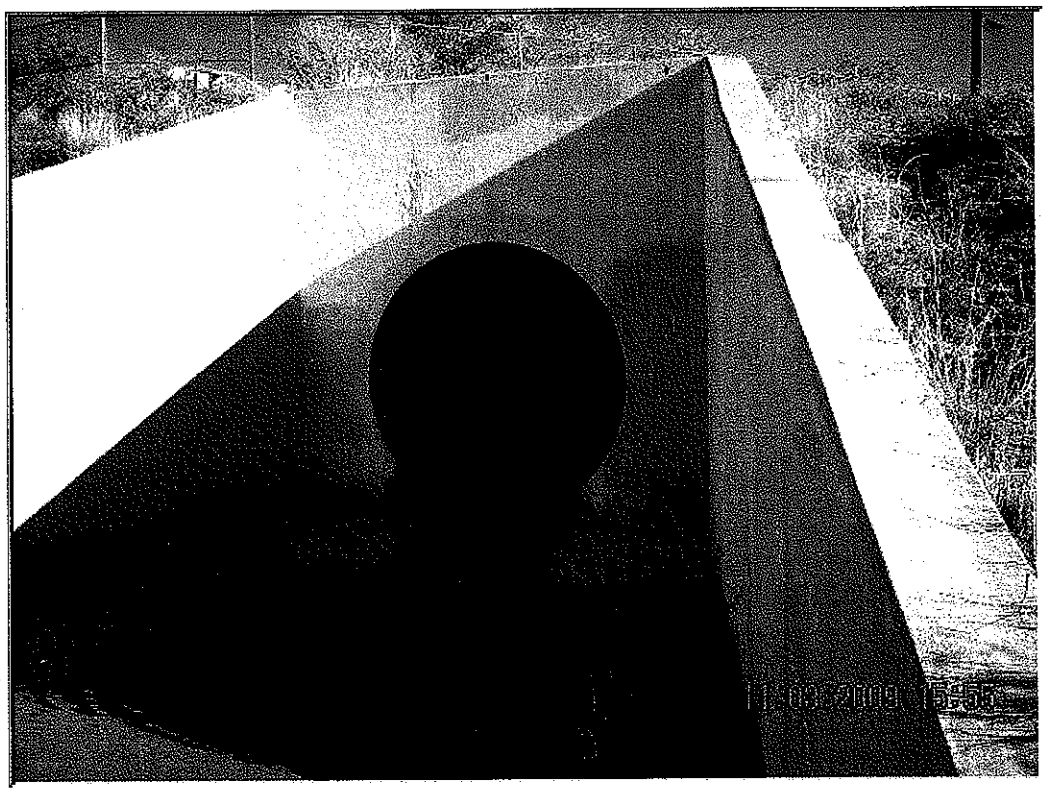
Location: 02 BROADWAY POND INFLOW CHANNEL

SUSPECTED PROBLEM TYPE Nuisance Flow

FIELD NOTES Engineer attempted to track source but was unable to do so. Supsected sources include over-watering by local neighborhoods and/or leaking water supply pipes.

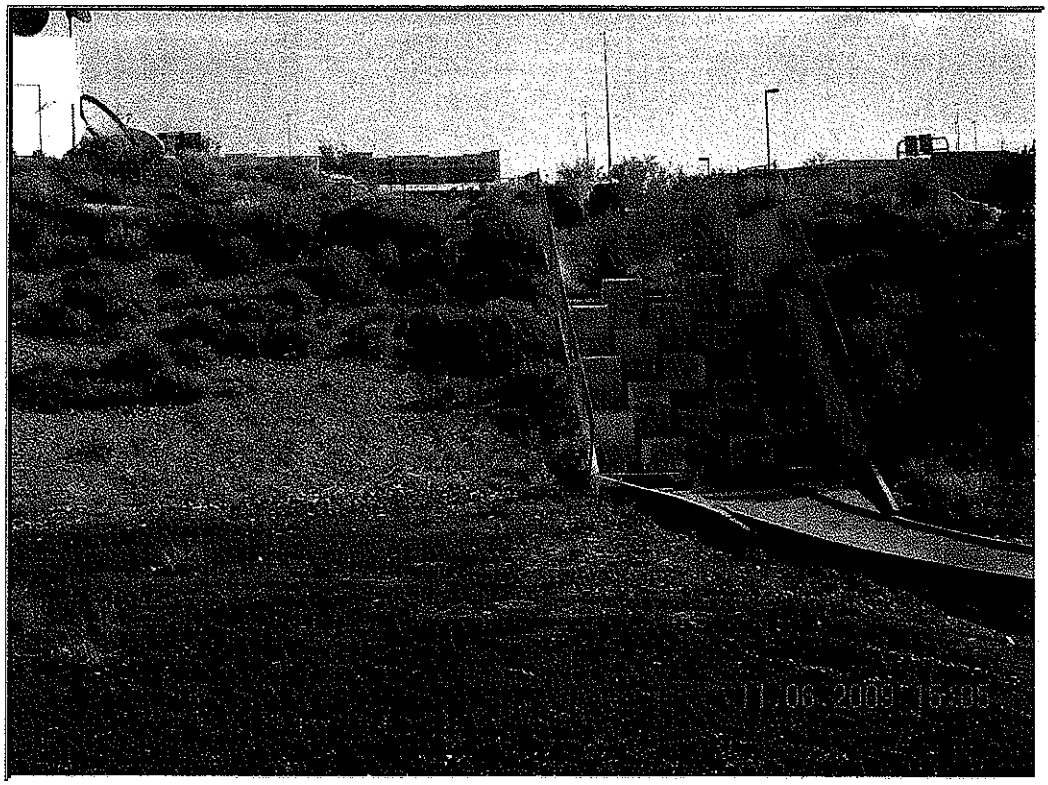
Location: 03 MENUAL POND INFLOW CHANNEL

FIELD NOTES no flow

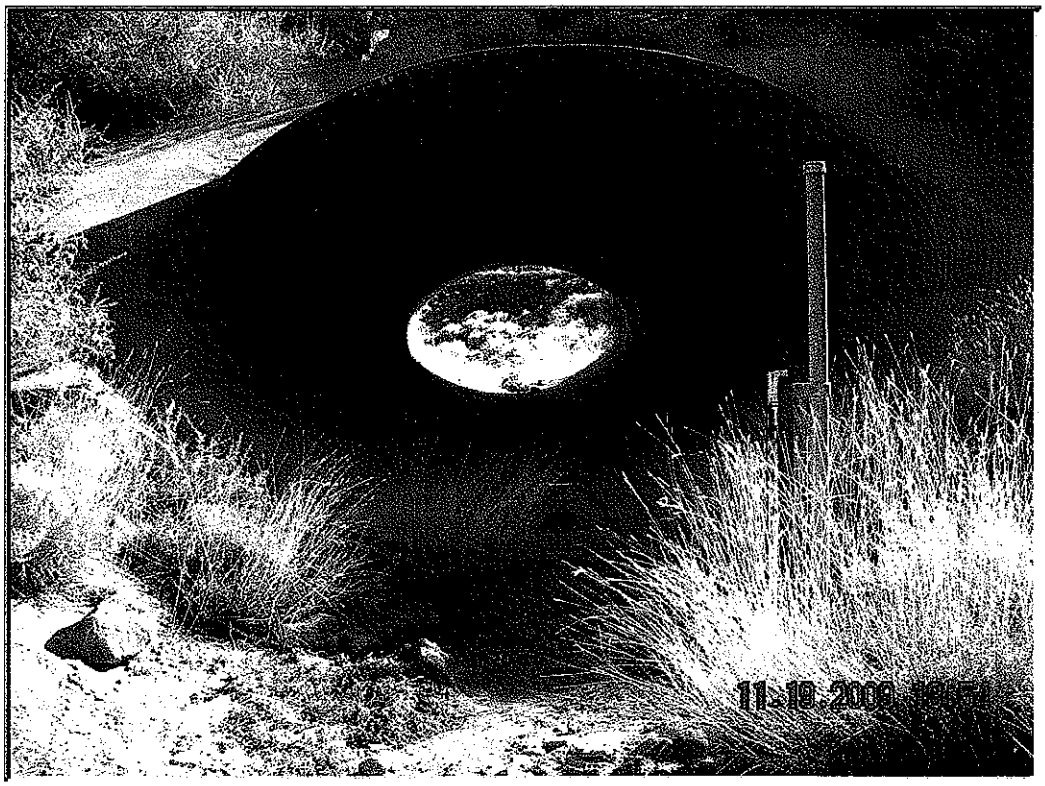
Location: 06 SAN ANTONIO ARROYO AT USGS GAGE (RIVER)

FIELD NOTES no flow

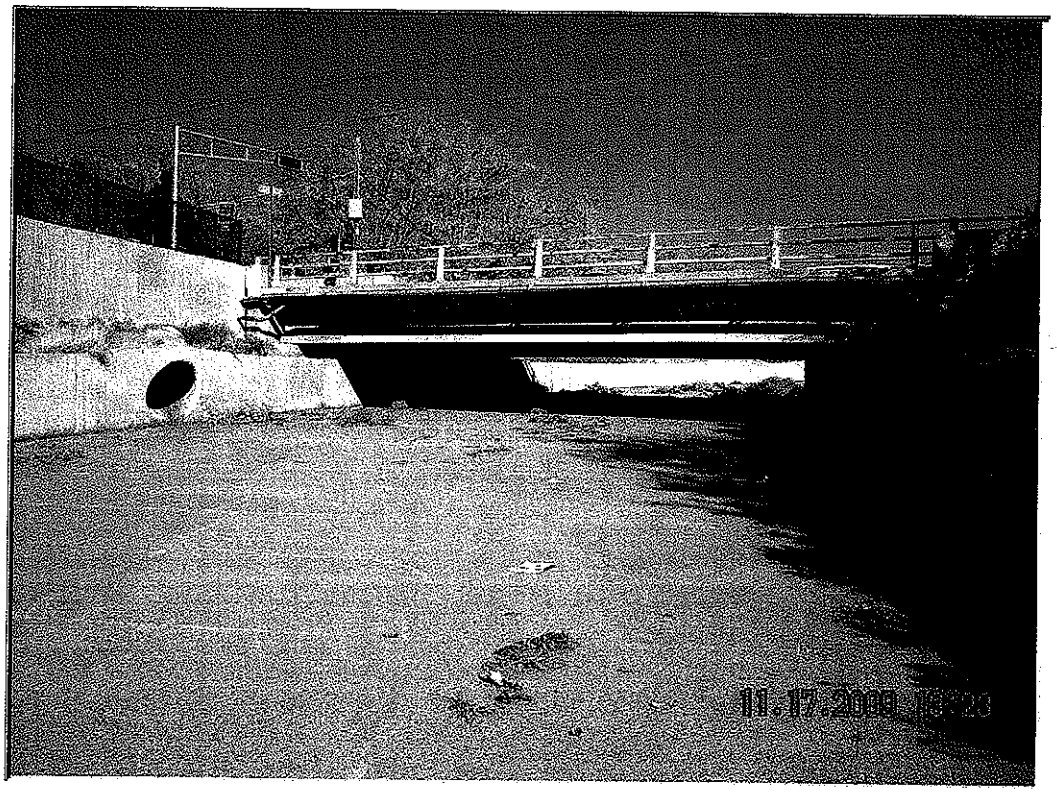
Location: 09 EMBUDO ARROYO AT PENNSYLVANIA

FIELD NOTES no flow

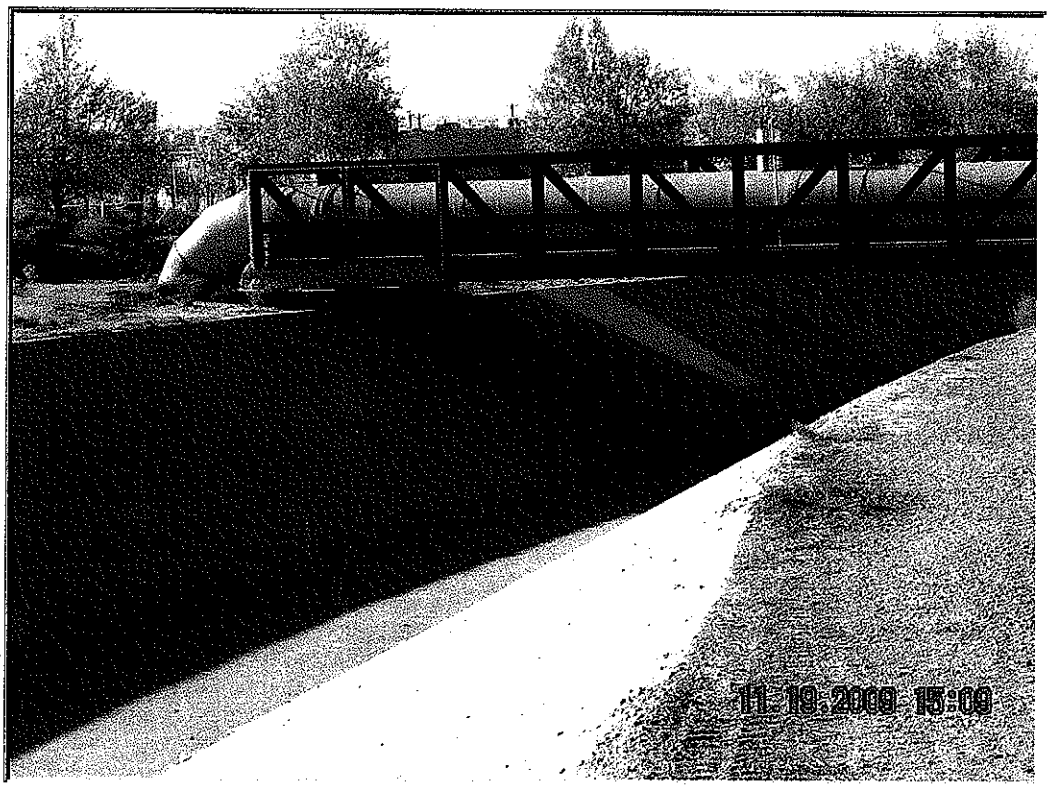
Location: 11 BEAR CANYON ARROYO AT NORTH DIVERSION CHANNEL-OSUNA

FIELD NOTES no flow

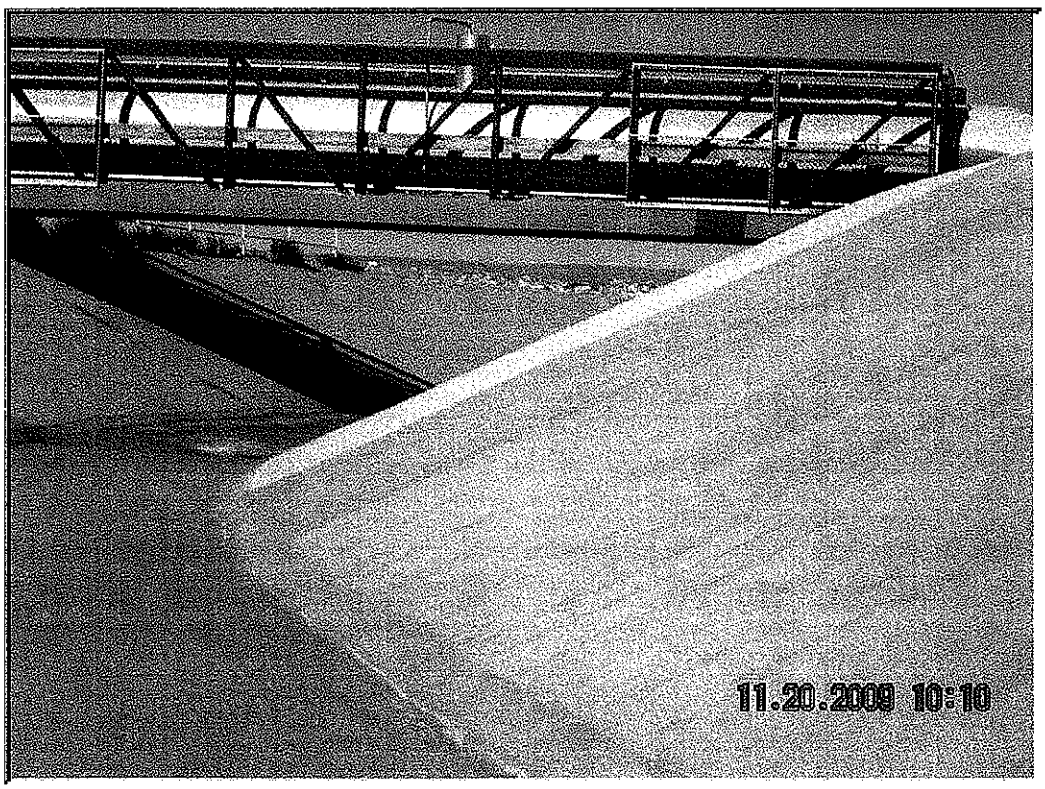
Location: 13 NORTH PINO ARROYO AT NORTH DIVERSION CHANNEL

FIELD NOTES no flow

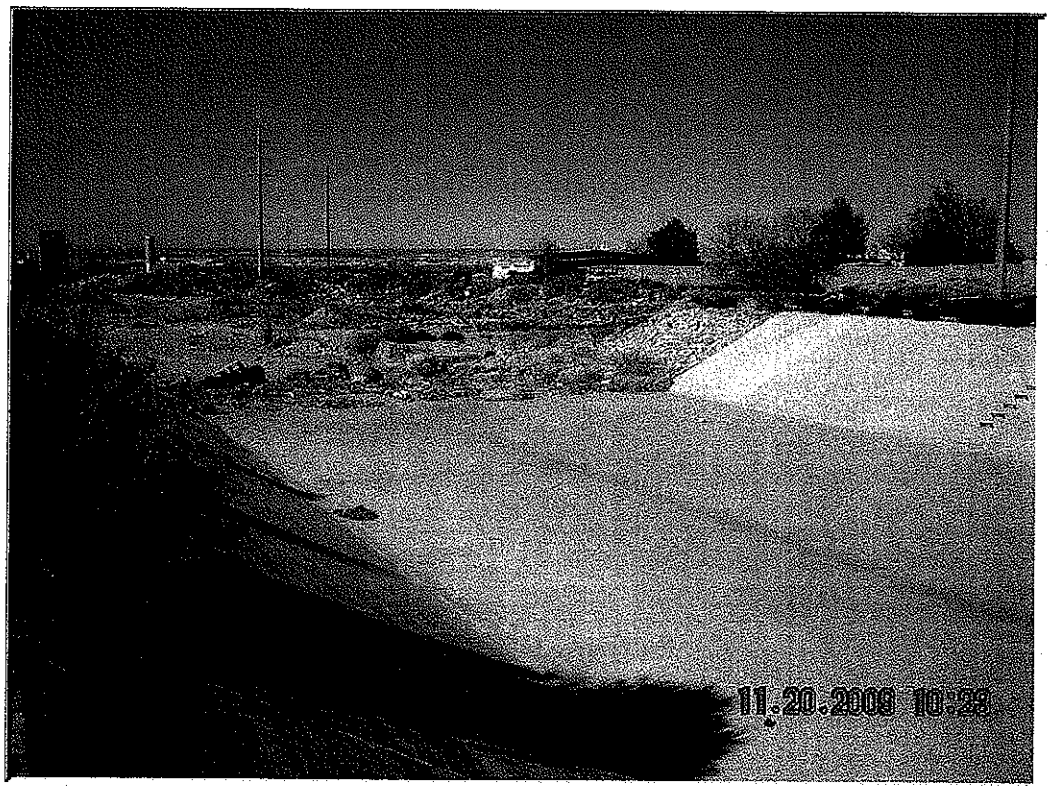
Location: 14 SOUTH DOMINGO BACA ARROYO AT WASHINGTON

FIELD NOTES no flow

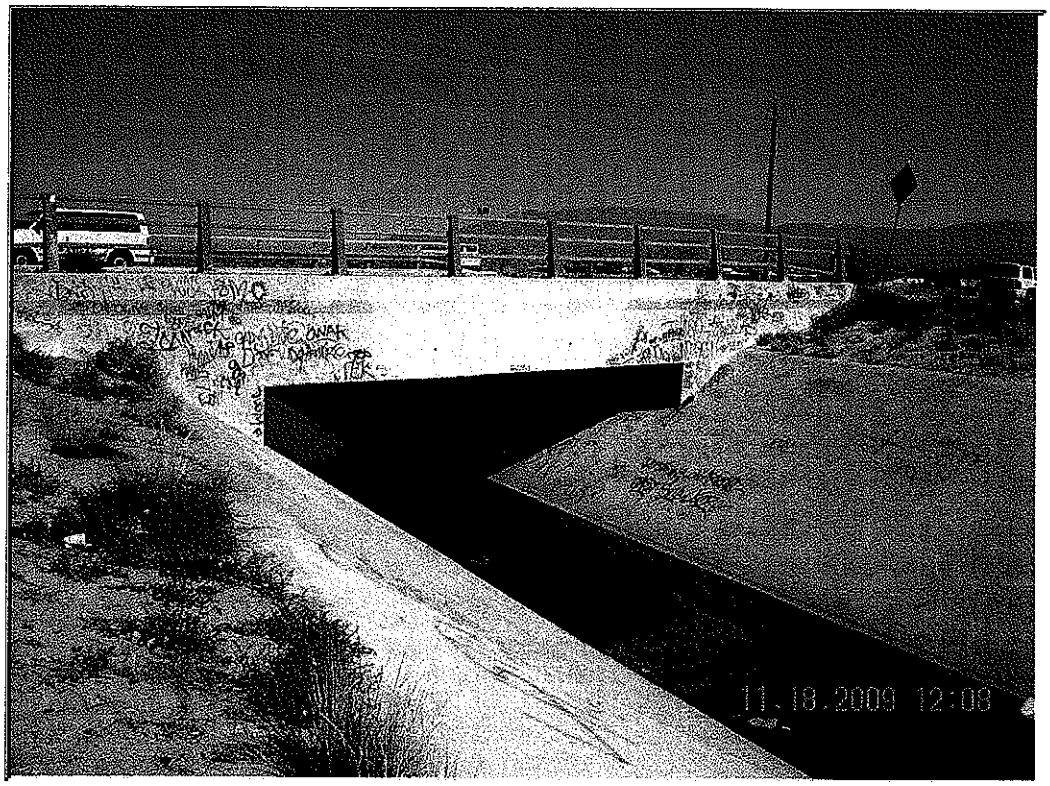
Location: 15 AMOLE DEL NORTE CHANNEL AT BLAKE RD

SUSPECTED PROBLEM TYPE Nuisance Flow

FIELD NOTES Engineer attempted to investigate the source of the nuisance flow but could not pinpoint it with accuracy. Suspected sources are potential leaks in nearby water supply lines or overwatering in nearby neighborhoods.

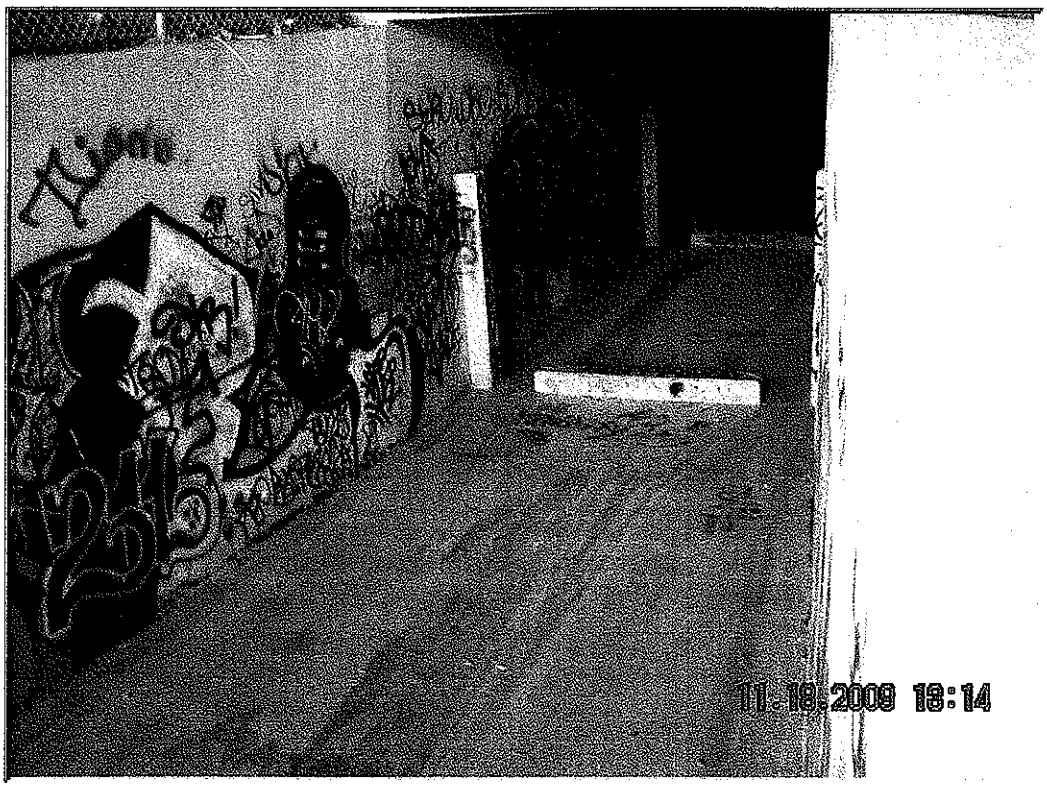
Location: 16 WEST BLUFF I-40 OUTFALL AT RIO GRANDE

FIELD NOTES no flow
